National Transportation Safety Board

Marine Accident Brief

Fire on Board Uninspected Towing Vessel Ivory Coast

Accident no.	DCA-12-LM-001
Vessel	<i>Ivory Coast</i>
Accident type	Fire
Location	General Ship Repair, near Domino Sugar Pier, Baltimore Northwest Harbor, Maryland 39° 16.46 N, 076° 36.02 W
Date	October 10, 2011
Time	1645 eastern daylight time (universal coordinated time – 4)
Damage	Estimated more than \$1 million
Injuries	None
Weather	North-northeast winds at 4 knots, visibility 10 mi., air temperature 82° F, dew point temperature 55° F

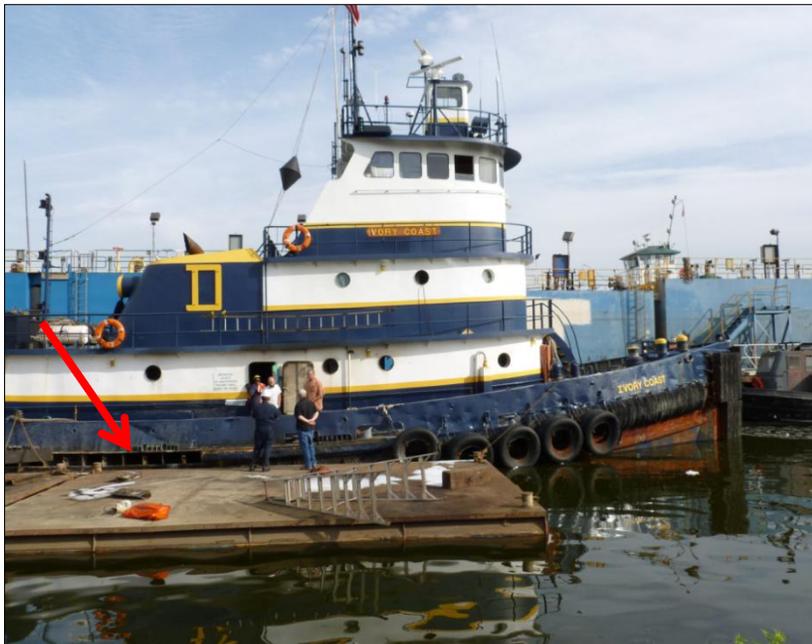
Ivory Coast starboard side showing area of hot work for replacement of rub rails (red arrow). (Photo: US Coast Guard)

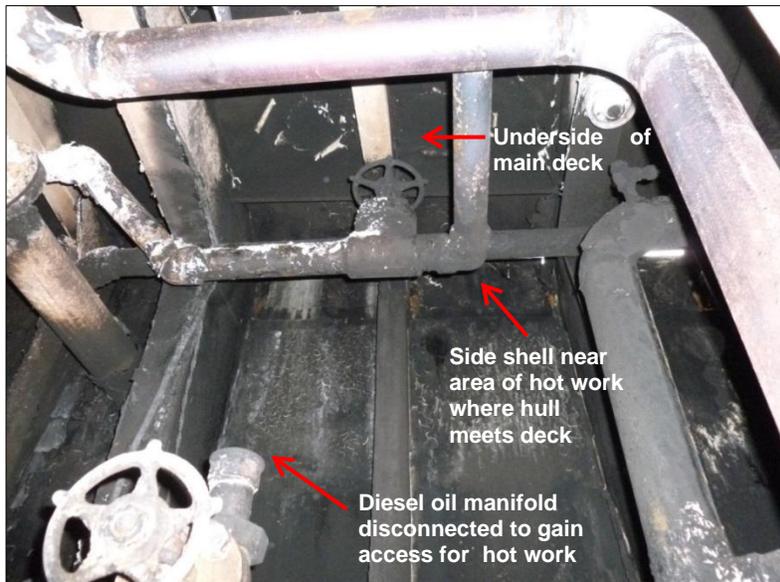
View of the starboard side engine room looking up to the point at which the side shell insert hull meets the underside of the main deck. As hot work was performed at this location, sparks fell down into the engine room onto a wooden cabinet located below this area. (Photo by US Coast Guard)

The chief engineer stated that before starting hot work he drained and disconnected the diesel oil manifold so the shipfitter could gain access for the repairs. He also said that below the manifold was a wooden tool box, which over time had become saturated with diesel oil. This was confirmed by testing of a sample of residue from the wooden box by the Bureau of Alcohol, Tobacco, Firearms, and Explosives (ATF). Therefore, a possible ignition source of the fire could have been a shipfitter's spark igniting the unprotected diesel oil-soaked wooden tool box below the area of the hot work.

The National Transportation Safety Board determines the probable cause of the fire on board the uninspected towing vessel *Ivory Coast* was sparks from welding and cutting repair work conducted with an oxygen-acetylene torch igniting unprotected combustible material in the engine room.
