National Transportation Safety Board

Marine Accident Brief

Sinking of Uninspected Fishing Vessel Plan B in Gulf of Maine

| Accident no. | DCA12LM010 |

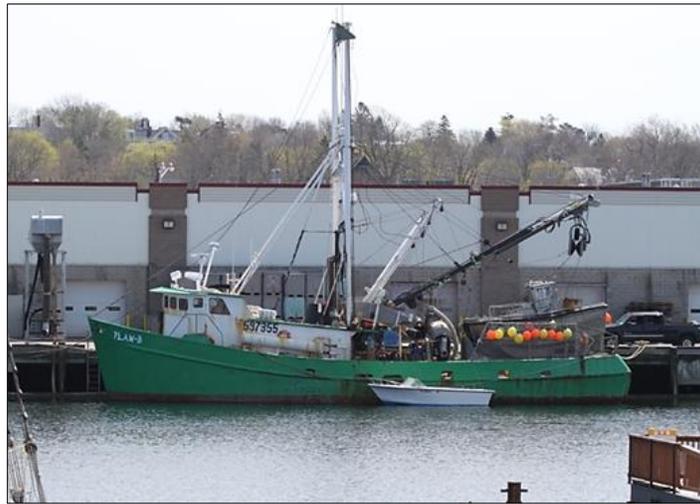
The fishing vessel *Plan B* from the port side at the berth. The vessel's skiff on the stern was not on board at the time of the sinking.

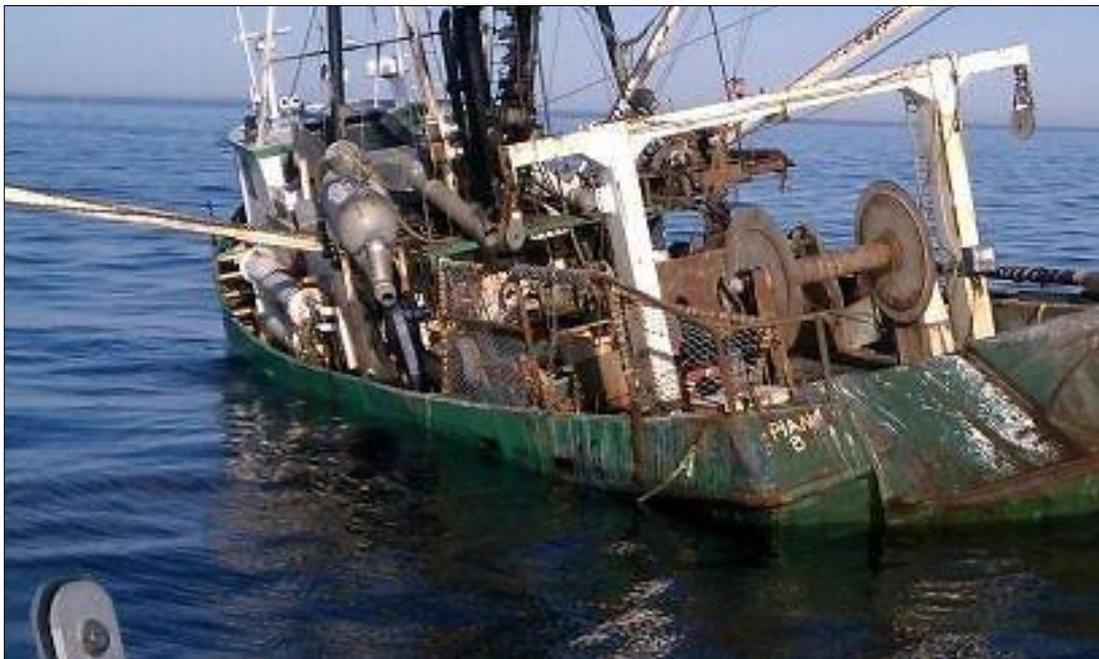
While opening the starboard fish-hold tank valve (located in the main engine room) to dewater the fish tank, the pipe broke and allowed seawater to flood into the engine room through the 4-inch pipe. The captain attempted to run the vessel's pumps to remove the water; however, the pumps could not keep up with the ingress of water. He tried to plug the pipes to stop the flooding, but they failed to hold. About 30 minutes later, when the engine room was flooded about 3 feet deep, the captain called the US Coast Guard and said that the water had reached "almost to the engine, with secondary alarms starting to sound."

As the flooding increased, the captain was soaked by water and received shocks as electrical panels and wires were shorting. The continued flooding and the inability of the crew to arrest it led to the eventual sinking and total loss of the vessel and equipment. (The loss of a mechanically propelled vessel of 100 gross tons or more is classified as a major marine casualty.) The crew of a nearby good samaritan vessel, the lobster boat *Cameron Lee*, assisted the captain and the deckhand as they departed the sinking *Plan B*.

The *Plan B* listing to port before sinking. (Photo by Coast Guard)

The National Transportation Safety Board determines that the probable cause of the *Plan B* sinking was the inability of the crew to control flooding from the broken PVC (polyvinyl chloride) pipe, which was in open communication with the sea.
