National Transportation Safety Board

Marine Accident Brief

Fire on Board Passenger Vessel *Safari Spirit*

Accident no.	DCA-12-LM-016
Vessel name	<i>Safari Spirit</i>
Accident type	Fire
Location	Pier 9, Fisherman's Terminal, Seattle, Washington 47°39.385' N, 122°22.896' W
Date	April 27, 2012
Time	0100 Pacific daylight time (coordinated universal time – 7 hours)
Damage	Est. \$1.5 million
Injuries	None
Environmental damage	None
Weather	Winds southerly at 10 knots, air temperature 45° F, sky overcast, visibility good
Waterway characteristics	Fisherman's Terminal, a marina near the Lake Washington Ship Canal about 1.5 miles east of Puget Sound

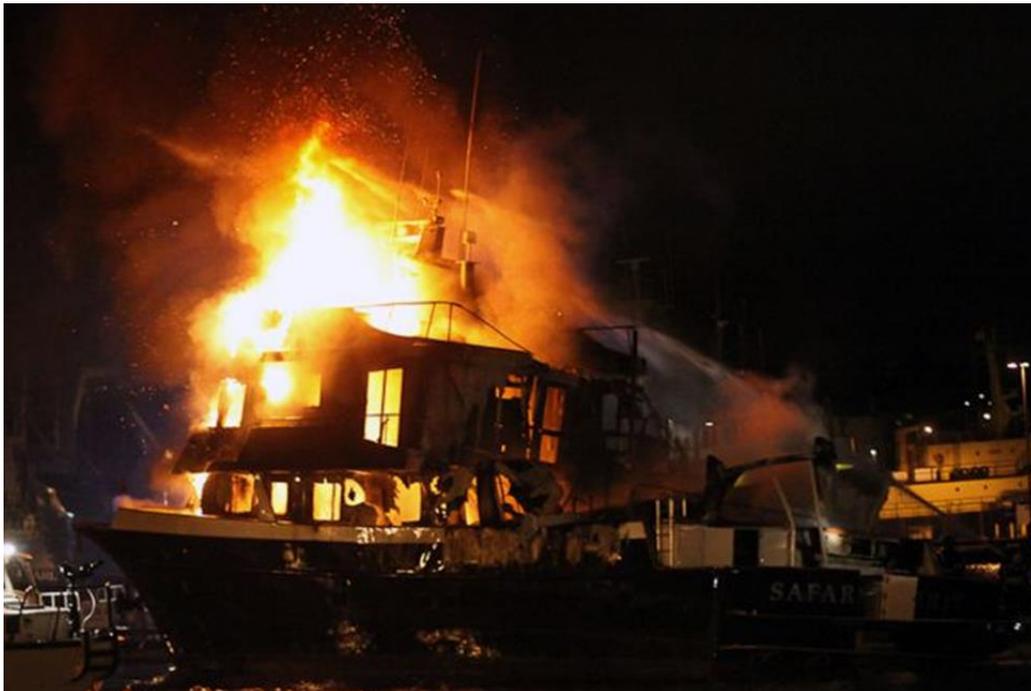
Safari Spirit ablaze at Fisherman's Terminal in Seattle, Washington. (Photo by Joshua Lewis, KOMO News)

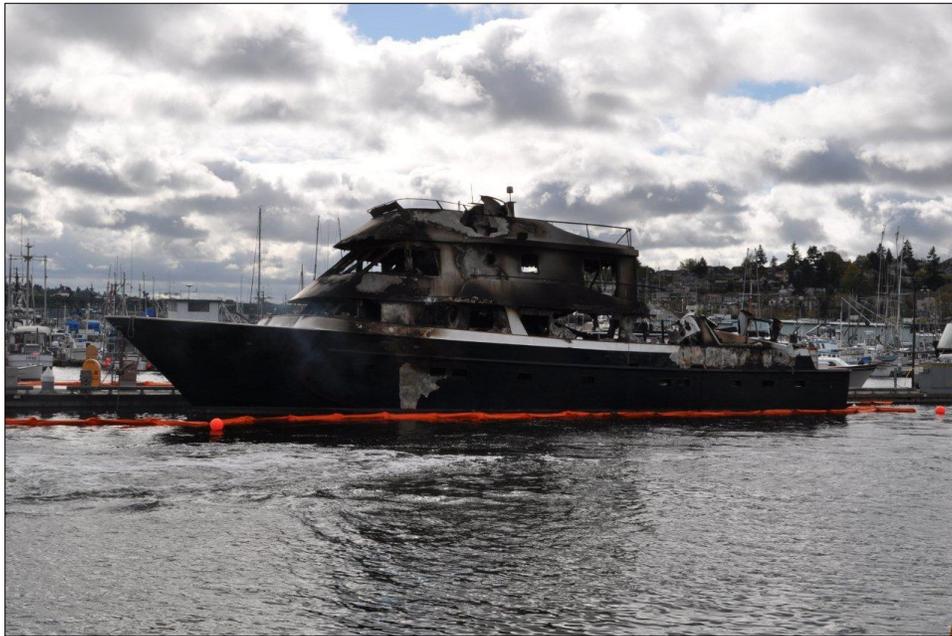
Charred wreckage of the *Safari Spirit*. (Photo from Bowditch Marine, Inc.)

The National Transportation Safety Board determines that the fire aboard the passenger vessel *Safari Spirit* ignited due to unknown causes and was accelerated by the flammable materials stored on the aft portion of the main deck.
