National Transportation Safety Board

Marine Accident Brief

Dockside Capsizing and Sinking of Towing Vessel *Invader* and *Dry Dock #3*

Accident no.	DCA-12-LM-013
Accident type	Capsizing and sinking
Vessels	Uninspected towing vessel <i>Invader</i> and <i>Dry Dock #3</i>
Location	Vigor Industrial Shipyard, Port of Everett, Washington (47°58.904' N, 122°13.101' W)
Date	March 18, 2012
Time	0630 Pacific standard time (UTC -8)
Injuries	None
Property damage	<i>Invader</i> : More than \$5 million <i>Dry Dock #3</i> : \$818,000
Environmental damage	Minor
Weather	Mostly cloudy with a trace of rain; east winds at about 5 mph; air temperature about 40° F
Waterway characteristics	Port Gardner Bay, eastern Puget Sound, Washington (see NOAA chart 18444 for additional information)

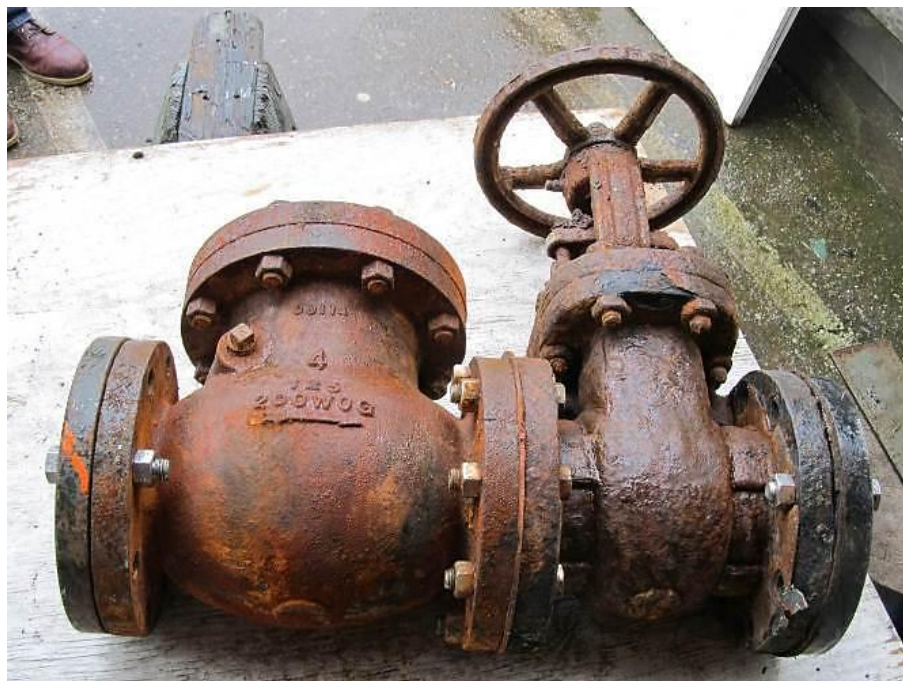
Check (left) and discharge valves from Dry Dock #3. (Photo by Bowditch Marine, Inc.)

During the day on March 17, 2012, pumping activities had taken place on board *Dry Dock #3*. That evening, water leaked past the check valve of Tank #5 on the dry dock's starboard side; debris in the check valve prevented it from closing. In addition, the 4-inch discharge valve had been left open (even though the dock master told investigators it was customary to close the discharge valves after use), and this allowed ingress of water. The weight of the water gradually caused the dry dock to list to starboard. Further, the cover plates to the access manholes on Tanks #1 and #7 had been left open and unattended. As the dry dock continued listing to starboard, water began flooding through the open manholes into Tanks #1 and #7, causing additional listing. As the flooding progressed, the *Invader* fell off its support blocks placed on the dry dock's floor, set heavily against the dry dock's starboard wall, and then partially sank. *Dry Dock #3* also sank as a result of the flooding; however, both the *Invader* and the dry dock were later refloated. Fuel and liquids were pumped from both the *Invader* and *Dry Dock #3* during salvage operations and pollution was minimal.

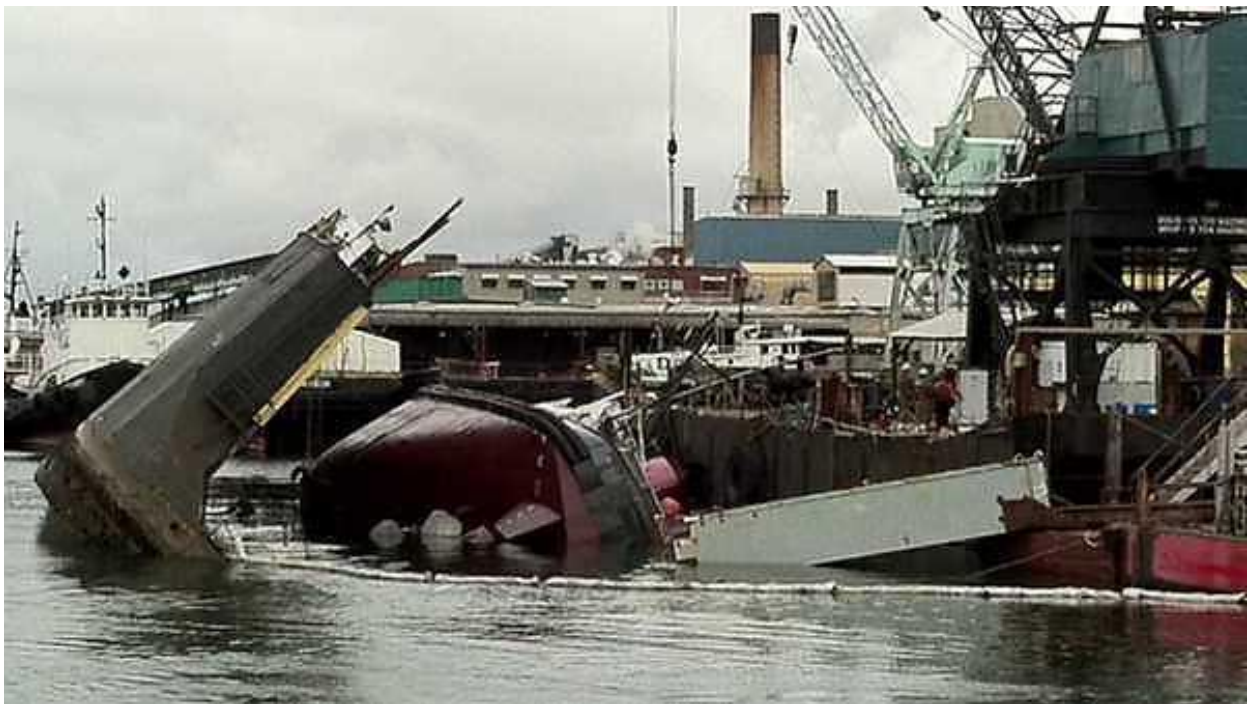
The capsized *Invader* and *Dry Dock #3*. (Photo by KCPQ, Seattle, Washington)

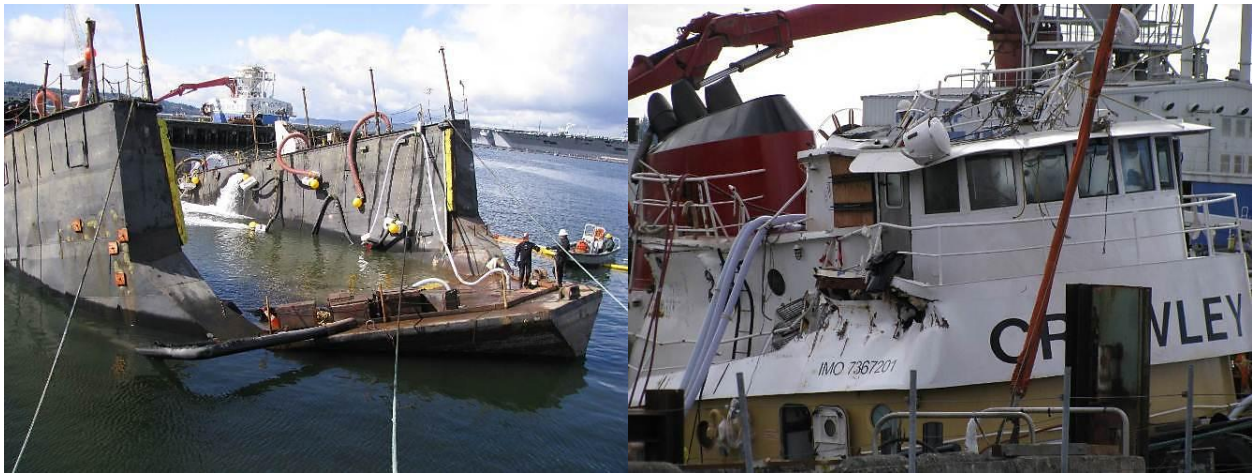
The damage to *Dry Dock #3* was estimated to be \$818,000. The *Invader* was a total constructive loss at over \$5 million.

Damaged *Dry Dock #3* and the damaged *Invader*. (Photos by Bowditch Marine, Inc.)
