National Transportation Safety Board

Marine Accident Brief

Allision of Tanker *Overseas Reymar* with San Francisco–Oakland Bay Bridge

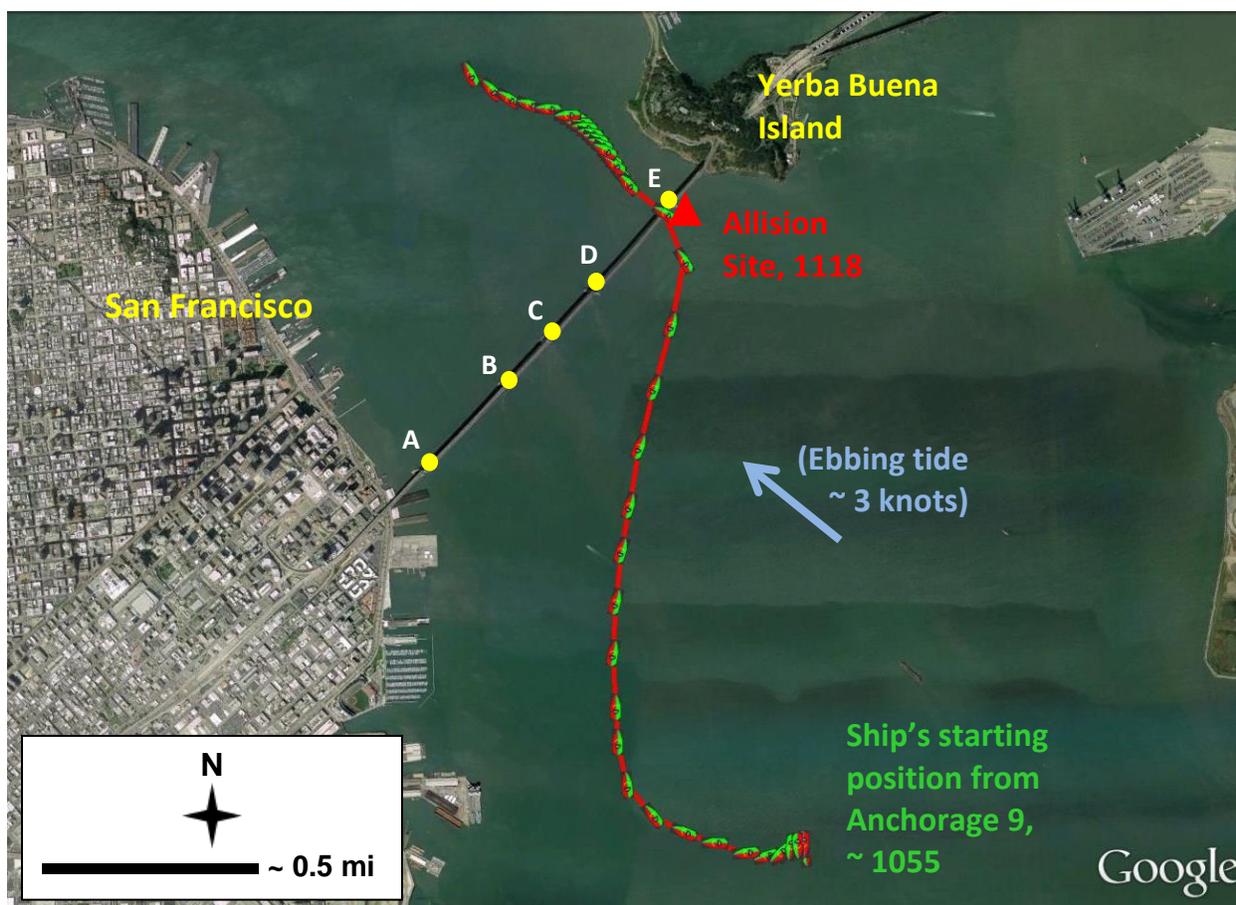
Aerial view of San Francisco Bay. The *Overseas Reymar* was proceeding from Anchorage 9 south of the Bay Bridge to the sea. The vessel’s trackline is overlaid in red and green. The towers and pier on the bridge’s San Francisco side are overlaid in yellow. (Background by Google Earth)

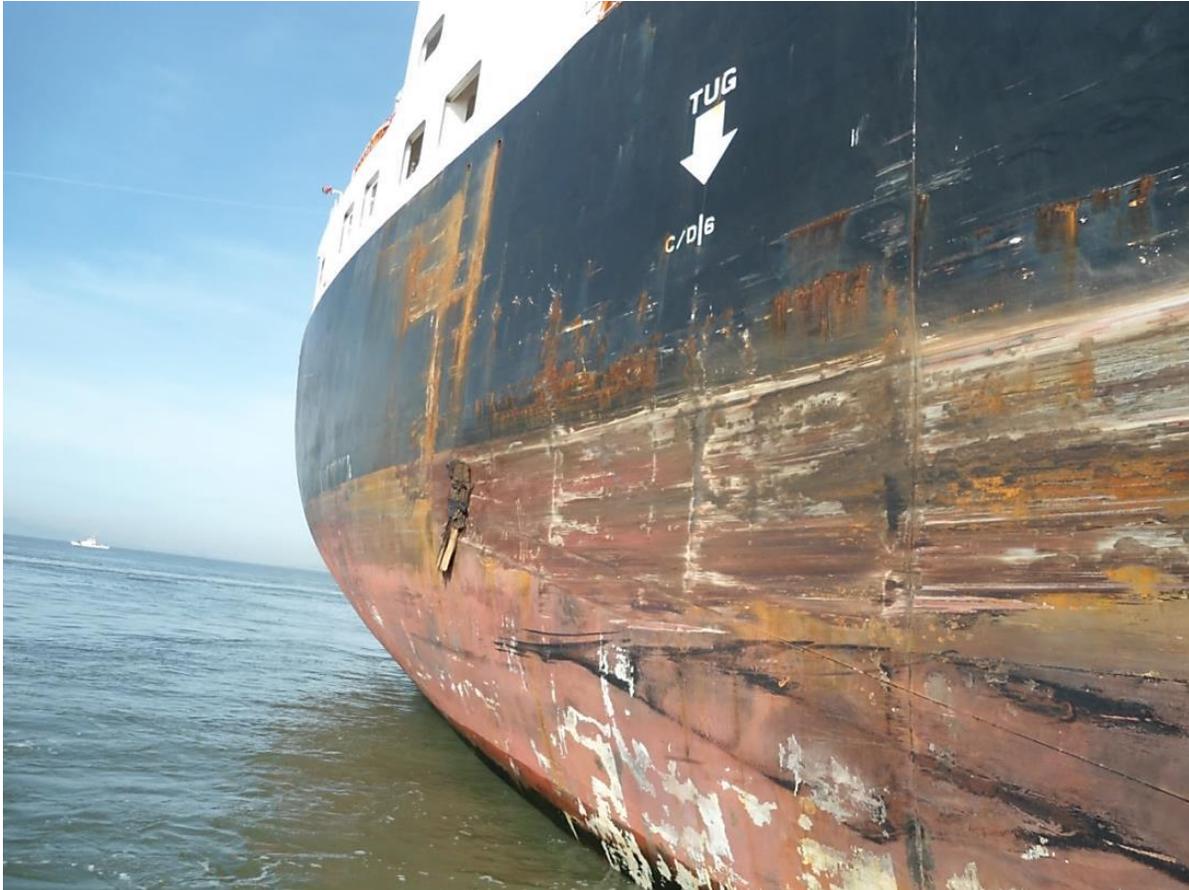
At 1115:46, the pilot ordered the rudder hard to port to align the ship for passage under the DE span. At 1117:25, VTS contacted the pilot and informed him that the vessel was proceeding directly toward the Echo tower. The pilot replied, "We're going under the bridge right now." Seconds later, about 1118, the vessel's aft starboard side allided with the Echo tower's fendering system.

Allision damage to the *Overseas Reymar's* aft starboard side. (Photo provided by the Coast Guard)

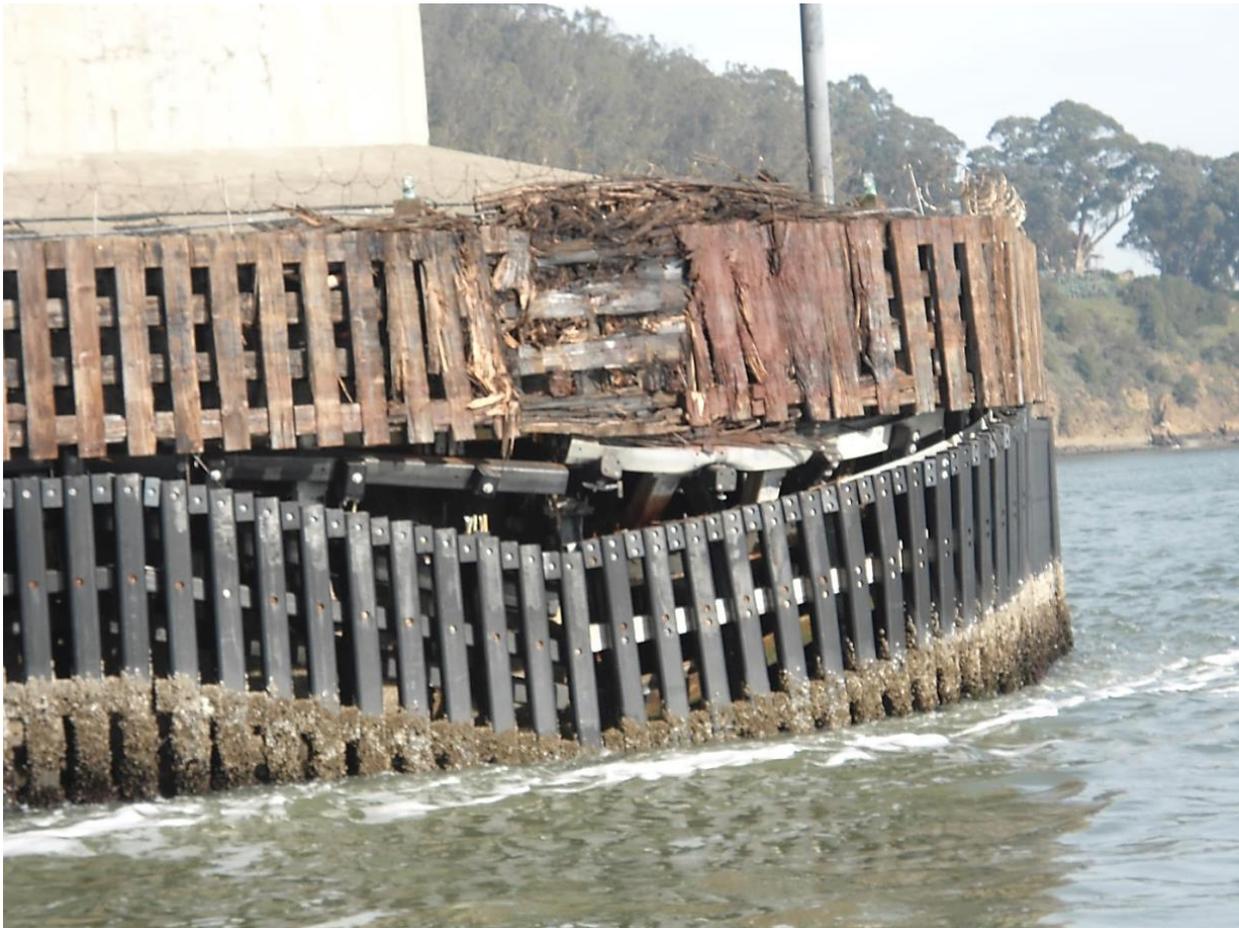
On January 7, 2013, at 1118 local time, the 752-foot-long tanker *Overseas Reymar* allided with the fendering system of the San Francisco–Oakland Bay Bridge's Echo tower. The vessel was outbound in San Francisco Bay. No one was injured and no pollution was reported. Damage to the vessel was estimated at \$220,000, and the cost to repair the Echo tower's fendering system was estimated at \$1.4 million.

Damage to the Echo tower's fendering system. (Photo provided by the Coast Guard)
