National Transportation Safety Board

Marine Accident Brief

Engine Room Fire On Board Towing Vessel *Marguerite L. Terral*

Accident no.	DCA-12-LM-020
Vessel name	<i>Marguerite L. Terral</i>
Accident type	Fire
Location	Lower Mississippi River, mile marker 911, near Hickman, Kentucky
Date	June 9, 2012
Time	1705 central daylight time (coordinated universal time –5 hours)
Injuries	None
Damage	\$2.6 million
Environmental damage	No discharge of oil reported
Weather	Clear skies; winds 10–15 knots from the south-southeast; visibility of 5 nautical miles; air temperature 85°F; river current at 3 knots to the south.
Waterway information	Mississippi River – Major water highway. The US Army Corps of Engineers maintains a 9-foot-deep shipping channel for towboats and barges between Baton Rouge, Louisiana, and Minneapolis, Minnesota.

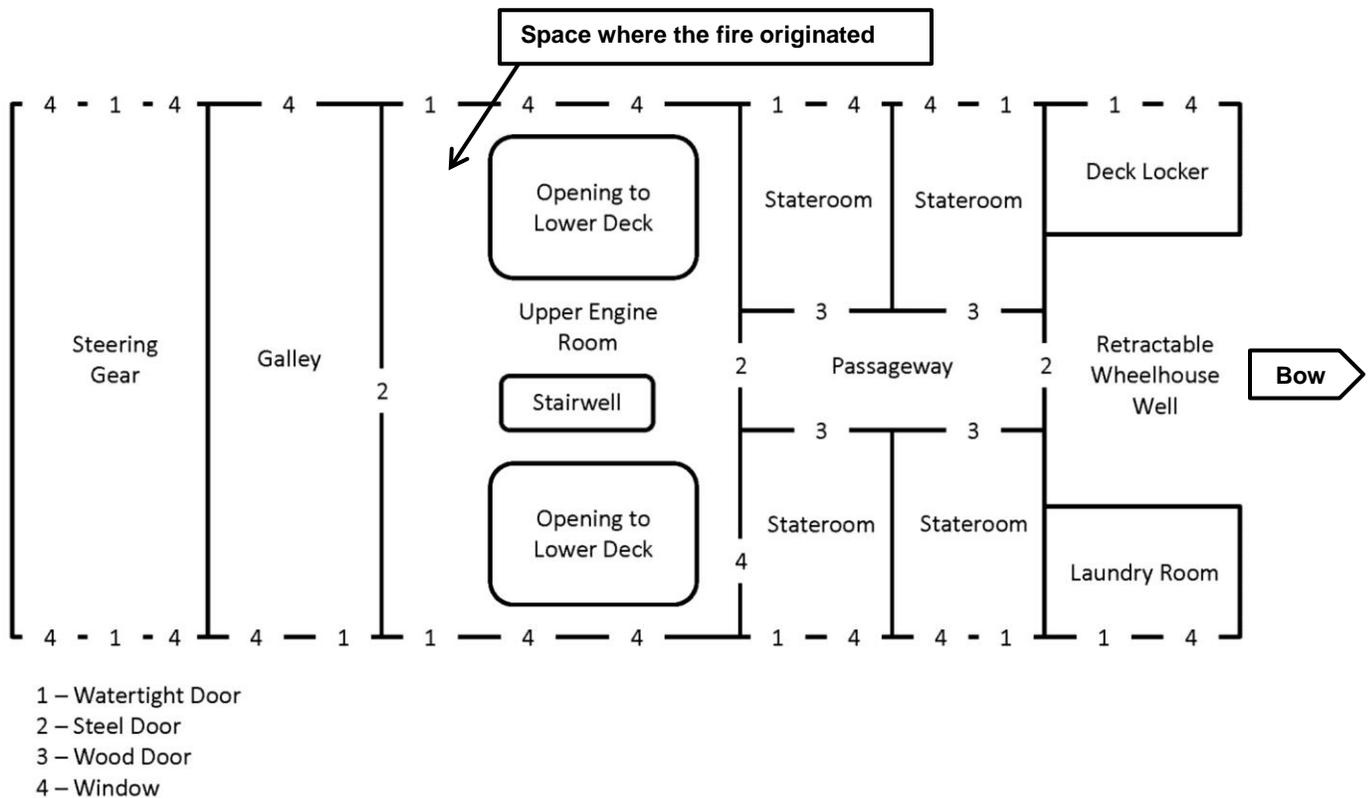
The *Marguerite L. Terral* was equipped with a fixed CO₂ fire suppression system for the engine room. At 1706, the captain and two deckhands tried to reach one of the stations for releasing the CO₂ remotely (the station located on the exterior of the vessel, aft of the portside door to the engine room). However, because the portside door to the engine room was open—like the starboard-side door—smoke and fire extended out from the engine room, preventing the crew from reaching the CO₂ pullboxes. The fire suppression system could also have been activated directly from the manual pull at the CO₂ bottles located in the steering gear room; however, no evidence indicates that the crew attempted to activate the system from this room.

Drawing of the main-level layout on board the *Marguerite L. Terral*. (Original drawing by the Coast Guard's Towing Vessel National Center. For the purpose of this report, the drawing has been slightly modified.)

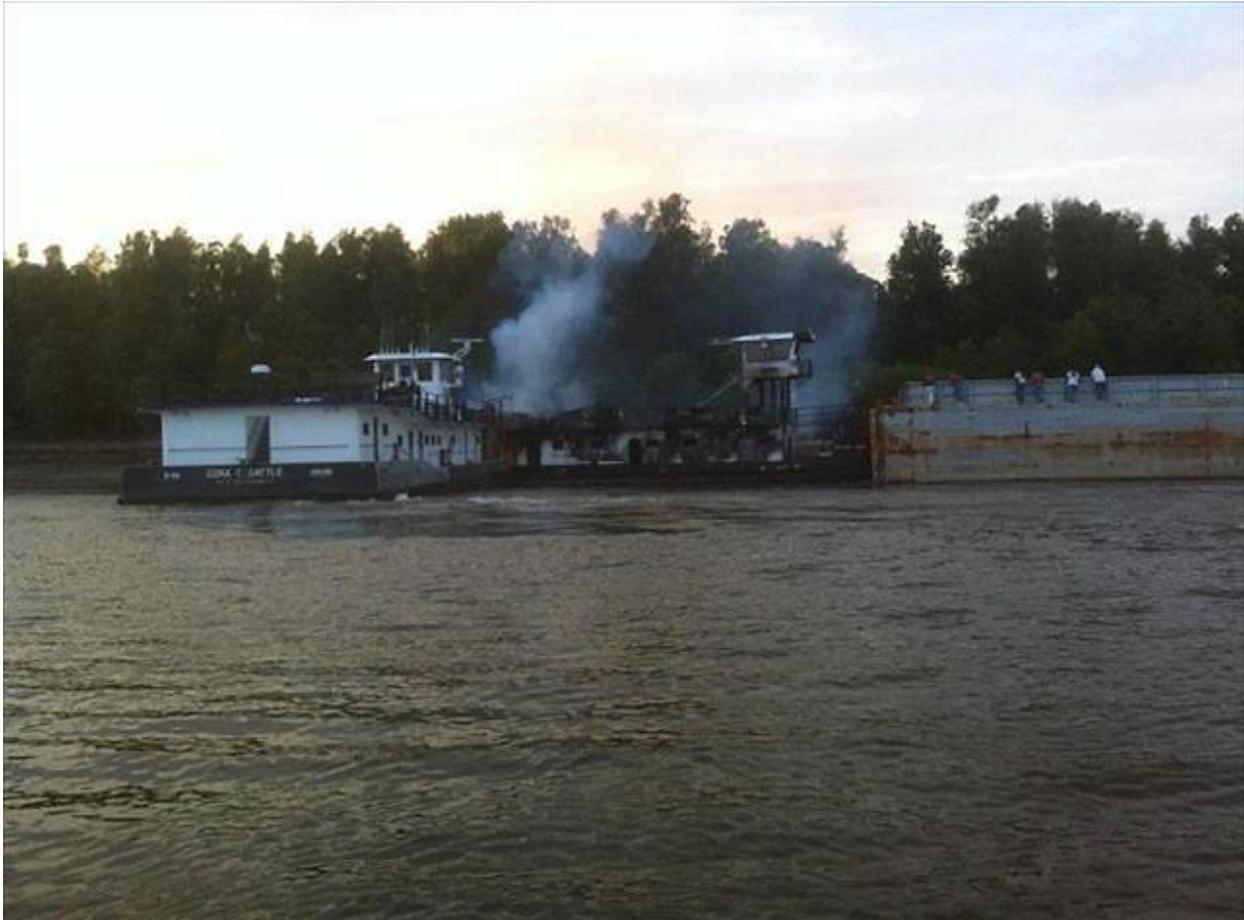
The scene after the assisting towing vessel *Edna T. Gattle* arrived. The evacuated crewmembers from the *Marguerite L. Terral* are standing on the barge adjacent to their vessel. (Photo provided by the Coast Guard; unknown photographer)

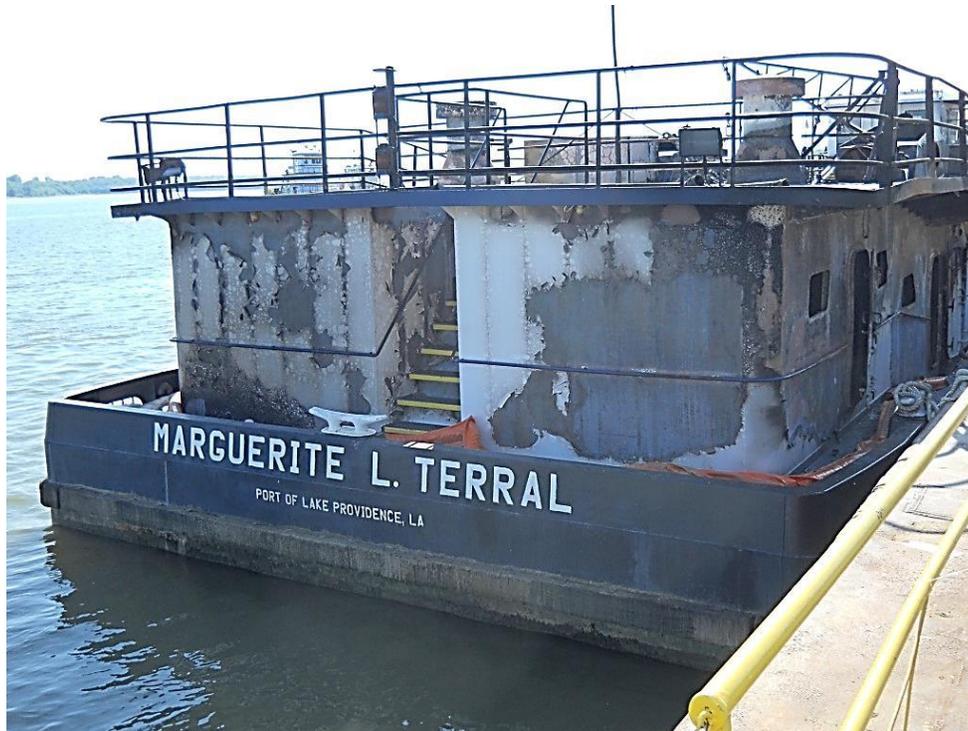
All spaces and equipment on the *Marguerite L. Terral*'s main and upper decks were damaged or destroyed, except for the wheelhouse and the portside deck locker. The fire spread from the engine room to the staterooms and laundry room through a window between the engine room and one of the staterooms. This window gave way from the intensity of the fire's heat. Below the main deck, the damage was limited to the engine room.

Fire damage to the vessel. (Photo by the Coast Guard)

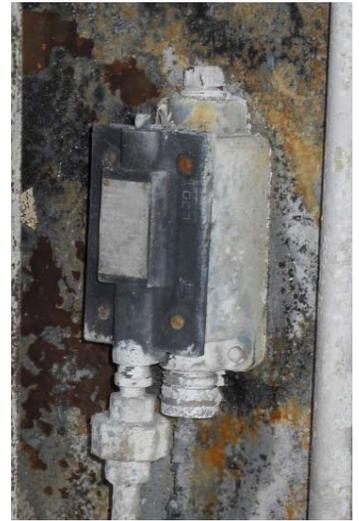
Recently, a vessel with an installed fixed CO₂ fire suppression system, suffered extensive damage due to a fire that started in the engine room. During the firefighting efforts the crew reported that the engine room ventilation could not be secured. A post casualty damage survey of the vessel revealed that the pressure switch used to secure the ventilation was located within the engine room. See the photograph of the damaged pressure switch at the right and new switch below.

The Coast Guard **strongly reminds** Owners and Operators of vessels with installed fixed fire suppression systems to ensure that these switches are properly located aboard their vessels. If the pressure switch or switches are located within the space being protected, they should be relocated by a properly trained fire suppression service technician. Doing so will assist in ensuring system functionality and accessibility in the event of an emergency. Failing to do so could have serious consequences to the vessel, its crew and the environment.
