# National Transportation Safety Board

## Marine Accident Brief

### Foundering of the Fishing Vessel *Moonlight Maid*

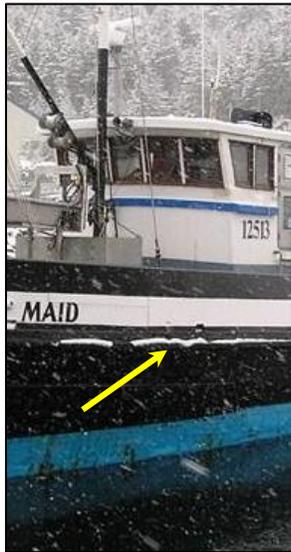
Arrow indicates snow-covered rub rail on *Moonlight Maid*.

At 1700, with the vessel east of Seal Rocks, the master had the watch crewmember take the wheel so he could check the engine room. He discovered a “fair amount of water” in the tool room, a space forward of the engine room. The master put both bilge pumps online and said the situation was then “OK.” When he returned to the wheelhouse through the engine room, he noticed that a 3- to 4-foot section of hull planking in way of the port rub rail was missing, and another section 10 to 12 feet long was loose.

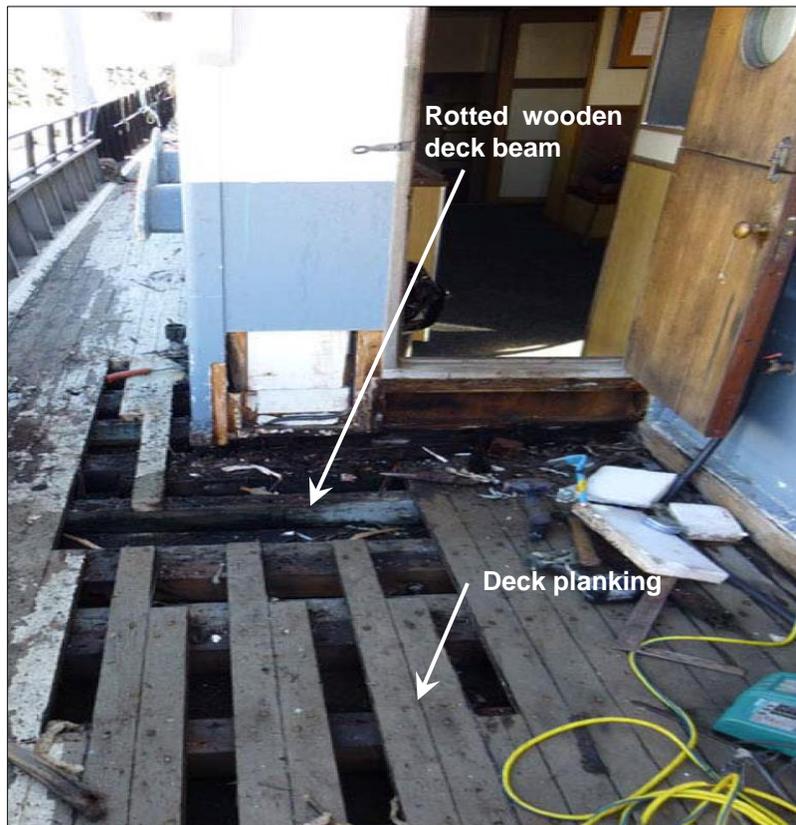
During the repair work, evidence was found of severely rotted deck beams that supported planking (see photo at right). This rot may have extended to the adjacent hull frames, which would have compromised the frames to which the rub rail and hull planking were fastened. The Coast Guard investigation report for this accident also found the port rub rail was attached to planking and structural members that were in need of replacement.

***Moonlight Maid* portside deck under repair, Seward Dock, September 2012. The top arrow indicates an area of rot found in structural member. (Photo provided by Coast Guard Sector Anchorage)**

The National Transportation Safety Board determines that the probable cause of the foundering of the wooden-hulled fishing vessel *Moonlight Maid* was the detachment of portside hull planking in heavy weather, which resulted in uncontrolled flooding. Contributing to the hull failure was inadequate maintenance of the aging wooden vessel.
