National Transportation Safety Board

Marine Accident Brief

Allision of Tanker *Wawasan Ruby* with CSX Bayside Coal Pier

Accident no.	DCA-12-LM-025
Vessel name	<i>Wawasan Ruby</i>
Accident type	Allision
Location	CSX Bayside Coal Pier, Curtis Bay coal facility, Baltimore, Maryland 39° 13.30' N, 76° 34.57' W
Date	August 25, 2012
Time	1245 eastern daylight time (coordinated universal time –4 hours)
Injuries	One worker on the pier sustained moderate back and shoulder injuries
Damage	Pier: More than \$2 million; <i>Wawasan Ruby</i> : \$15,000
Environmental damage	None
Weather	Partly cloudy; good visibility; winds out of the east at 10 knots; air temperature 77°F
Waterway information	Baltimore Harbor, Curtis Bay, Curtis Bay Channel

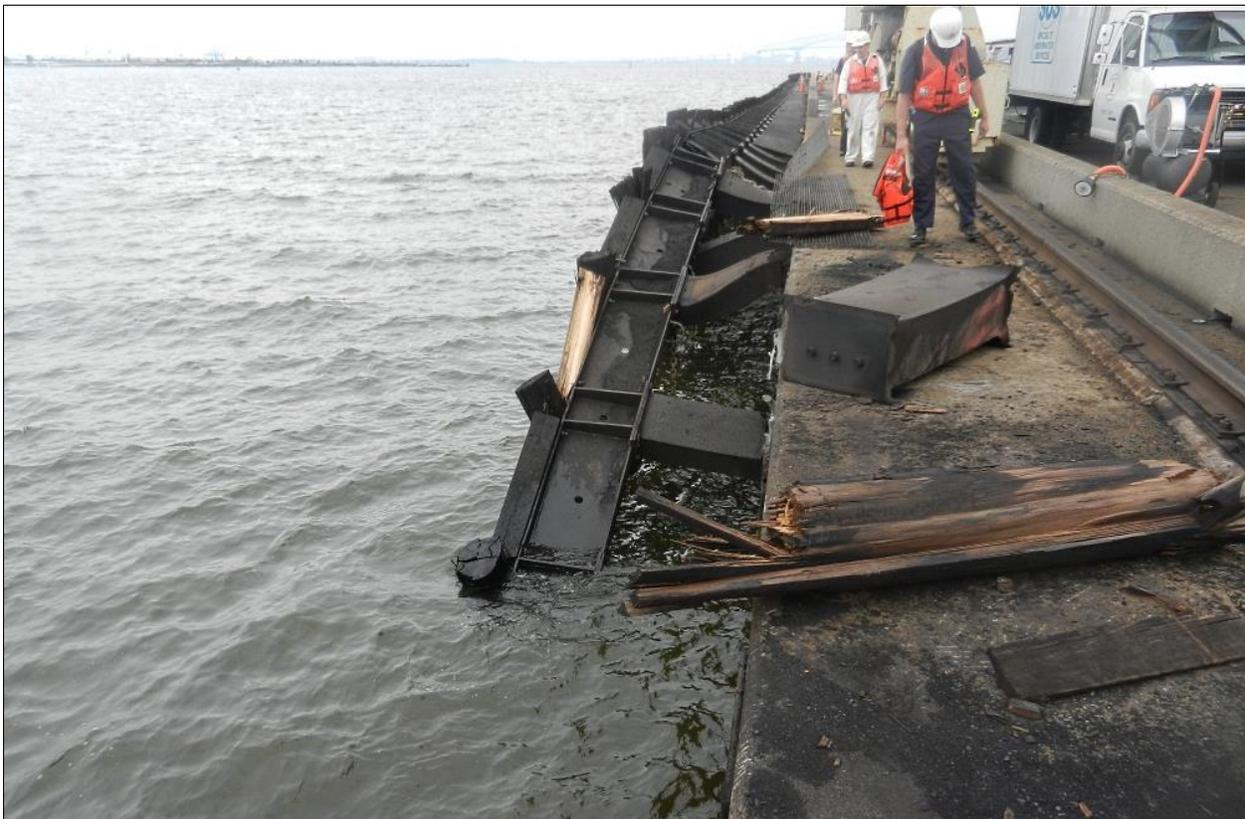
As the *Wawasan Ruby* approached the CSX Pier, no one on board the ship sounded the whistle to warn of the impending allision. Forward momentum carried the vessel's bow, particularly the bulbous lower portion, into the pilings under the dock of the CSX Pier. As the ship continued forward, it broke the pilings along a roughly 200-foot-long stretch until finally coming to a stop. The allision also damaged the pier's horizontal timbers, the fendering system on the dock, and the securing bolts and concrete. The upper part of the *Wawasan Ruby* bow struck and damaged the crane (loader) on the pier. A worker on the crane sustained back and shoulder injuries as a result of the allision.

The CSX Pier after the allision. (Photo by the US Coast Guard)

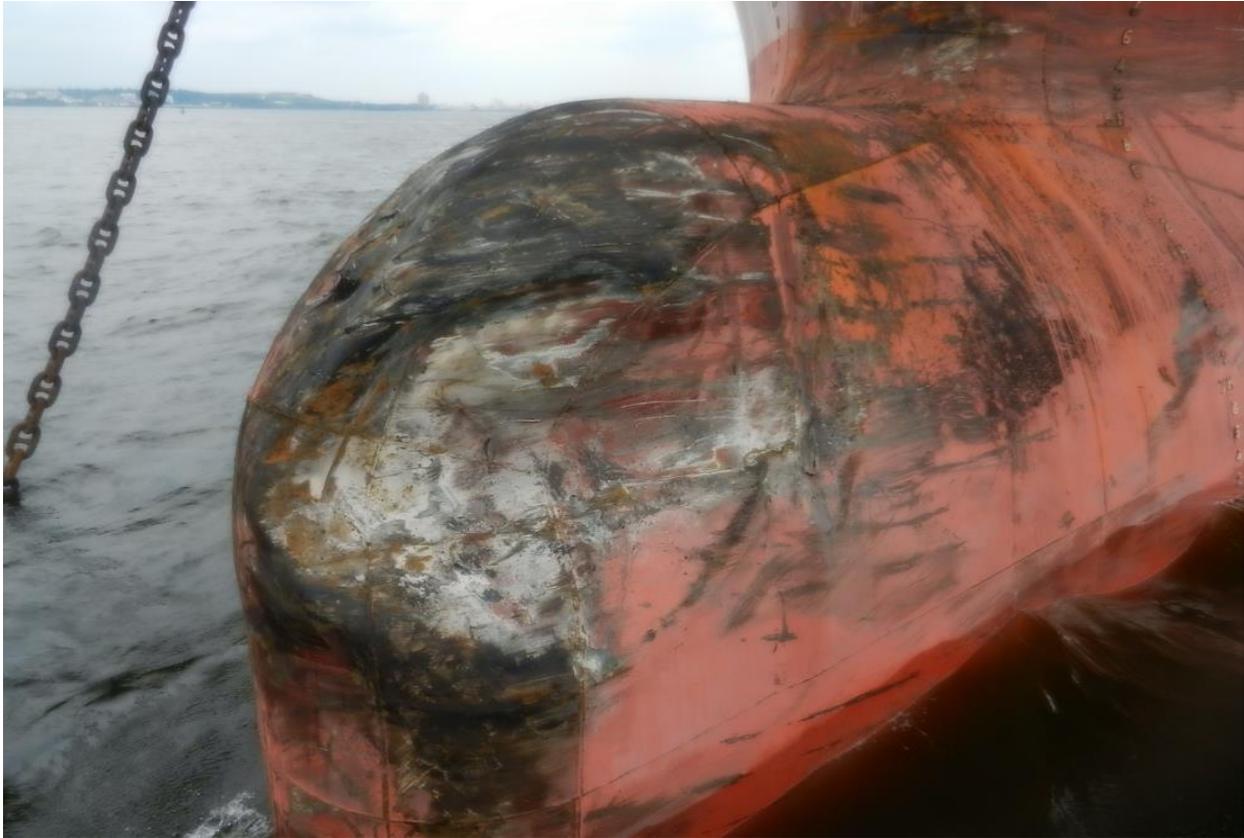
The damaged bulbous bow of the *Wawasan Ruby* after the allision. (Photo by the Coast Guard)
