National Transportation Safety Board

Marine Accident Brief

Sinking of Towing Vessel *Delta Captain*

Accident no.	DCA-13-NM-016
Vessel name	<i>Delta Captain</i>
Accident type	Sinking
Location	Pacific Ocean, 13 nautical miles west of Point Sur, California 36°17.9' N, 122°09.6' W
Date	April 13, 2013
Time	1455 Pacific daylight time (coordinated universal time – 7 hours)
Injuries	None
Damage	Est. \$2.5 million
Environmental damage	Potential 18,000 gallons of diesel oil (total fuel on board at time of sinking)
Weather	Winds 25–35 knots from the north-northwest; clear; visibility 10 nautical miles; air temperature 60°F
Waterway information	Pacific Ocean

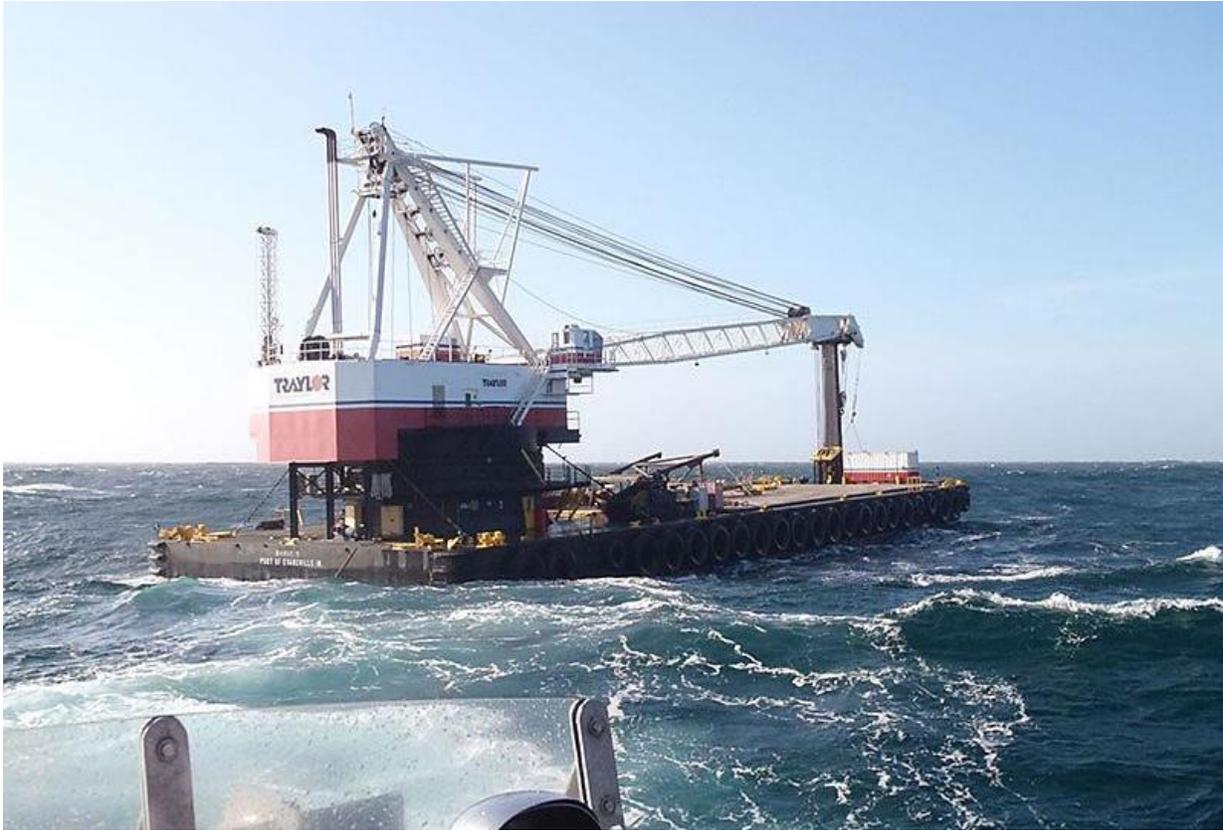
The deck barge *DB 5* after the accident. (Photo by California Department of Fish and Wildlife)

The water depth at the location of the accident was about 3,000 feet, and the *Delta Captain* crew reported that the vessel appeared to still be attached to the towline of barge *DB 5* after sinking. However, about 1100 the next day, two towing vessels arrived at the location of the adrift *DB 5* and reported that the *Delta Captain* was not still connected to the barge's towline. About 1500, one of the two responding towing vessels began towing the barge to Los Angeles, arriving there the following day, April 15.
