National Transportation Safety Board

Marine Accident Brief

Engine Room Fire On Board Fishing Vessel *Arctic Storm*

Accident no.	DCA13LM022
Vessel name	<i>Arctic Storm</i>
Accident type	Fire
Location	North Pacific Ocean, about 46 nautical miles west of Aberdeen, Washington 46° 49' N, 124° 54' W
Date	May 20, 2013
Time	1505 Pacific daylight time (coordinated universal time – 7 hours)
Injuries	None
Damage	Est. \$5 million
Environmental damage	None
Weather	Northwest winds at 10 knots; clear skies; visibility 8 nautical miles; air temperature 55°F; current at 3.1 knots
Waterway information	North Pacific Ocean fishing grounds off the coast of Washington state

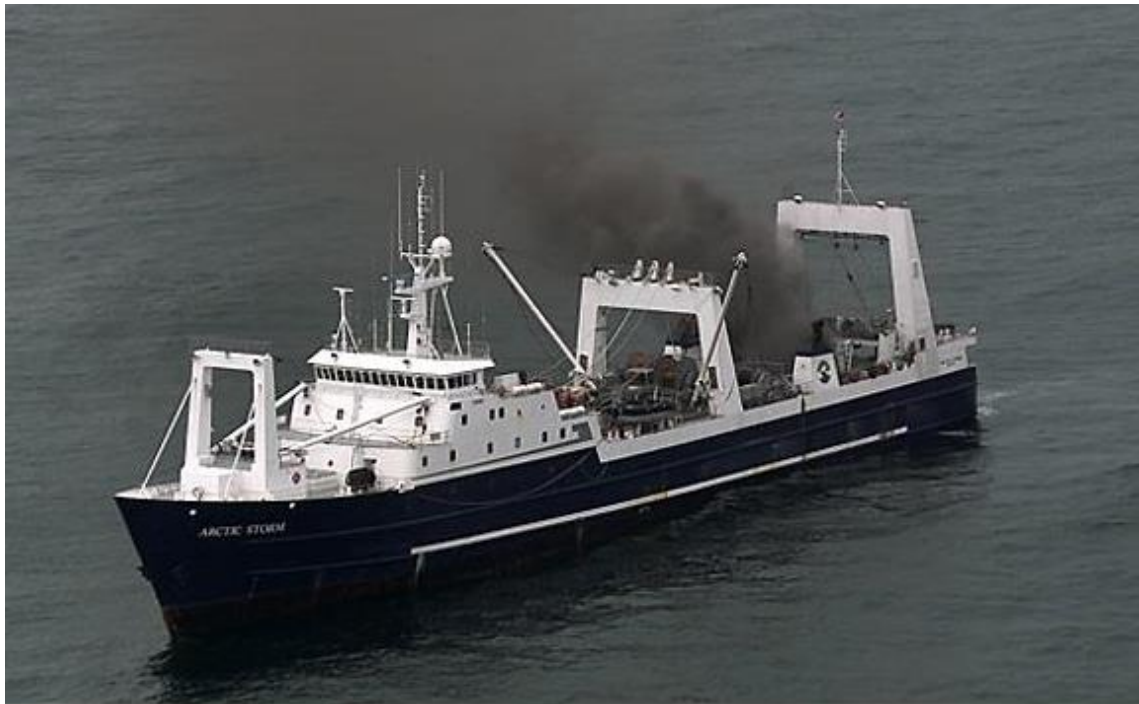
The *Arctic Storm* during the fire emergency. (Photo by the United States Coast Guard)

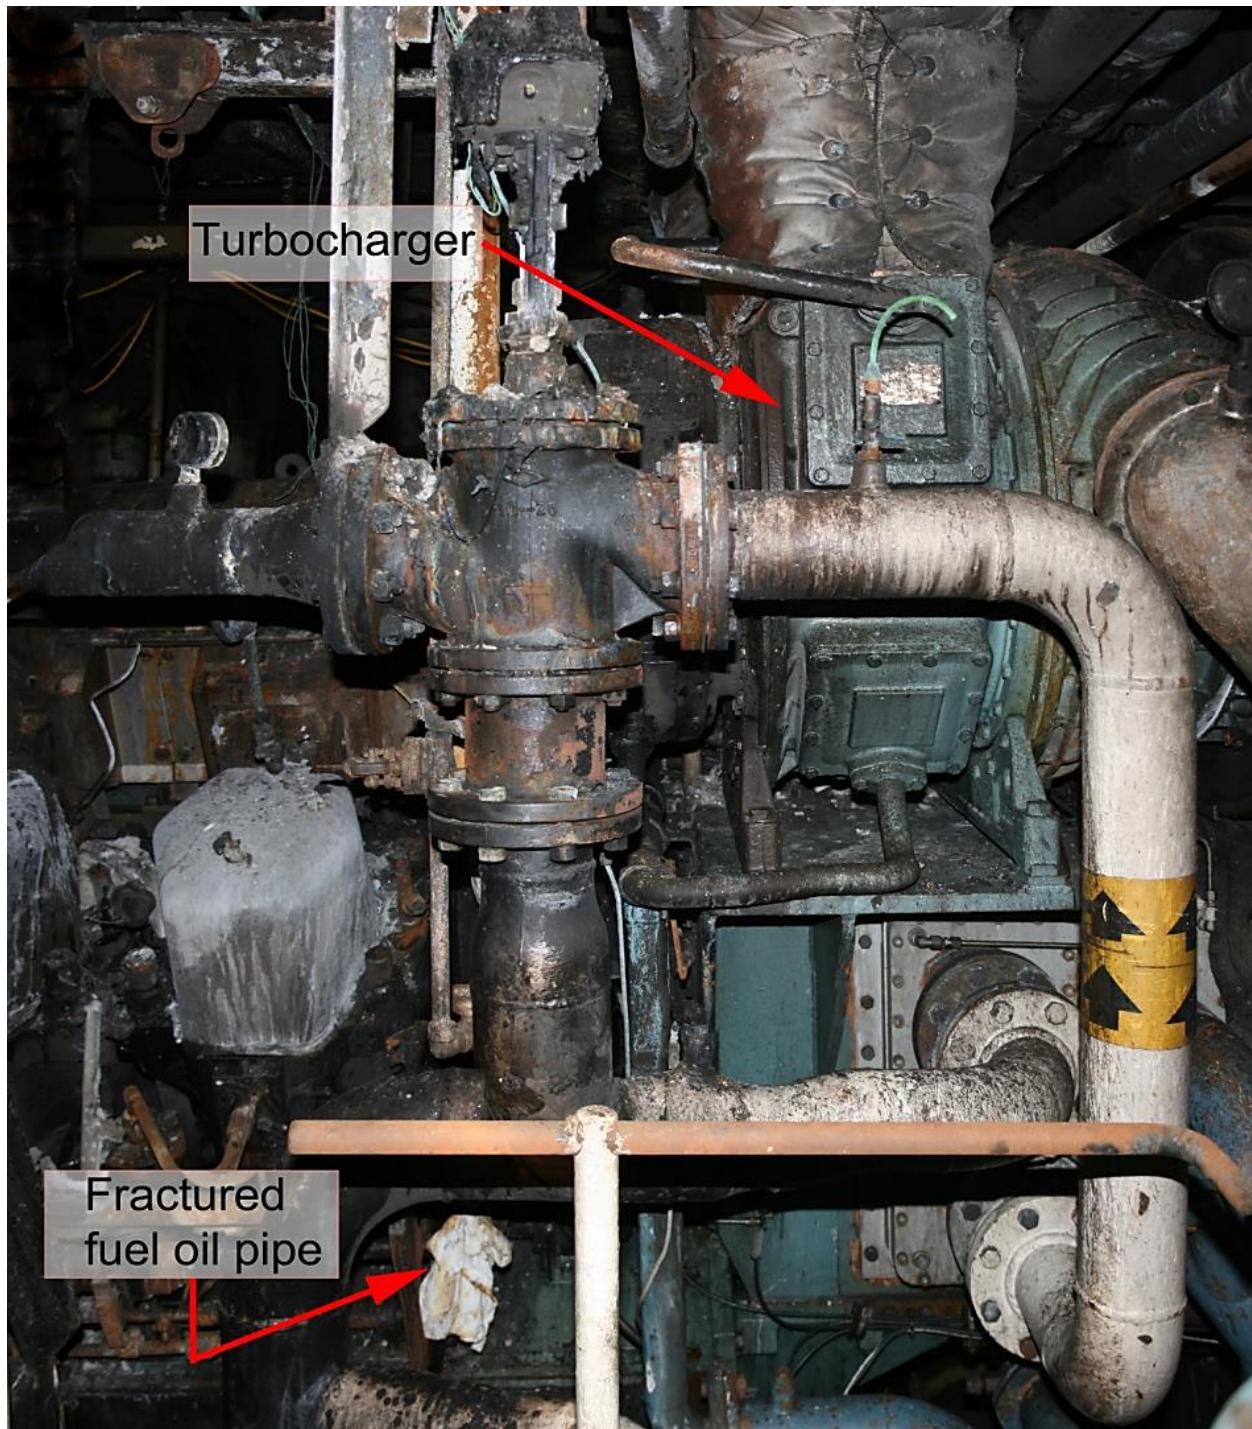
As a result of the fire, the upper portions of the *Arctic Storm*'s engine room near the main propulsion engine were extensively burned. The combustible components located in the overhead area—such as electrical wiring insulation, lighting fixtures, and ventilation motors—were melted or entirely consumed by the fire. The insulation on electrical power cables in a cableway located above the main engine had completely burned away, leaving only bare copper conductors. These cables provided electrical power to equipment located in spaces forward of the engine room. In addition, the area near the starboard forward side of the main engine, both upper and lower, was damaged. The engine components in this area appeared to be the most heavily damaged from the fire, with paint burned off the engine components, rubber expansion joints melted, and fire soot deposited on most surfaces. Damage to the adjacent fish meal plant, located just forward of the engine room, included charred and burned hard-foam insulation on the overhead; however, no equipment was damaged.

After the fire was extinguished, the chief engineer found a vent valve lying atop one of the engine's attached pumps. He determined that the valve was associated with the fuel oil piping system located on the engine's starboard-side fuel oil header near the starboard-side turbocharger. The valve had become detached from the fuel oil piping system as a result of a fracture at its threaded connection fitting. The quarter-inch, 2,000-psi valve had been installed at an elevated position at the forward end of the fuel oil piping system, and it was used to vent air from the system as needed. After the accident, the crew pressure-tested the fuel oil piping system and found no abnormal leaks or openings other than at the vent valve connection.

Photo of the area with the most fire damage, near the main propulsion engine's starboard-side turbocharger. Shown is the location of the fuel oil pipe fitting (covered by a white rag) that was found to be fractured.

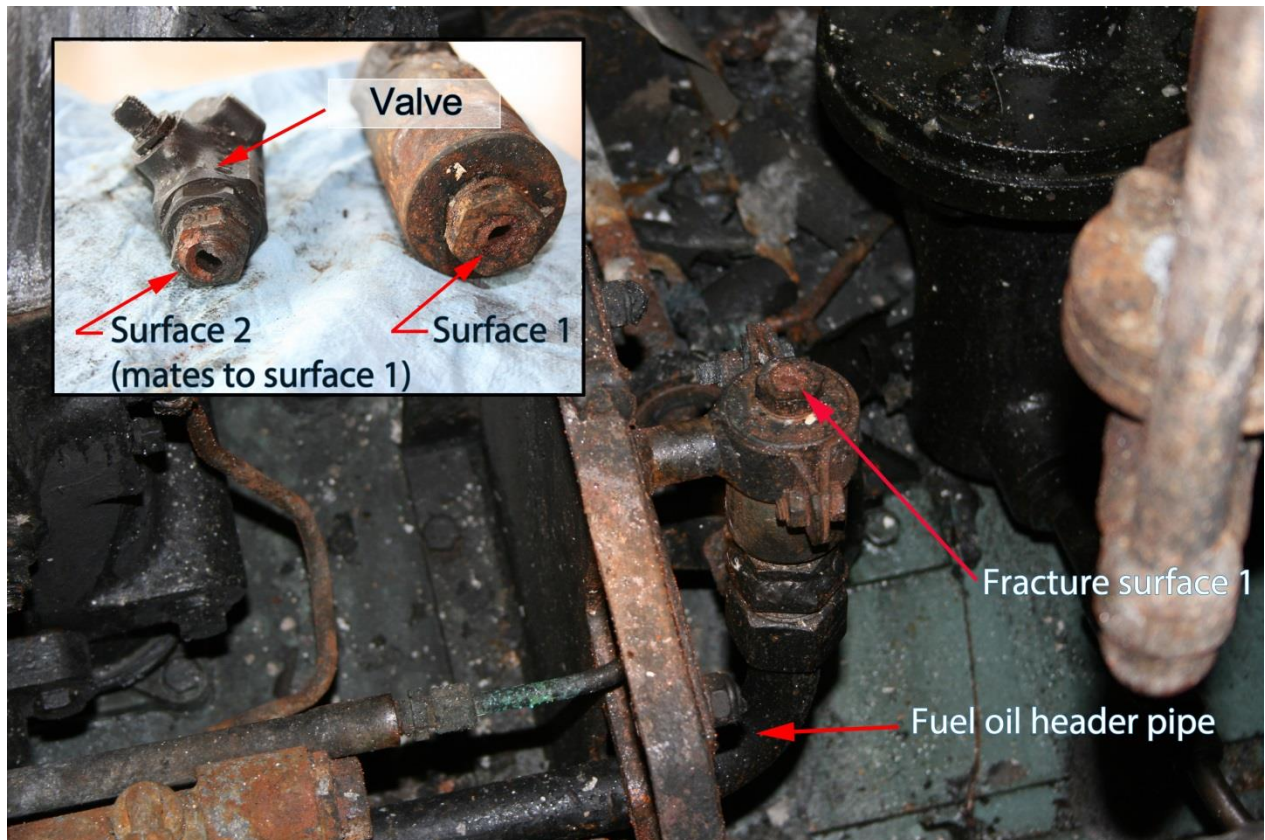
At the request of the vessel's insurers, a forensic engineering firm metallurgically examined the fracture surface of the valve fitting. The analysis report indicated that the fracture resulted from "ductile overload with a torsional component." The analysis report also found that the appearance of the fracture indicated that "the fitting fractured due to a single load, such as an impact, that caused it to separate."

Composite image of the quarter-inch fuel oil vent valve and pipe fitting fracture surfaces. The larger photo shows the valve as installed on the main propulsion engine, below the starboard-side turbocharger at the forward end of the fuel oil header.

The National Transportation Safety Board determines that the probable cause of the fire on board fishing vessel *Arctic Storm* was a fractured fitting on a fuel oil vent valve, located on the main propulsion engine, which resulted in fuel oil spraying onto a hot engine surface and igniting.
