# National Transportation Safety Board

## Marine Accident Brief

### Grounding of Commercial Towing Vessel *Justice*

<b>Accident no.</b>	DCA13NM013
<b>Vessel name</b>	<i>Justice</i>
<b>Accident type</b>	Grounding
<b>Location</b>	Hog Island Channel, 140 yards northeast of light 17, near Cape Cod Canal, MA 41°43.04' N, 70°38.80' W
<b>Date</b>	March 21, 2013
<b>Time</b>	0001 eastern daylight time (UCT – 4 hours)
<b>Injuries</b>	None
<b>Damage</b>	\$1,207,600
<b>Environmental damage</b>	Est. 232 gallons of unrecoverable gear oil released into Buzzards Bay, causing a visible sheen in 50- to 500-sq-ft patches
<b>Weather and sea conditions</b>	Clear, winds west to northwest 5 to 10 knots, calm seas, air temperature 30°F; Hog Island Channel had a northeasterly current and was beginning flood tide
<b>Waterway information</b>	Hog Island Channel, connecting the west side of Cape Cod Canal to Buzzards Bay, is 4 miles long, 500 feet wide, dredged to a controlling depth of 32 feet

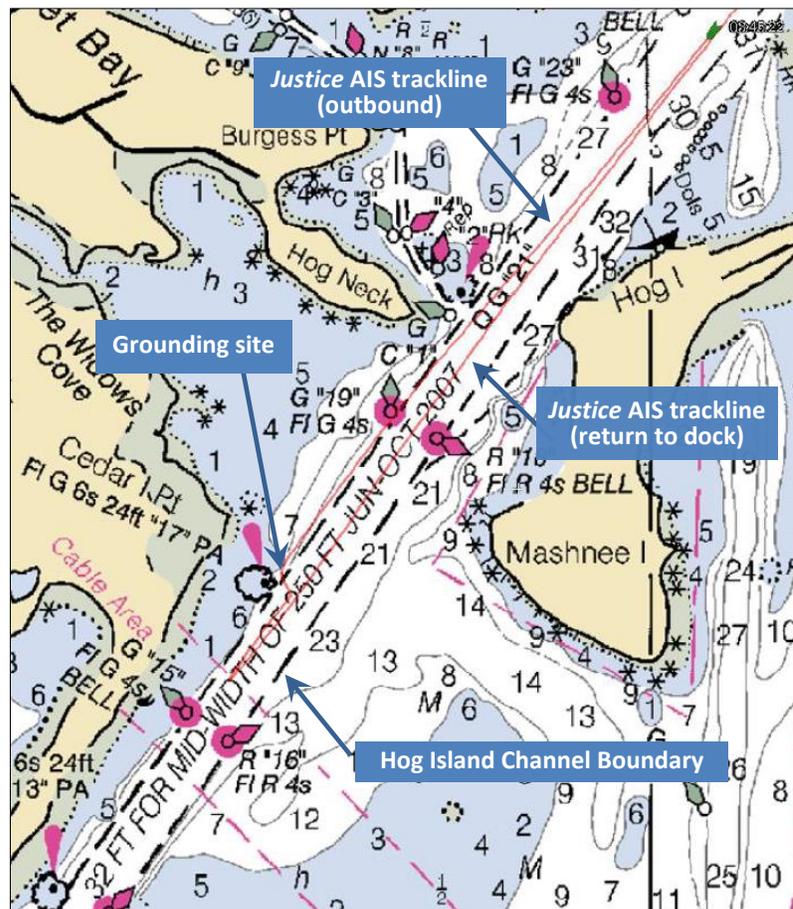
The Coast Guard developed a trackline from automatic identification system (AIS) data that showed the tug had been moving progressively to starboard and crossed outside the channel's western edge near buoy 19 (see AIS trackline, at right). About 0001, the mate determined that the current autopilot command would not bring the vessel back into the channel given its speed and course, and he manually took control of the steering. Five seconds later, the *Justice* grounded about 140 yards northeast of the charted position of Hog Island Channel light 17, shearing off the integrated nozzle and propeller (lower part) of the starboard ASD.

AIS trackline in red, channel boundaries (black dashes), and site of grounding. (Excerpt from NOAA Nautical Chart 13236)

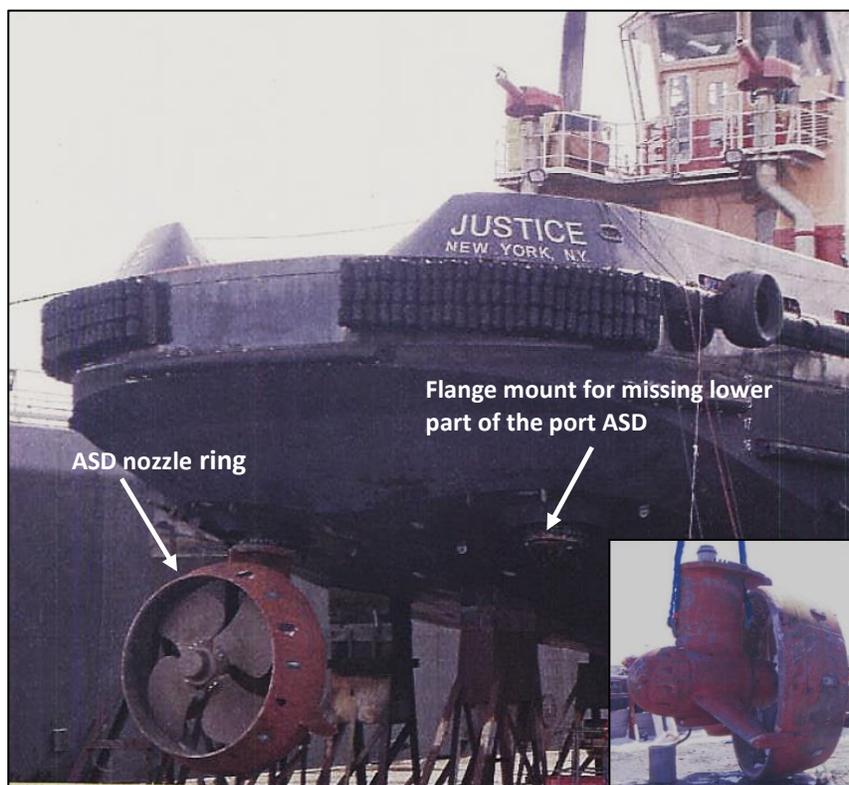
the hull structure, provides mounting flanges for the upper and lower parts and allows for shaft penetration through the hull. The lower part consists of the propeller and nozzle ring. A flange mounting surface with threaded fasteners connects the lower part to the intermediate part. These fasteners sheared off as a result of the impact, causing the lower part of the ASD to fall from the tug to the channel bottom. The port and starboard ASDs extend below the hull by about 32 inches. This allowed the forward portion of the tug to pass over the obstruction that impacted the aft-mounted ASD. (See photo of *Justice* in dry dock, below.)

After the grounding, the Cape Cod Canal was closed to deep-draft vessels by the US Army Corps of Engineers, New England District, which is responsible for operations and maintenance of the waterway, and reopened after the lost ASD was located later the same day. The lower part of the ASD was recovered by 1806 on March 21 and placed on a barge. As the unit was designed, the upper part of the starboard ASD filled with seawater after the loss of the lower part, but flooding was contained in the upper part and no water entered the hull.

Stern view of *Justice* in dry dock after the accident. Inset, lower part of starboard ASD after salvage. (Photo by Coast Guard)

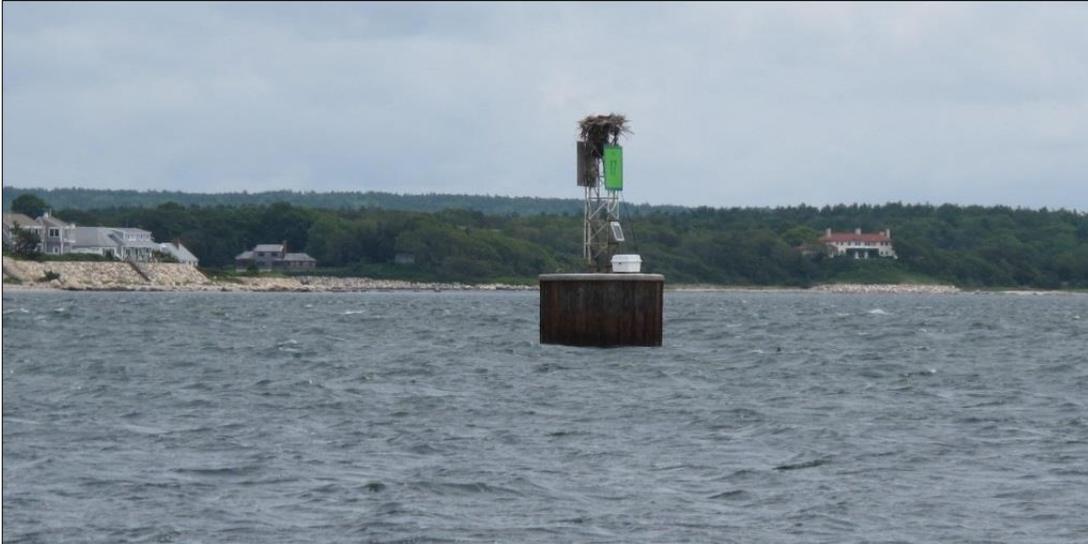
Looking east at light 17 in Hog Island Channel. The structure is 24 feet high and flashes a green light every 6 seconds.

On the night of the accident, navigational aids—channel markers, lights, and lighted buoys—as well as the vessel’s chart plotter would have provided clear visual indications of the 500-foot-wide navigable channel. Light 17, above, is a large fixed structure with a flashing green light. AIS data show the *Justice* was on a course toward this light when the vessel grounded on a charted rocky ledge 140 yards before it. The mate’s use of autopilot was considered typical, and he was making minor course corrections to the autopilot in an effort to maintain his position in the channel. However, avoiding the rocky ledge would have required aggressive course adjustment well in advance of light 17.
