# National Transportation Safety Board

## Marine Accident Brief

### Sinking of Oceanographic Research Vessel *Seaprobe*

<b>Accident no.</b>	DCA13NM008
<b>Vessel name</b>	<i>Seaprobe</i>
<b>Accident type</b>	Sinking
<b>Location</b>	Gulf of Mexico, about 130 nautical miles south-southeast of Mobile, Alabama 28°12.2' N 86°27.3' W
<b>Date</b>	January 18, 2013
<b>Time</b>	About 0315 central standard time (coordinated universal time – 6 hours)
<b>Injuries</b>	Three (two minor, one serious)
<b>Damage</b>	Total loss of vessel
<b>Environmental damage</b>	Potential release of 44,000 gallons of diesel fuel on board at the time of sinking
<b>Weather</b>	Clear skies; north winds at 20–25 knots, gusting to 34 knots; wave height 14–16 ft; 3+ miles visibility; air temperature 56°F; water temperature 71°F
<b>Waterway information</b>	Gulf of Mexico, open water

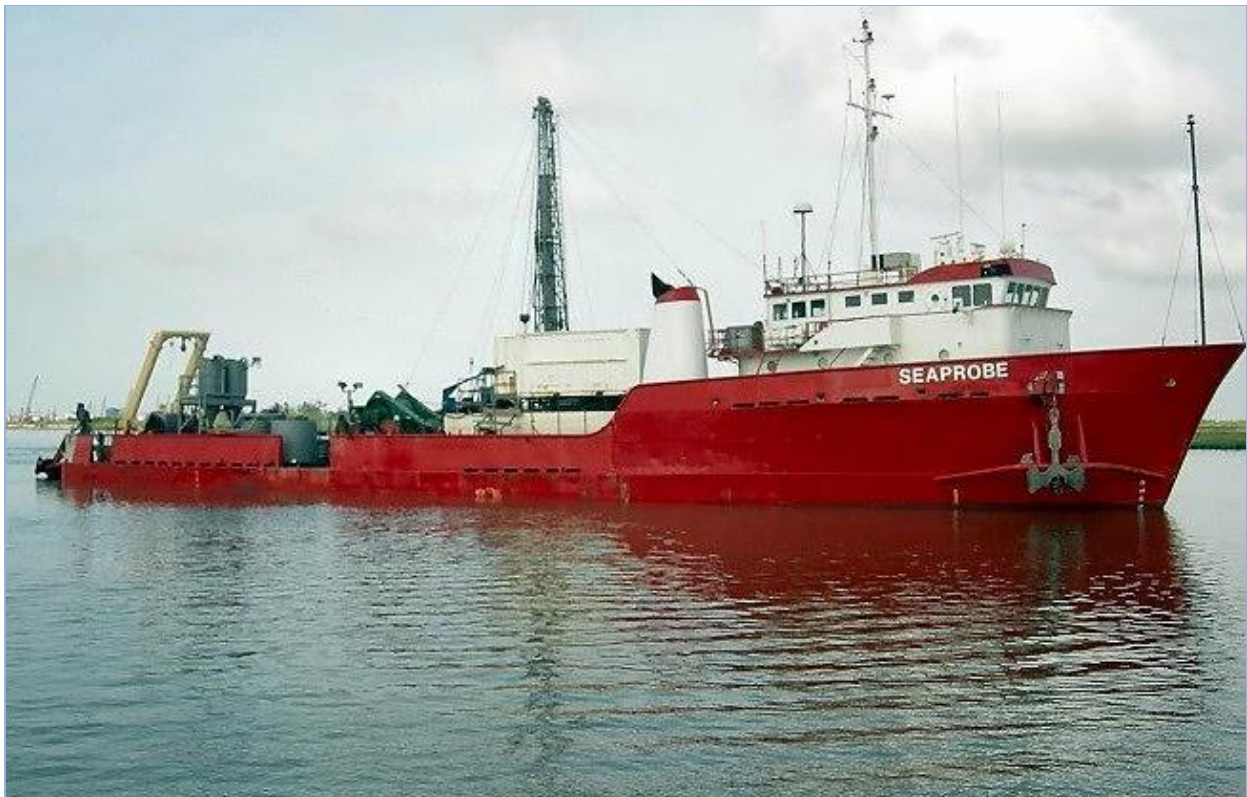
The *Seaprobe* before the sinking. (Photo source: Baynews9.com)

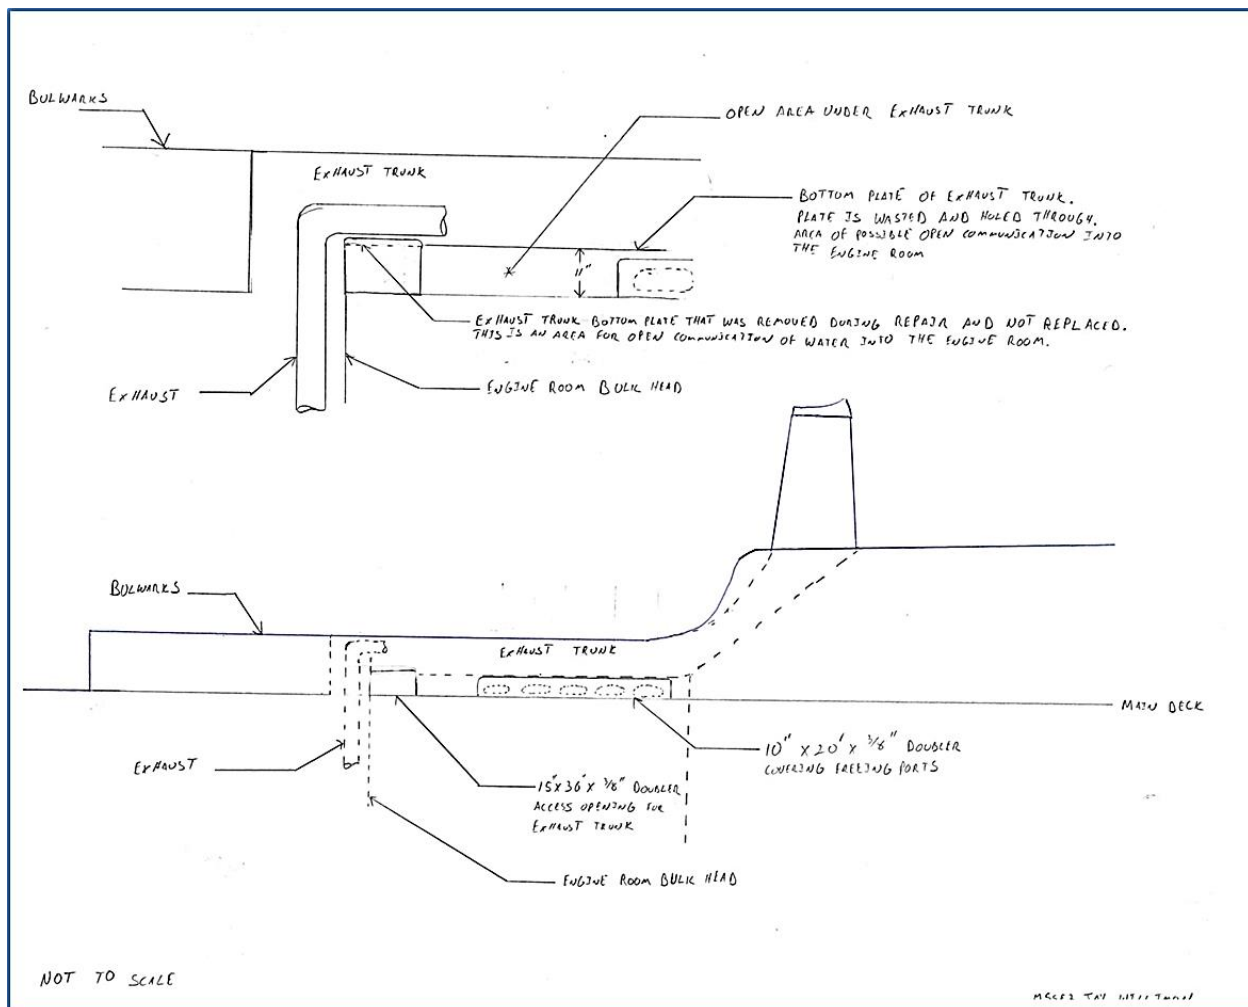
In late December 2012, the *Seaprobe* departed the site of its oceanographic research operations off the coast of South America, en route to Morgan City, Louisiana. While in transit, the captain and crew noted seawater entering the engine room where the exhaust pipe for the starboard main engine exited through the engine room overhead. The captain told investigators that he maneuvered the vessel to minimize water on the deck in the area of the water entry. Also, the crew made temporary repairs including fastening thin sheets of metal to the starboard-side exhaust trunk where the original metal was wasted.<sup>1</sup> The exhaust trunk housed exhaust pipes from machinery in the engine room and ran forward horizontally above the deck to the stack, just aft of the deckhouse. The captain told investigators that, to address the flooding, he diverted the *Seaprobe* to the Gulf Marine Repair (GMR) shipyard in Tampa, Florida.

Diagram, sketched by a Coast Guard investigator after meeting with GMR employees, of the location and condition of the *Seaprobe*'s exhaust trunk.

used doubler plates to temporarily repair the starboard main engine and generator exhaust pipes housed within the exhaust trunk. The Coast Guard also learned that portions of the exhaust trunk's bottom plate were not renewed after this plate, some of its metal wasted, was removed to gain access to damaged sections of the exhaust pipes within the exhaust trunk. The port engineer—a representative of the vessel owner who was at the GMR shipyard during the repair work—told investigators that he did not direct shipyard personnel to replace the bottom plate because he wanted to allow for further examination of the exhaust pipes during the vessel's next scheduled drydock. Shipyard personnel had asked the port engineer if he wanted the exhaust trunk repaired or left open, and, if the latter, the personnel would install a doubler plate over the six starboard-side freeing ports near the bottomless exhaust trunk to protect it from seawater. The port engineer said that he believed, as an interim measure, "if the freeing ports were closed it would improve protection against seawater contact in that area." Therefore, shipyard personnel installed the doubler plate over the six freeing ports and left the exhaust trunk open to the atmosphere on the bottom.

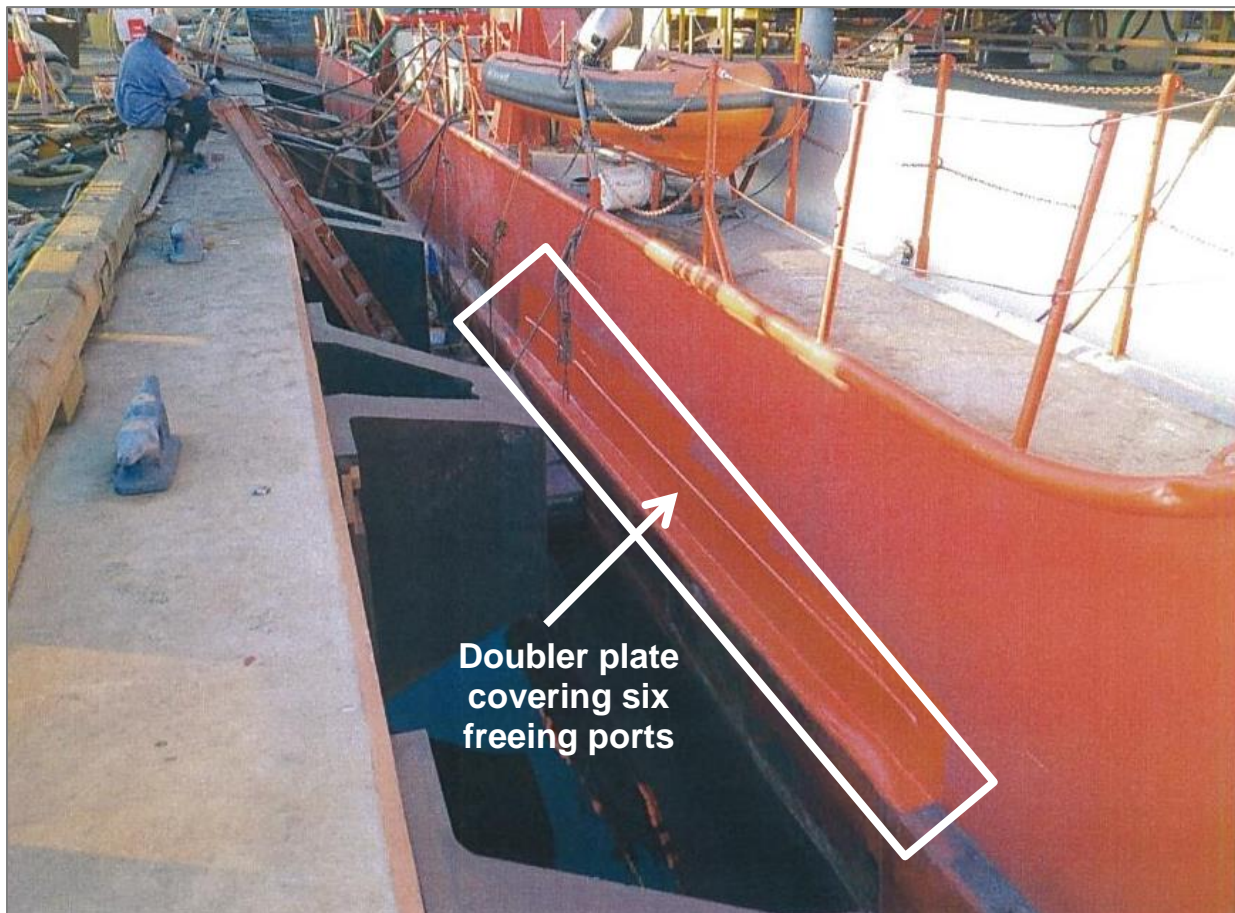
The *Seaprobe* in the GMR shipyard. The doubler plate, which was installed to cover six starboard-side freeing ports, is marked by an overlaid box. (Photo by GMR) The six freeing ports can be seen in their original uncovered condition in the photo on page 1, about midship on the vessel.

were closed caused seawater to collect on deck. This water made its way into the open bottom of the exhaust trunk and downflooded into the engine room. The captain told investigators that the vessel lost power to its main engines and generators about 2000 that evening. The chief engineer discovered water in the engine fuel and in the starboard-side day tank. He also saw water entering the engine space near the exhaust trunk. The chief engineer told investigators that he initially kept up with the flooding by using the oily water separator to pump the water to a holding tank. About 2030, he restored the portside generator and about 2130 brought the portside main engine back on line. However, over the next few hours, he noted that the flooding increased and used the bilge pumps to remove the incoming water. One of the deckhands also observed the engine room flooding and told investigators that every time the *Seaprobe* rolled in the high seas, a large amount of water entered the engine room on the starboard side.

The National Transportation Safety Board determines that the probable cause of the flooding and subsequent sinking of the *Seaprobe* was the decision of the vessel owner to delay making permanent repairs to the starboard-side exhaust trunk and covering six of the vessel's freeing ports, leaving the *Seaprobe* susceptible to downflooding from boarding seas. Contributing to the accident was the owner's failure to comply with the vessel's safety management system and mandatory load line regulations.
