National Transportation Safety Board

Marine Accident Brief

Grounding and Sinking of the Harbor Tug *Kaleen McAllister*

Accident no.	DCA13LM020
Vessel name	<i>Kaleen McAllister</i>
Accident type	Grounding and sinking
Location	Northwest Harbor, Baltimore, Maryland (39°16'9.38" N, 76°34'47.73" W)
Date	May 4, 2013
Time	1951 eastern daylight time (coordinated universal time – 4 hours)
Injuries	None
Damage	Est. \$1.5 million in repair costs
Environmental damage	Est. 2,400 gallons of marine diesel fuel discharged to the harbor
Weather and sea conditions	Clear skies, winds northeast 14 to 18 knots, air temperature 61°F, water temperature 61°F, mean wave height 1 foot, tide ebbing (1 foot higher than predicted)
Astronomical data	Sunset 2003, civil twilight ending 2032 eastern daylight time
Waterway	Patapsco River, sheltered harbor channel

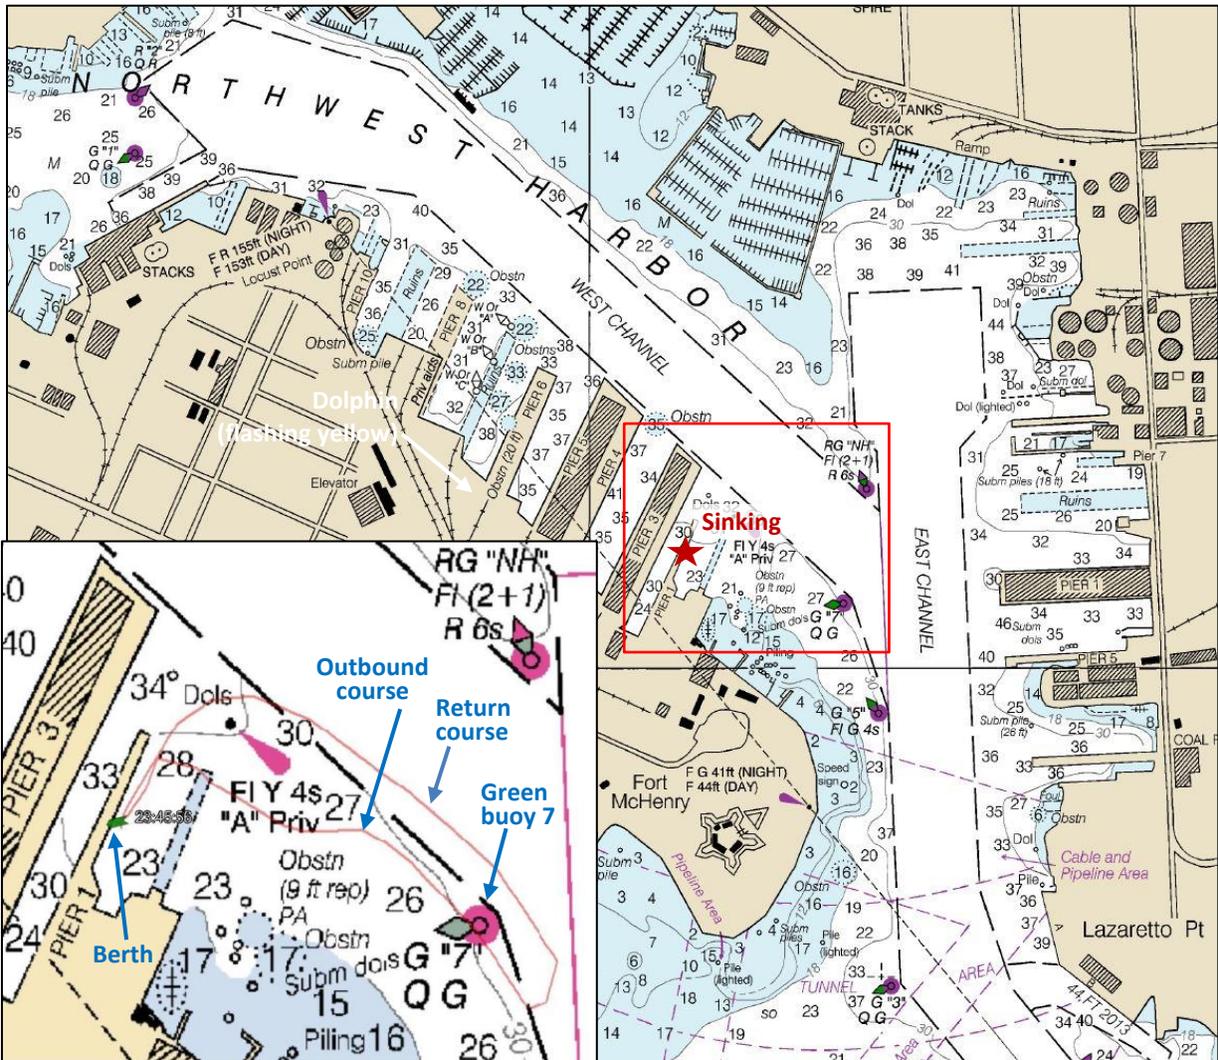
Portion of NOAA Chart 12281, Baltimore Harbor, showing the West Channel. Inset at lower left is a close-up of Pier 1 showing the *Kaleen McAllister's* outbound and return tracklines in light red. The outbound course from the tug's berth travels east past the end of the submerged pier, also indicated on the chart.

The mate stated that he was navigating by visual reference to maintain the green no. 7 buoy dead ahead of him, and he intended to pass between the lighted yellow dolphin (cluster of closely driven piles) and the adjacent collapsed pier that was parallel to Pier 1. Based on his experience with the area, he judged that he would pass clear to the north of any hazards associated with the collapsed pier. He also stated that he did not refer to the chart plotter on a laptop in the wheelhouse. About 1951, he felt “a rumble under the hull” and stopped the engine. At that time he noted that “the pilings of the abandoned pier were closer to my starboard side than anticipated.”

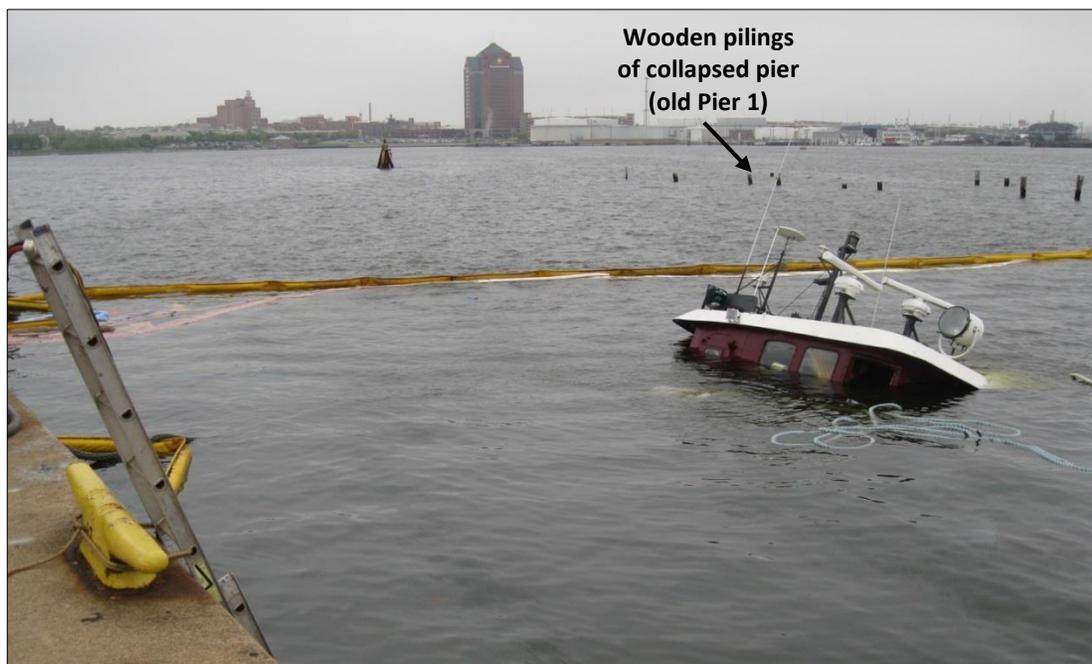
The mate stated that McAllister's shoreside managers arrived on scene and assisted in the damage control and prepared a pollution response. They considered using another tug to push the *Kaleen McAllister* further into the berth where the water was shallower, but due to the vessel's large list and the rapid rate at which it was sinking, an attempt was deemed too dangerous. By about 2030, the tug had sunk and an oil sheen was observed. The vessel settled on the bottom with a port list and its wheelhouse top just above the surface of the water.

The sunken vessel oil-boomed off and resting on the bottom at its berth on the east side of Pier 1 on May 6, 2013. The remaining exposed pilings of the collapsed pier and associated dolphin are seen above the wheelhouse.

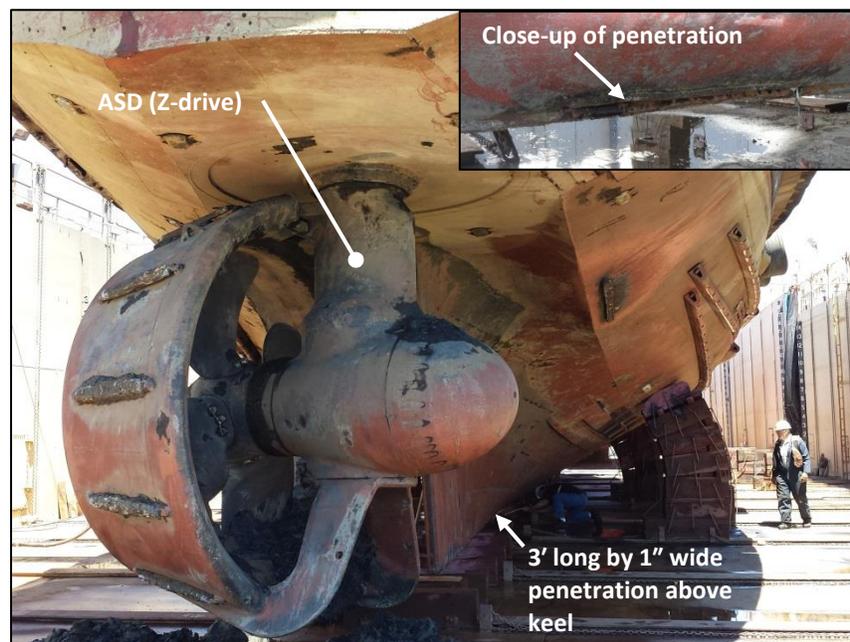
The tug was refloated on May 25, 2013, and divers found a 3-foot by 1-inch hole in the 5/8-inch hull plating adjacent to the keel on the starboard side. The hole was temporarily patched, and the vessel was towed to a Baltimore shipyard on May 26.

***Kaleen McAllister* in dry dock after salvage. Location of 3-foot-long hull tear shown in upper right inset. (Photographs by Coast Guard)**

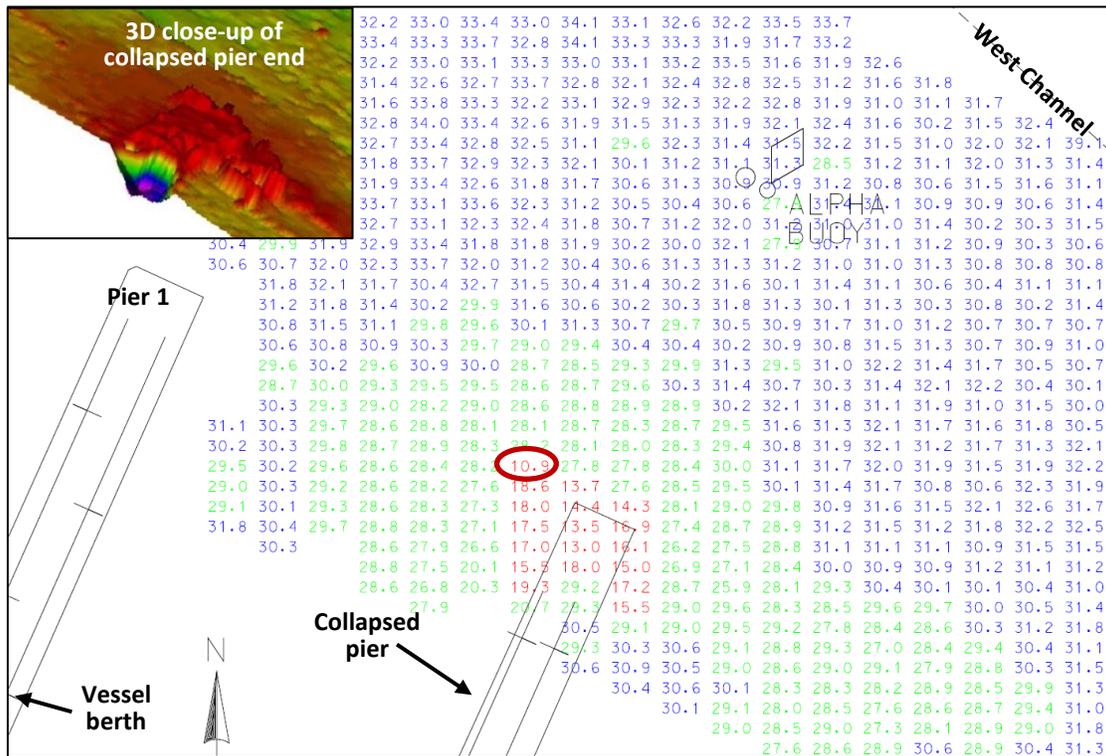
A hydrographic sidescan sonar survey conducted by the US Army Corps of Engineers on May 10 detailed the bottom profile at the north end of the collapsed pier, east of the current Pier 1 where the tug was berthed. The survey shows that depths near the northwest corner of the pier along the *Kaleen McAllister*'s AIS trackline were as low as 10.9 feet at mean lower low water (MLLW). Data from the buoy nearest the accident verified the tide at the time of the grounding was 1.6 feet above MLLW (1 foot higher than predicted), resulting in a water depth

above the northwest corner of 11.5 feet. These data, in conjunction with the tug’s draft of over 14 feet and crew statements regarding the time they heard and felt the tug strike something, indicate the vessel struck a fixed, submerged object at the northwest end of the collapsed pier.

US Army Corps of Engineers sidescan sonar hydrographic survey results for the area between the West Channel and collapsed pier struck by the tug. Soundings are measured in feet to mean lower low water, the same baseline used on local NOAA nautical charts. Red circle indicates the shallowest sounding near the end of the collapsed pier.
