# National Transportation Safety Board

## Marine Accident Brief

### Breakaway of Tanker *Harbour Feature* from its Moorings and Subsequent Allision with the Sarah Mildred Long Bridge

<b>Accident no.</b>	DCA13LM014
<b>Vessel name</b>	<i>Harbour Feature</i>
<b>Accident type</b>	Breakaway from moorings; subsequent allision with bridge
<b>Location</b>	Piscataqua River at the Sarah Mildred Long Bridge, Portsmouth, New Hampshire 43° 05.1'N, 70° 45.6'W
<b>Date</b>	April 1, 2013
<b>Time</b>	1324 eastern daylight time (coordinated universal time – 4 hours)
<b>Injuries</b>	None
<b>Damage</b>	Ship: \$1 million; bridge: \$2.5 million
<b>Environmental damage</b>	None
<b>Weather</b>	Northwest winds at 5–10 knots; air temperature 55°F; visibility 10 miles
<b>Waterway information</b>	River waterway, known for rapid tidal currents and hazardous crosscurrents. At the time of the allision, the tide was flooding at 3–4 knots.

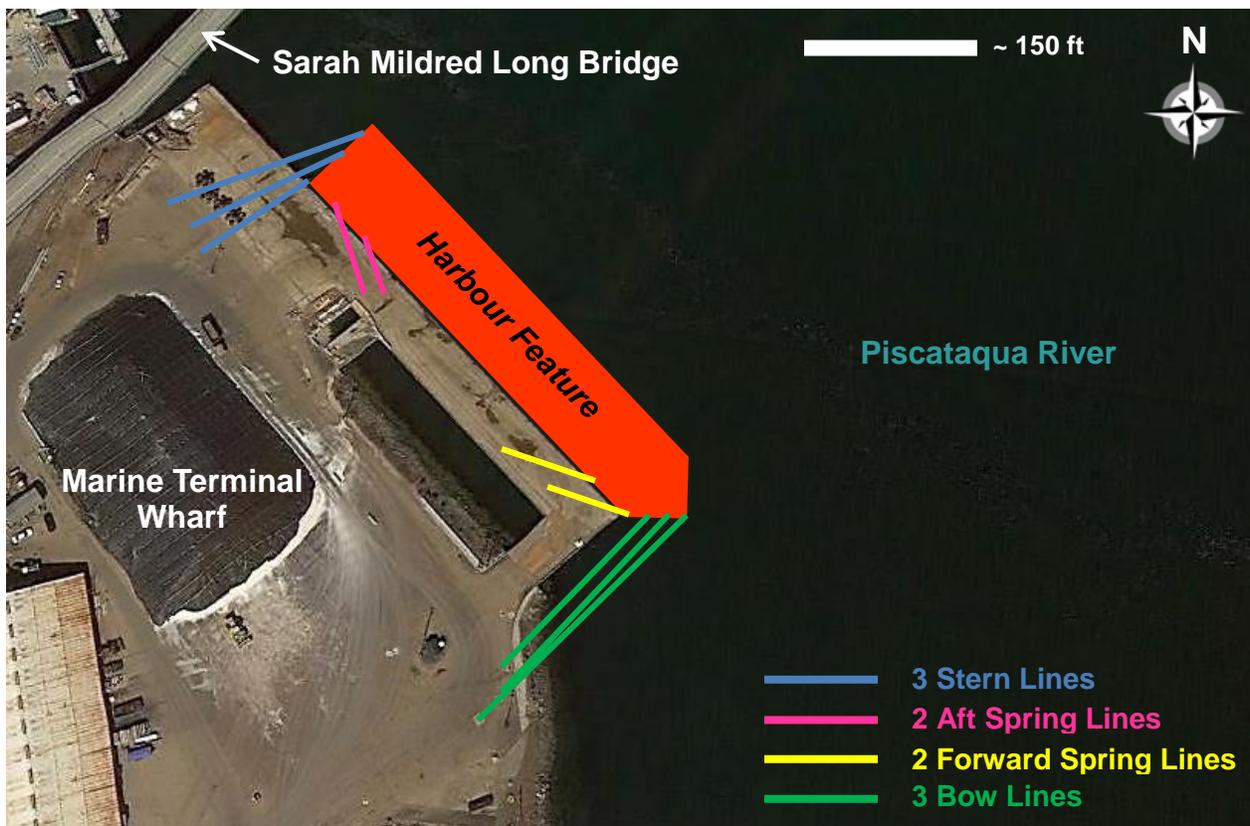
At 1115 on April 1, the same Portsmouth pilot from the previous day boarded the *Harbour Feature* to shift the vessel downriver. The 3-mile transit was uneventful, and at 1236 the *Harbour Feature* was moored starboard-side-to at the Marine Terminal Wharf. Ten of the ship's 23 total mooring lines were used: three bow and two spring lines forward; three stern and two spring lines aft. Each line was 5.5 inches in diameter and had a breaking strength of 40 tons. Because the *Harbour Feature* had a 29-foot draft at the stern and the wharf had a depth of only 30 feet at its west end, the pilot docked the ship farther down the wharf toward the east. The ship's bow extended 30 feet beyond the east end of the wharf and pointed downriver. The vessel's stern was positioned about 150 feet from the Sarah Mildred Long Bridge. The pilot disembarked at 1242.

Aerial view of the Marine Terminal Wharf, with an overlaid orange-red icon representing the *Harbour Feature*. Also overlaid are 10 colored lines, extending from the ship to the wharf, that represent the mooring line arrangement on the day of the accident. (Background by Google Earth)

During flood tide in the Piscataqua River, water rushes up the river and deflects off the river banks causing hazardous crosscurrents. Because the *Harbour Feature*'s bow extended beyond the eastern end of the wharf, the deflecting flood current pushed the bow away from the dock and increased the strain on the vessel's mooring lines.

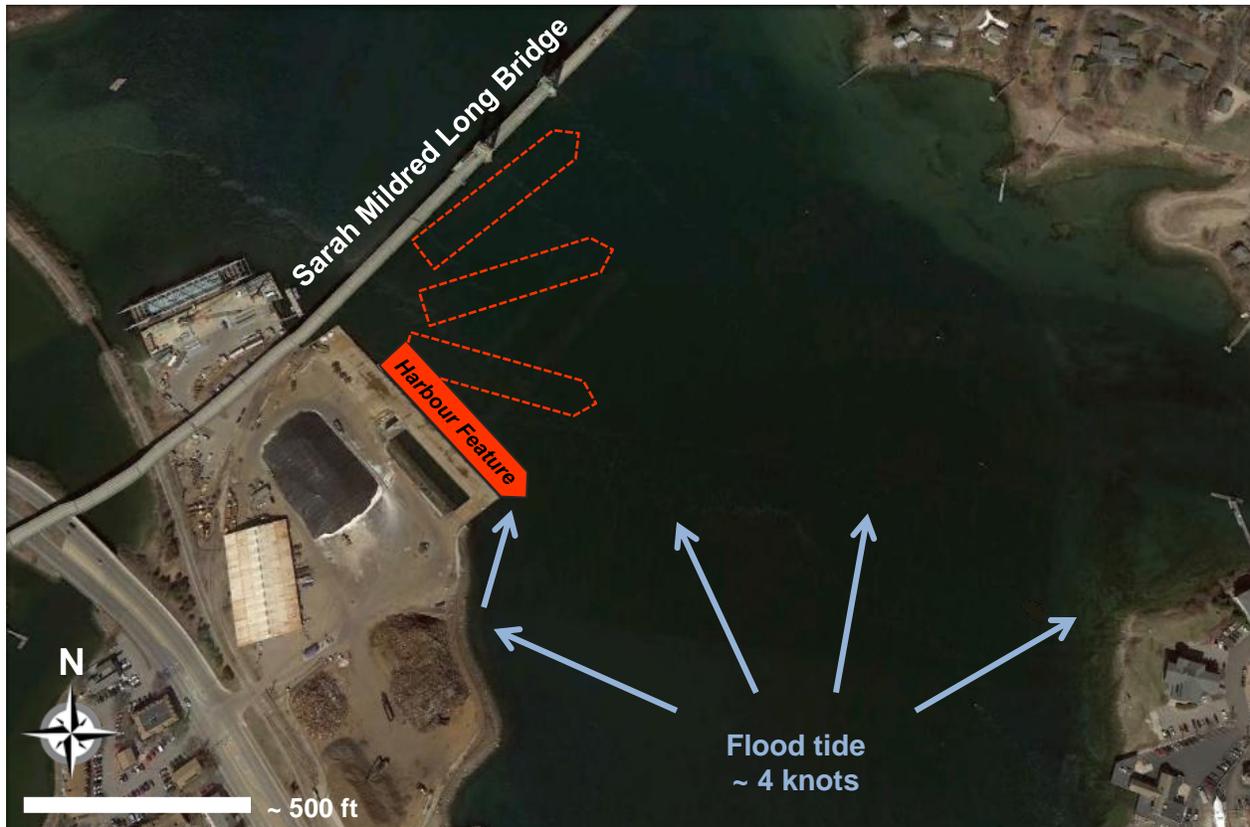
Aerial view of the Marine Terminal Wharf on the Piscataqua River. The overlaid blue arrows illustrate the direction of the strong flood current. The overlaid orange-red icons illustrate how the *Harbour Feature* moved toward the bridge after the mooring lines parted. (Background by Google Earth)

As the *Harbour Feature*'s bow was pushed into the river, the three mooring lines that were secured to the bits of the vessel (both of the forward spring lines and one of the aft spring lines) parted. As the mooring winch brakes slipped in place, all remaining mooring lines ran free off the drums and fell into the water.

By 1324, the bridge team had ordered both anchors deployed in an attempt to keep the ship at the dock. At this point, the crew at both the forward and aft mooring stations had reported that all of the 10 mooring lines had now run off the vessel and fallen in the water, and the ship was adrift in the river. The master tried to gain control of the ship by using the main engine and rudder. The anchors did slow the drift, but the *Harbour Feature* was carried by the current and at 1327, the vessel's port side struck the Sarah Mildred Long Bridge.

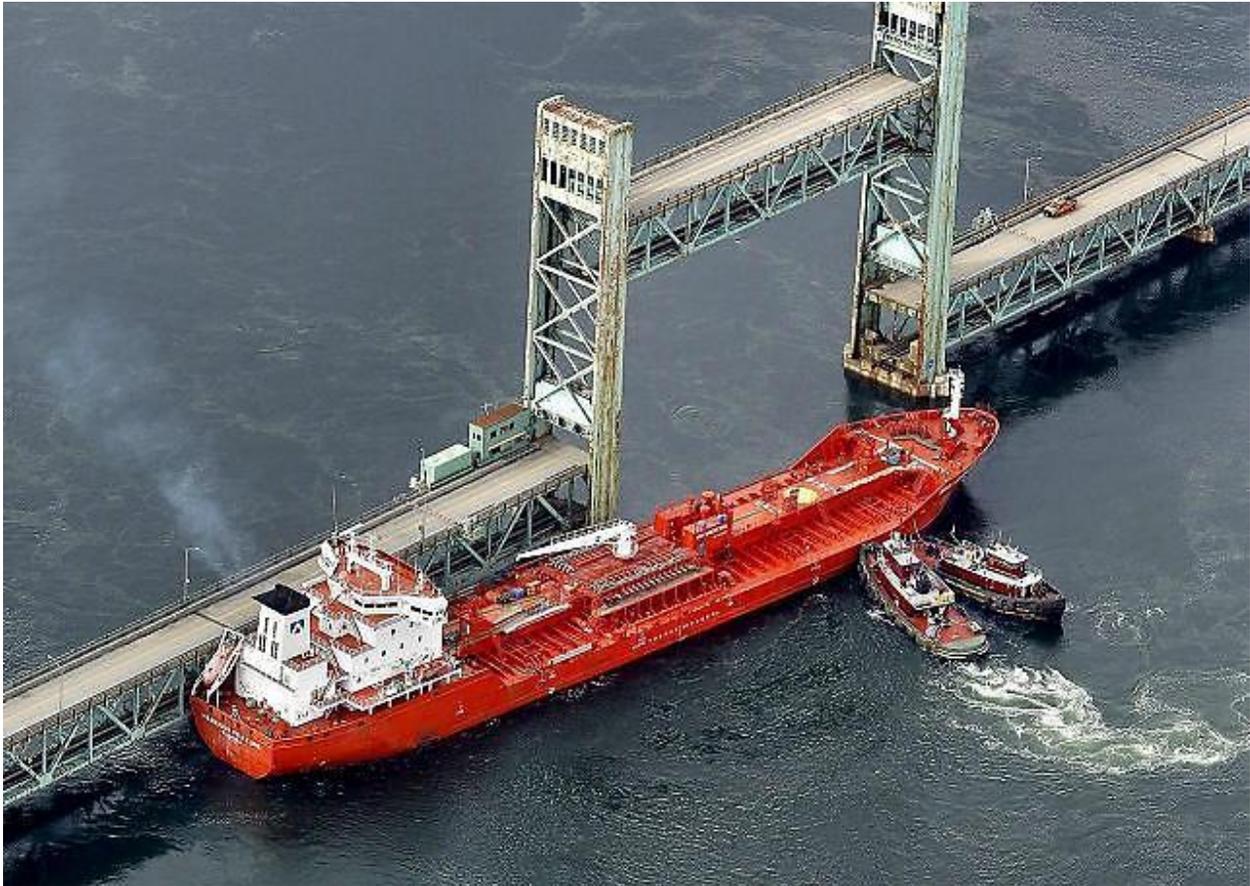
The *Harbour Feature* pressed against the Sarah Mildred Long Bridge after the allision. Two responding towing vessels, the *Mary M. Coppedge* and the *Drum Point*, can be seen on the ship's forward starboard side. (Photo by the Coast Guard)

Drug and alcohol testing was completed on all pertinent crewmembers; the results were negative. Damage to the *Harbour Feature* was estimated at \$1 million and included total destruction of the freefall lifeboat, penetration with flooding into a port wing ballast tank, extensive damage to the frames in several portside compartments, and a hull breach above the waterline into the inert gas generator room. Damage to the Sarah Mildred Long Bridge was estimated at \$2.5 million and caused the bridge to be closed to vehicle traffic for 6 weeks while

emergency repairs were being made to three structural members. No injuries or pollution resulted from the accident.

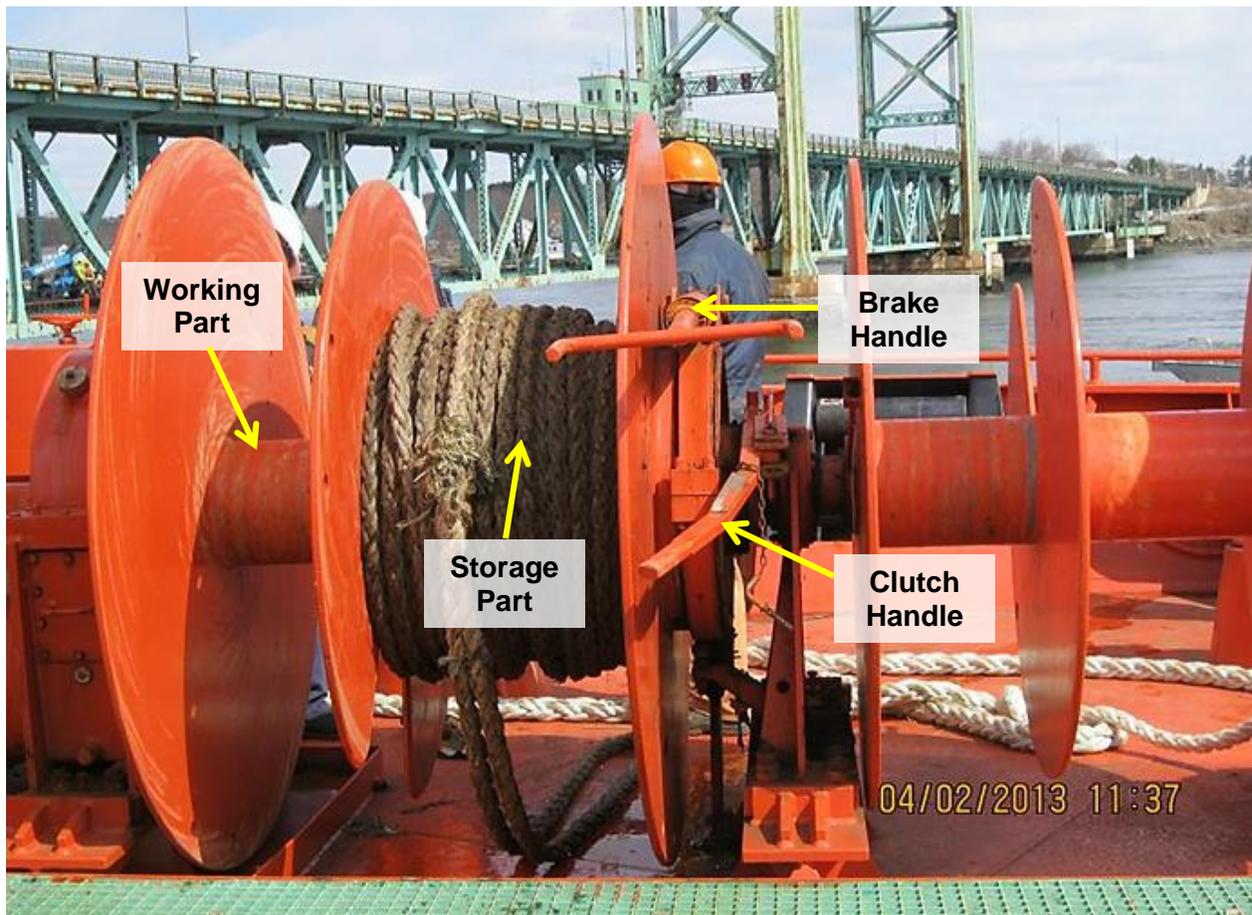
The *Harbour Feature* was equipped with eight non-auto-tension split mooring winches, four forward and four aft, with the mooring lines on the winch drums set on the brake. The winch brakes are designed to hold 80 percent of the mooring lines' minimum breaking load (MBL) but are operationally set to hold 60 percent of the MBL. A satisfactory test of the *Harbour Feature*'s mooring winch brake holding capacity (BHC) had been conducted on February 26, 2013. During the BHC test, the chief officer had inspected each mooring brake band and noted that about 3 millimeters of the asbestos brake lining remained. The manufacturer's operations manual stated that the brake lining should be replaced when worn down to 3 millimeters. However, the brake lining had not been replaced when the accident occurred, indicating that the mooring winch BHC may have been less than the operational setting. The heat that resulted from the mooring lines' rapidly paying out disintegrated the brake lining, and it could not be determined how thick the brake lining was before the accident.

The *Harbour Feature*'s mooring line winch and storage drum assemblies photographed the day after the accident. The Sarah Mildred Long Bridge is visible in the background. (Photo by the Coast Guard)
