National Transportation Safety Board

Marine Accident Brief

Fire On Board Fish Processing Vessel *Juno*

Accident no.	DCA14LM006
Vessel name	<i>Juno</i>
Accident type	Fire
Location	Grays Harbor, Westport, Washington
Date, time	December 28, 2013 0130 Pacific standard time (coordinated universal time – 8 hours)
Injuries	One minor
Damage	\$424,000
Environmental damage	None
Weather	Foggy with overcast skies, 45°F, winds 8 knots
Waterway information	Westport is located on a peninsula on the south side of the entrance to Grays Harbor, Washington, from the Pacific Ocean

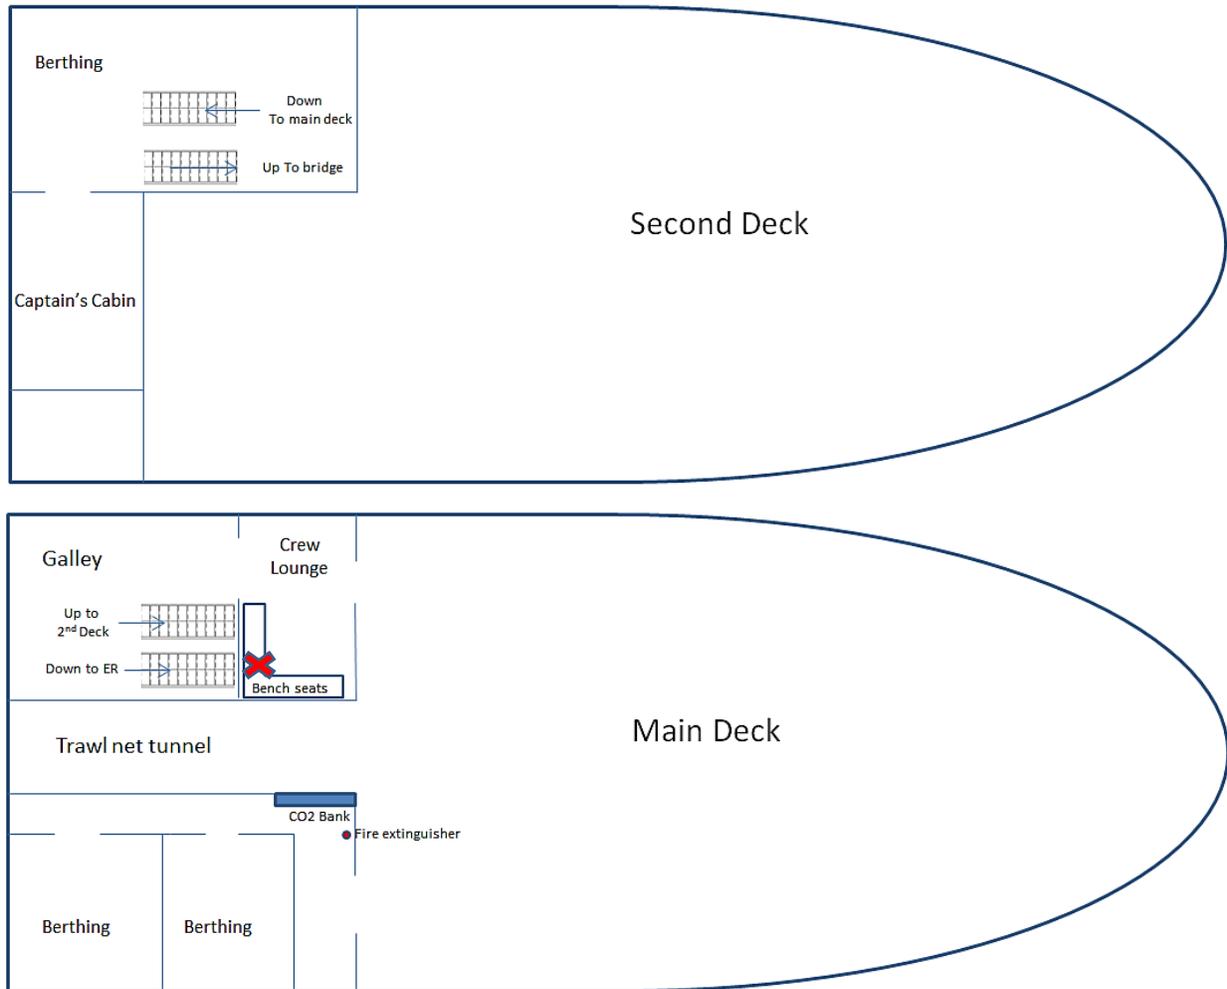
Deck plan for *Juno*. The bottom layout shows the main deck. The initial fire location is indicated by a red x. The top layout shows the second deck, immediately above the main deck.

The master told investigators that on Friday, December 27, he rented some movies and came back to the vessel to watch them in his cabin, located on the second deck on the starboard side. He estimated that he fell asleep watching movies around midnight and awoke about 0130 to the smell of smoke. He went down the ladder to the main deck and found the aft bulkhead in the crew lounge on fire above a built-in bench seating area.

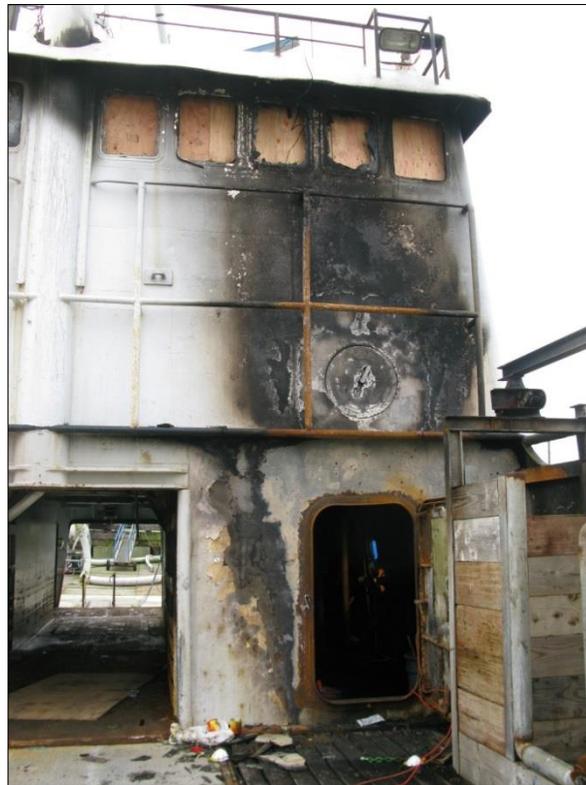
The fire department report stated, "A lack of built-in 'structural fire stops' in the vessel . . . created a chimney effect which allowed superheated gases to spread to the cabin areas." In addition, the report found that modifications made to the vessel using combustible interior finishes such as plywood and wood paneling contributed to the fire's propagation.

The vessel sustained major fire damage to the house on the main deck, the second deck, and the bridge. The only portion of the house not affected was the starboard side main deck, which was separated from the fire by the trawl tunnel.

Fire damage to exterior of house on port side.

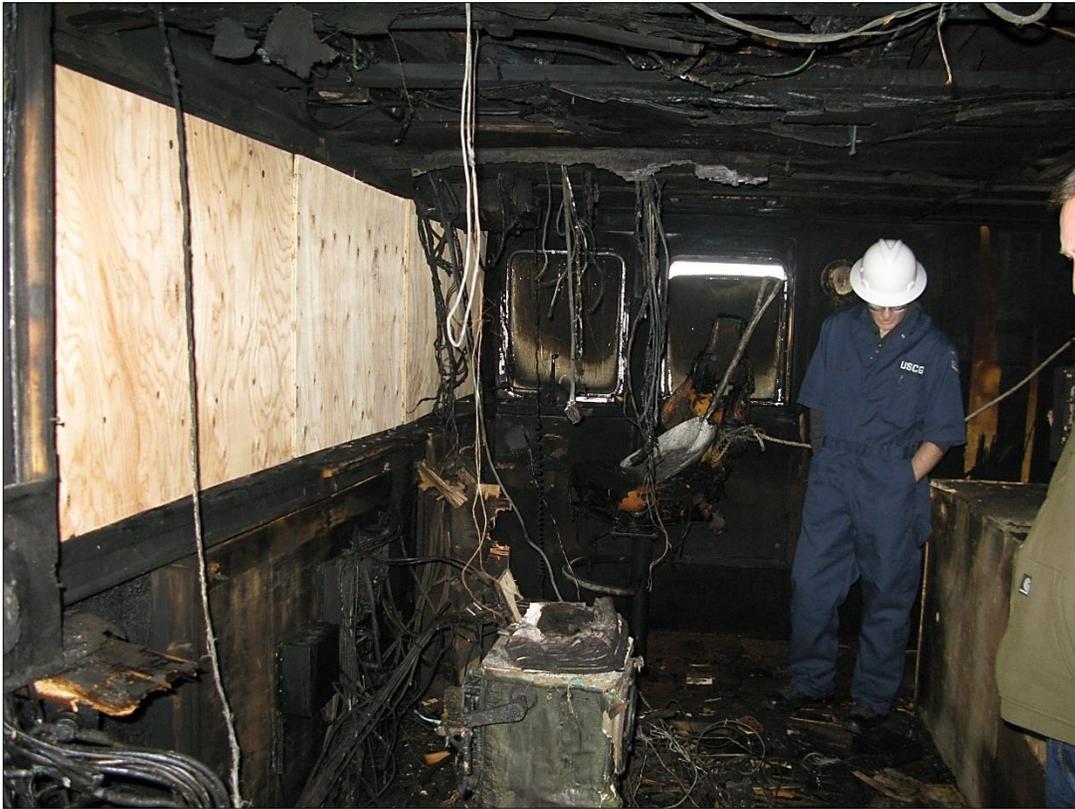
A Coast Guard investigator stands in the charred remains of the bridge, starboard side.
