National Transportation Safety Board

Marine Accident Brief

Grounding and Sinking of Commercial Fishing Vessel *Pacific Queen*

Accident no.	DCA13LM032
Vessel name	Commercial fishing vessel <i>Pacific Queen</i>
Accident type	Grounding and sinking
Location	Lung Island, Sumner Strait near Duncan Canal, southeast coast of Alaska 56° 30.7' N, 133° 04.0' W
Date, time	August 14, 2013 0100 Alaska daylight time (coordinated universal time – 8 hours)
Injuries	None
Damage	Loss of 113-gross-ton mechanically propelled vessel, valued at \$225,000
Environmental damage	Vessel carried est. 2,000 gallons of diesel fuel at sinking; release of product into waterway minimal
Weather	Clear, calm winds, air temperature 60°F, sea temperature 41°F
Waterway information	Between Duncan Canal and Sumner Strait, Inside Passage, southeastern Alaska

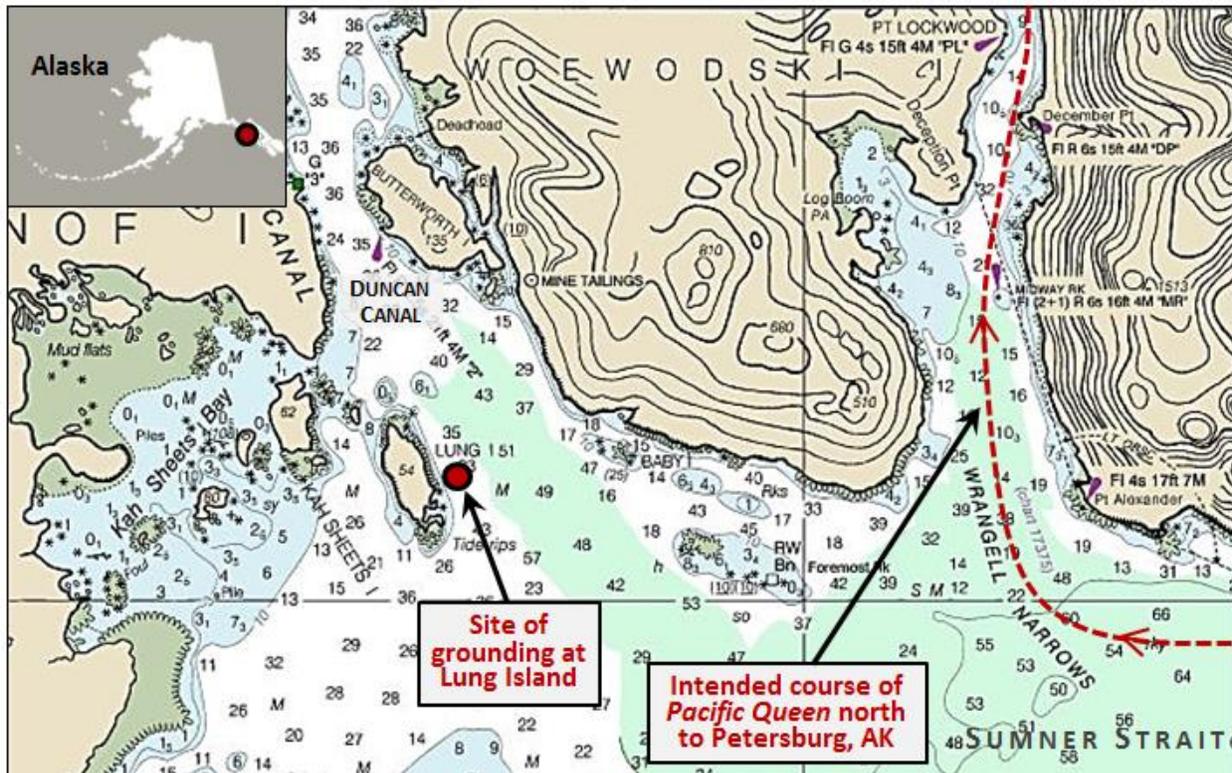
Approximate site of the grounding and sinking of the *Pacific Queen* near Lung Island, Alaska. At right, dotted red line indicates intended course of the fishing vessel north into Wrangell Narrows toward Petersburg, Alaska. (Background: Excerpt from National Oceanic and Atmospheric Administration nautical chart 17382)

The *Pacific Queen* continued on its heading and missed the turn, and about 0100, the vessel struck the rocky eastern shore of Lung Island at the entrance to Duncan Canal. Deckhand #1 stated that he went to the bridge after the impact, discovered it was unmanned, and saw on the computer navigation screen that the vessel was aground on Lung Island. The deckhand stated he was not sure if the vessel was still under way so he put the engines in neutral, then in reverse, then to neutral again.

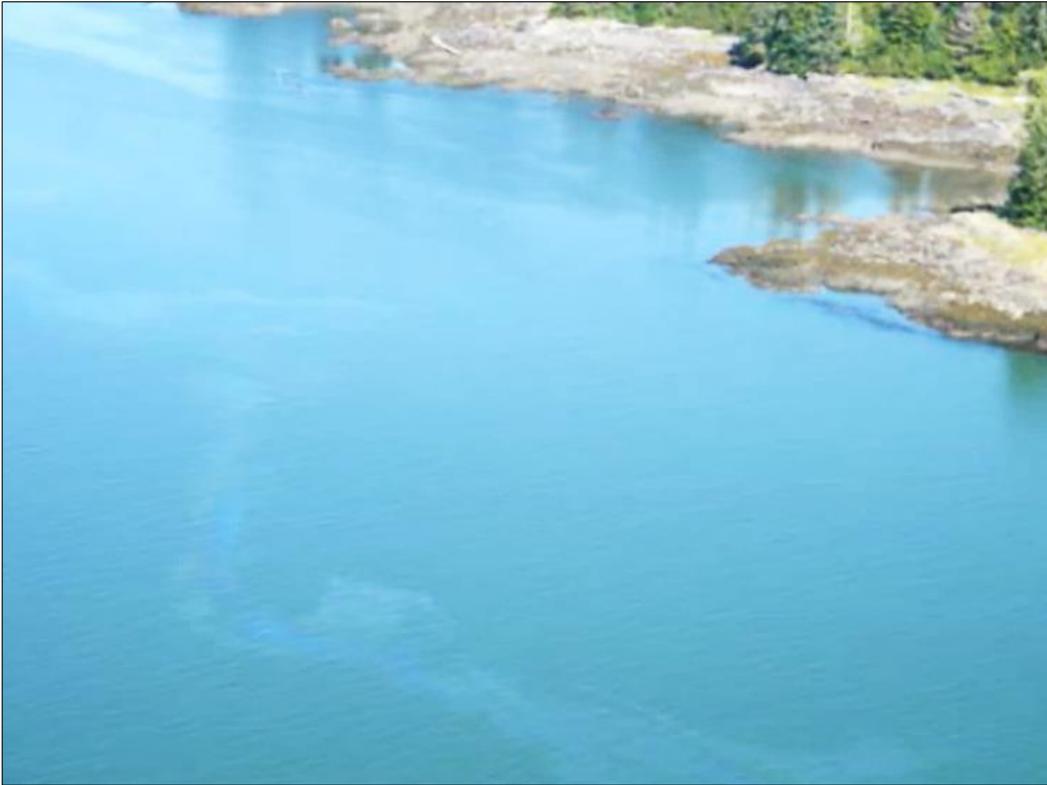
A Coast Guard helicopter flew over the area soon after the sinking, and the crew observed a silver sheen on the water about 0.75 miles long and 20 to 60 feet wide. Although the captain estimated the *Pacific Queen* was carrying 2,000 gallons of diesel fuel, Alaska Department of Environmental Conservation personnel believe a minimal amount of fuel was released because the fuel vents were secured prior to the sinking.

Light silver sheen was noted during an August 14, 2013, USCG overflight in the vicinity of the *Pacific Queen* sinking. (Photo provided by Coast Guard)
