National Transportation Safety Board

Marine Accident Brief

Subsea Pipeline Damage by Tug and Barge *Valiant/Everglades*

Accident no.	DCA15LM003
Vessel name	Tug <i>Valiant</i> and barge <i>Everglades</i>
Accident type	Loss of propulsion/pipeline damage
Location	Gulf of Mexico about 120 nautical miles southeast of Galveston, Texas 28° 14' N, 92° 46' W
Date	November 17, 2014
Time	0600 central standard time (coordinated universal time – 6 hours)
Injuries	None
Damage	Natural gas pipeline: est. \$2 million
Environmental damage	None reported
Weather	Northerly wind 30 knots with gusts to 35 knots, visibility 8 nautical miles, wave height 8–10 feet
Waterway information	Gulf of Mexico, open water, East Cameron production field

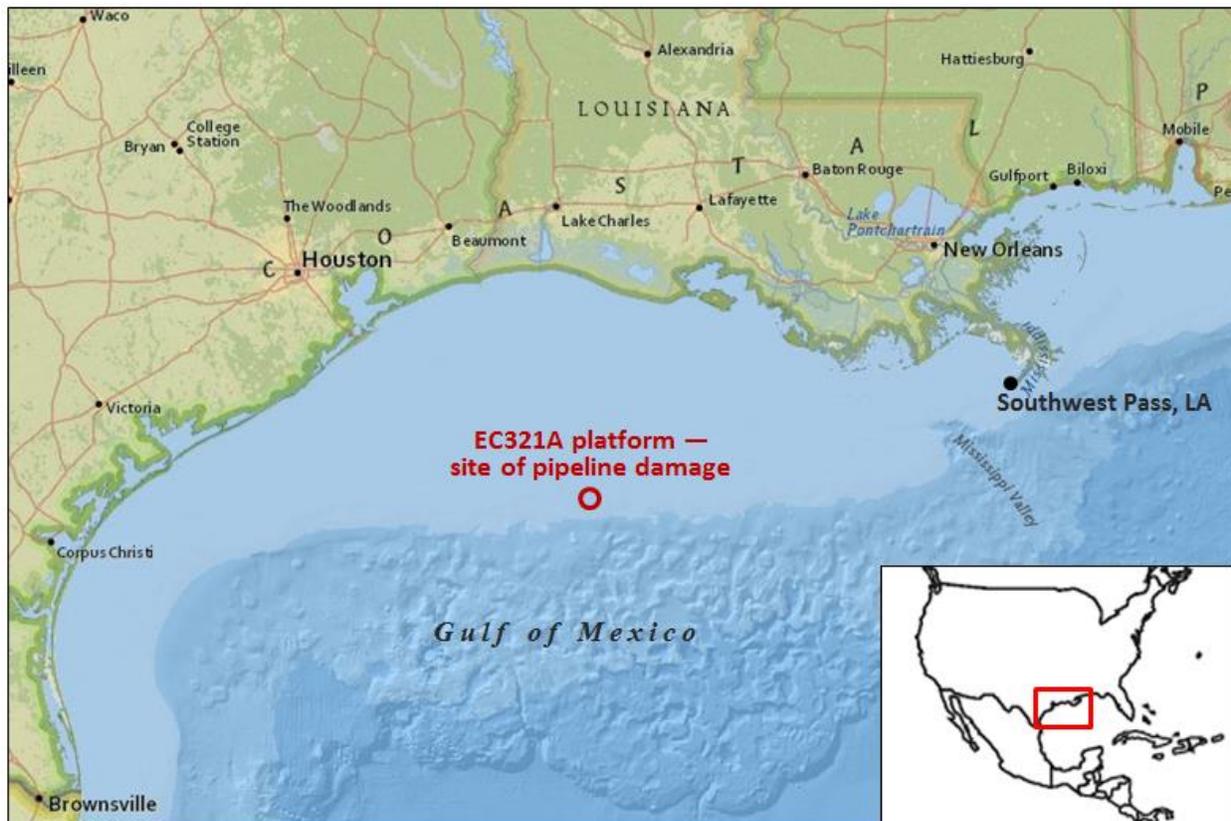
Site of production platform EC321A, where the *Valiant's* anchor damaged a subsea platform. (Background by National Geographic MapMaker Interactive)

A survey carried out by the pipeline owner stated that the anchor had dragged across six subsea pipelines and completely severed one 16-inch natural gas pipeline. The pipeline owner reported that 223,000 mcf of natural gas was released as a result of the rupture. An additional 26,800 thousand cubic feet was later released in a controlled manner to clear the line.

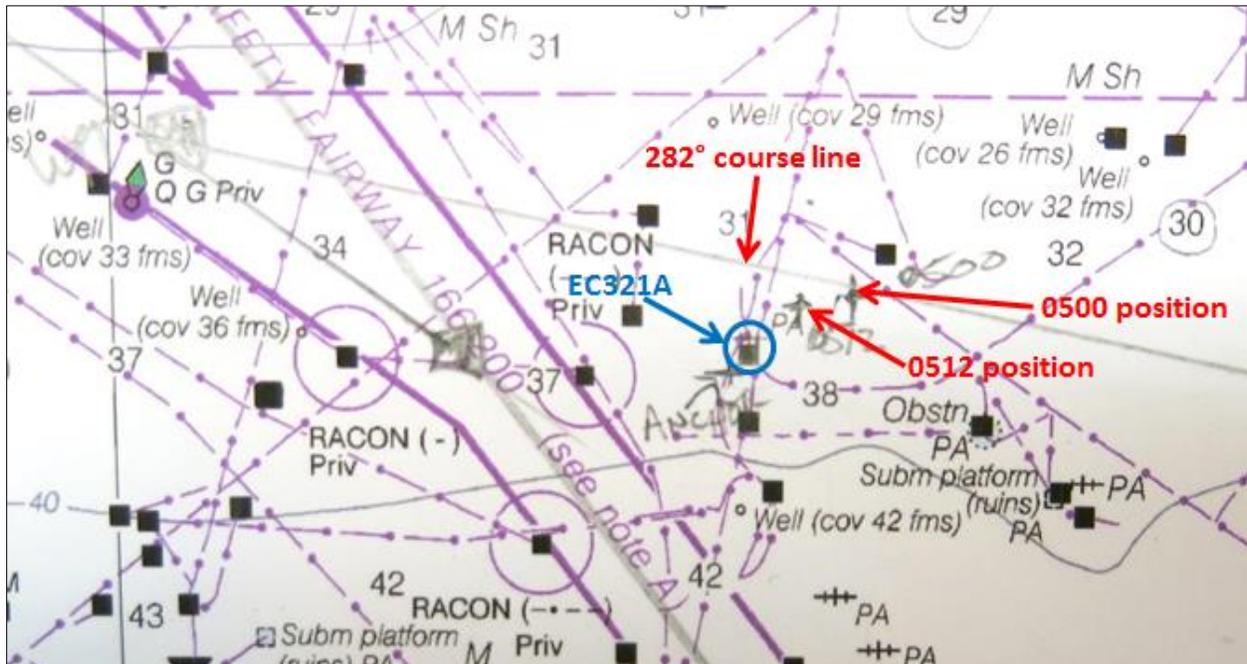
Portion of NOAA chart 11340 used by the *Valiant* crew, with vessel position at 0500 and 0512 and course line (labeled in red) relative to EC321A.

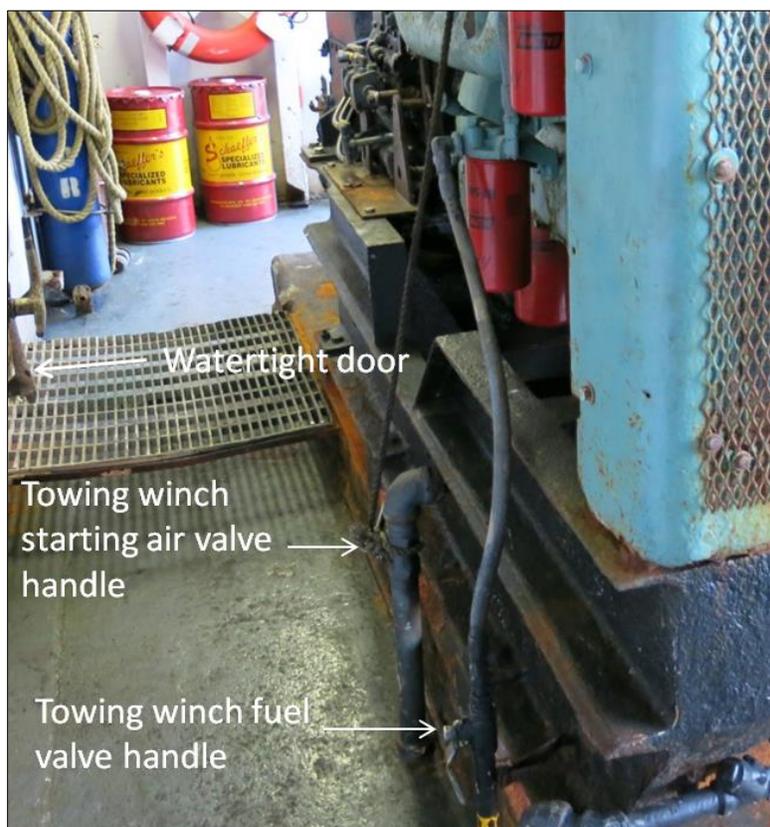
The vessel crew later found the source of the air leak was an air valve that supplied starting air to the towing winch engine on the *Valiant's* aft weather deck. Post-accident inspection and testing indicated the valve was operable but required only minimal force to open it, with no securing mechanism in place to protect it from unintentional opening. The investigation could not determine if the valve had been opened by the force of water on deck or by a loose object hitting the handle. *Valiant* crewmembers said the deck had been awash in the heavy seas. According to one, empty grease drums that had been secured on deck could not be found after the accident, suggesting they had come free. Additional crew statements indicated loose items such as buckets also were missing, but items mounted on the bulkhead directly adjacent to the towing winch appeared to be in place and undamaged. Investigators could not determine if any of these objects had been displaced before the accident, but no crewmembers recalled having to replace any of these objects.

Towing winch motor and locations of starting and fuel valve handles and watertight door into accommodation.

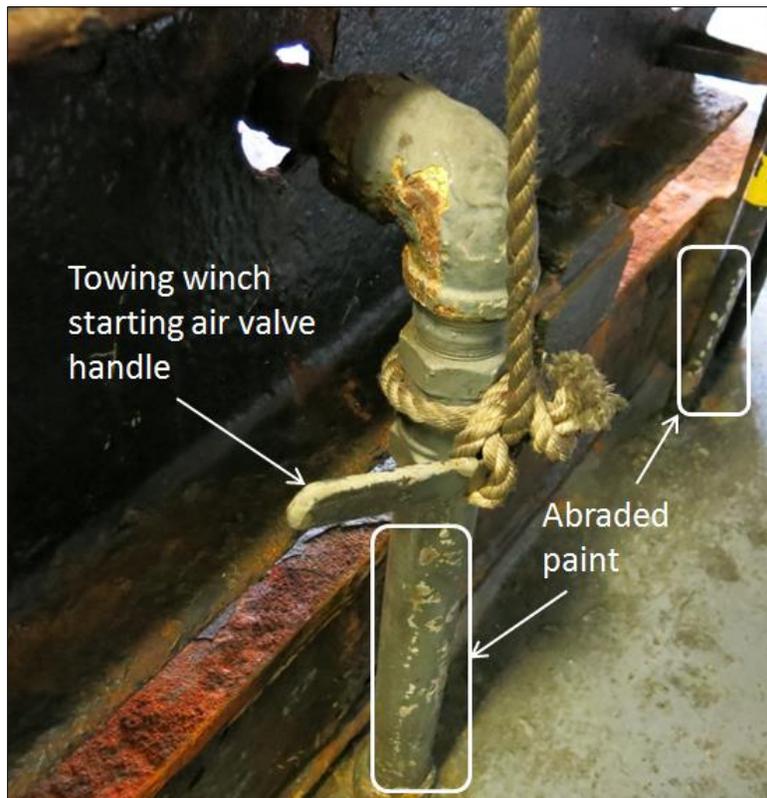
During the post-accident survey, abraded paint was noticed on the starting air pipe, likely due to impact from a solid object, but no loose equipment was found in the area. The investigation did not determine why the valve had moved to the open position.

Close-up of starting air valve (in closed position) for towing winch engine with recent paint damage (rope was not in place at time of accident).

The National Transportation Safety Board determines that the probable cause of the damage to the subsea natural gas pipeline was the anchor from the *Valiant/Everglades* dragging across the pipeline after the vessel lost starting air pressure and propulsion due to the opening of an unprotected air system valve on deck.
