National Transportation Safety Board

Marine Accident Brief

Sinking of Fishing Vessel *Blazer*

Accident no.	DCA15LM004
Vessel name	<i>Blazer</i>
Accident type	Sinking
Location	Pacific Ocean, about 8 miles* west of Siletz Bay, Oregon, and about 80 miles southwest of Portland, Oregon; 44°57.6' N, 124°3.3' W
Date	November 29, 2014
Time	0611 Pacific standard time (coordinated universal time – 8 hours)
Injuries	Minor injuries sustained in the rescue effort
Property damage	Total loss of vessel, valued at \$950,000
Environmental damage	No sheen sighted despite strong smell of diesel fuel (2,000 gallons on board)
Weather	Fair visibility, northwest winds at 25 to 30 knots, 10- to 14-ft seas, air temperature 42°F, water temperature 55°F
Waterway information	Near coastal waters off the Oregon coast

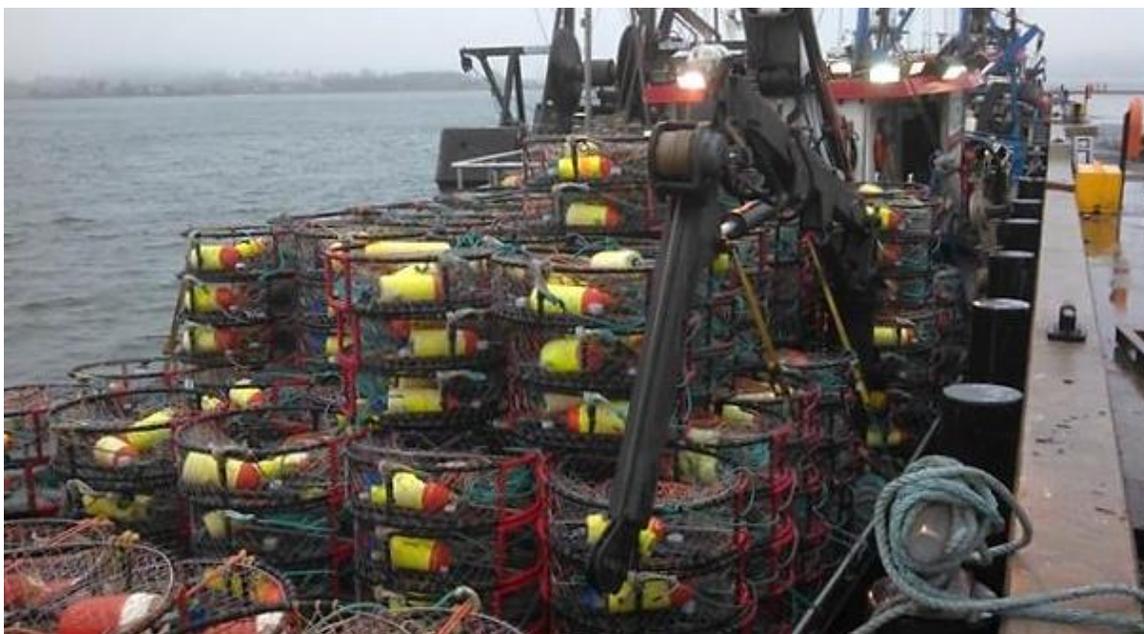
Dungeness crab pots strapped onto the *Blazer's* deck before the vessel left Newport, Oregon. (Photo provided by the Coast Guard)

Of the 500 crab pots on board the *Blazer*, 350 were stowed on the main deck; 100 were stowed in the forward no. 1 fish hold, which was deliberately filled with sea water to trim down the vessel's bow; and 50 were stowed in the no. 2 fish hold, which was dry. Each crab pot weighed 110 pounds, including weights, buoys, and line, for a total weight of about 27.5 tons.

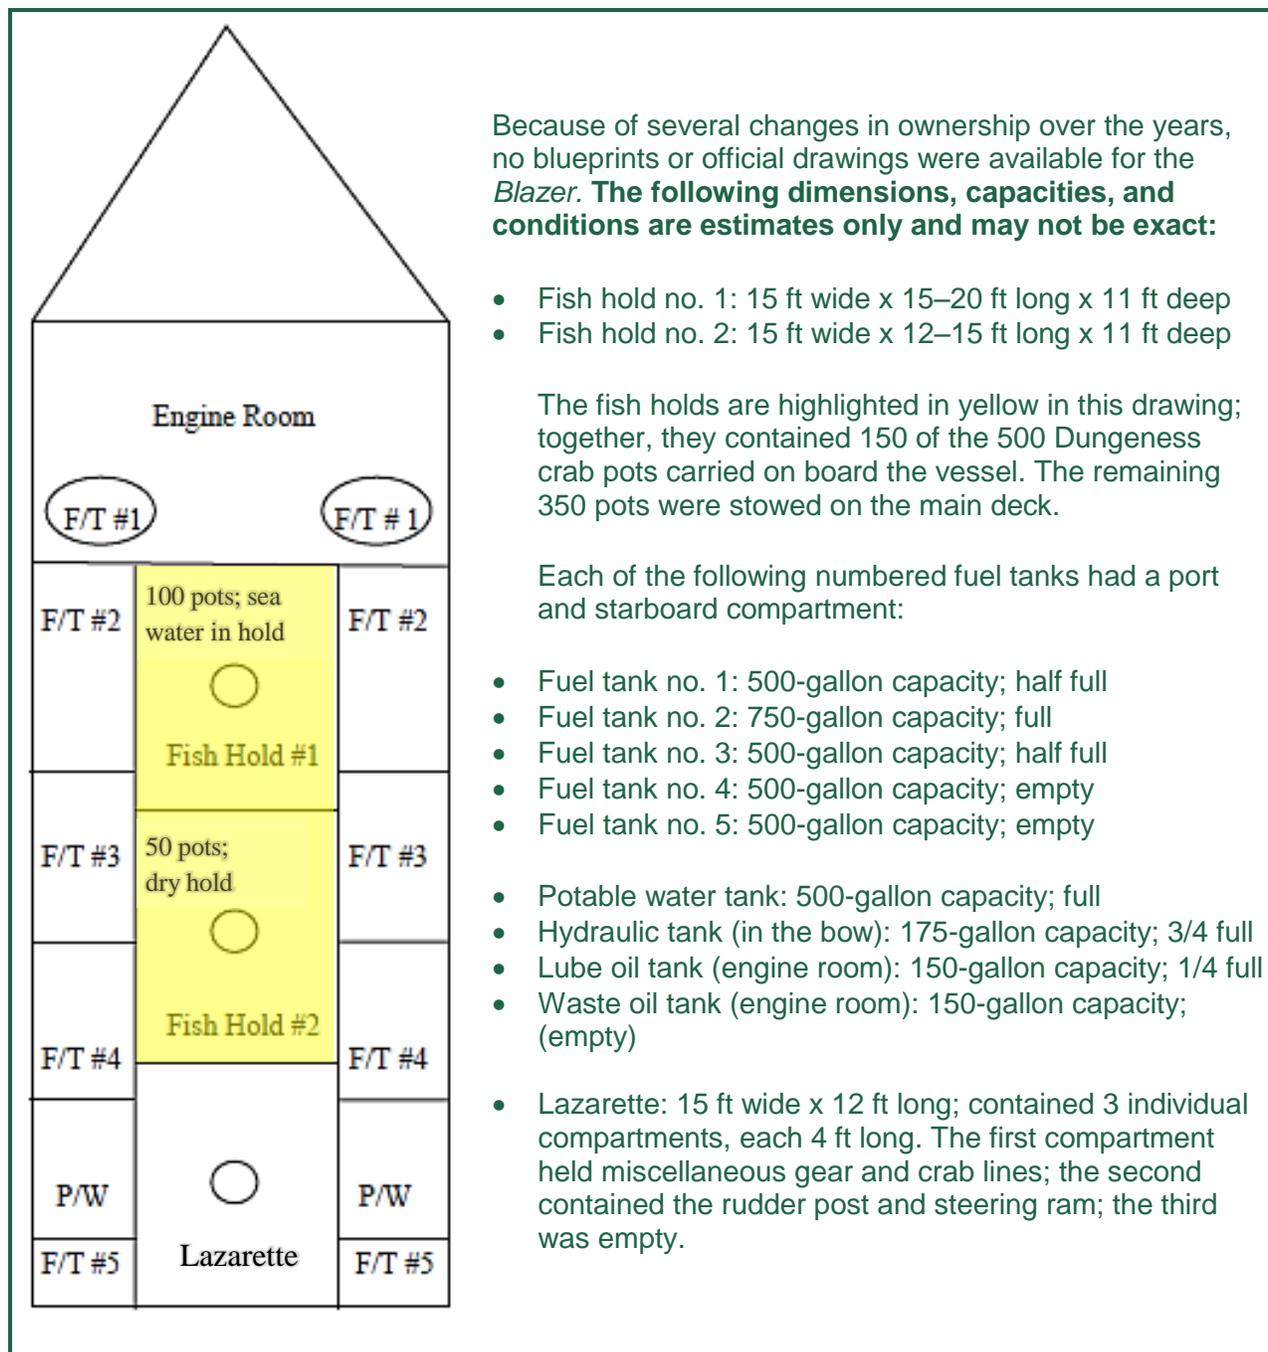
Vessel compartments on board the *Blazer*. (Original drawing by the Coast Guard, based on the captain's description)

The captain then tried to correct the list because he thought that it may have resulted from flooding in either the dry no. 2 fish hold (which held 50 crab pots) or in one of the empty tanks. He went below deck to the engine room, where he started the pumps for the no. 2 fish hold, which he suspected was filling with sea water. He also alerted the other crewmembers and instructed them to cut loose the crab pots on the starboard side of the main deck, as the list to starboard had increased to about 10 to 15 degrees by this time. According to crew statements, during the next 20 minutes or so, the crew pushed about 50 crab pots overboard, but the list was not corrected. When the *Blazer* was listing by nearly 20 degrees, the captain began turning the vessel in a circle to starboard to heel the vessel to port, but this attempt was unsuccessful. When the starboard list neared 30 degrees, the *Blazer* lost steerage ability. At that point, the captain concluded that he could not save the vessel and began preparations for all of the crewmembers to abandon ship.
