National Transportation Safety Board

Marine Accident Brief

Grounding and Sinking of Commercial Fishing Vessel *Titan*

Accident no.	DCA15LM007
Vessel name	<i>Titan</i>
Accident type	Grounding and sinking
Location	Jetty A off Cape Disappointment, Ilwaco, Washington, on the north side of the Columbia River bar, 46°15.8' N, 124°02.3' W
Date	December 5, 2014
Time	About 0215 Pacific standard time (coordinated universal time – 8 hours)
Injuries	None
Property damage	Total loss of vessel, estimated at \$1.825 million
Environmental damage	Unknown quantity of diesel, hydraulic, and lubricating oil on surface of water
Weather	Overcast skies, winds north-northeast at 10 to 20 knots, intermittent rain and mist, air temperature 48 to 49°F, dew point 45 to 47°F, water temperature 55°F, visibility more than 5 nautical miles, ebb current 1 to 2 knots (estimated)
Waterway information	The Columbia River runs along the border between Washington and Oregon and flows into the Pacific Ocean. At the mouth of the river are three rubble-mound jetties—the north jetty, south jetty, and jetty A—that are maintained by the US Army Corps of Engineers. These jetties are intended to minimize navigational channel

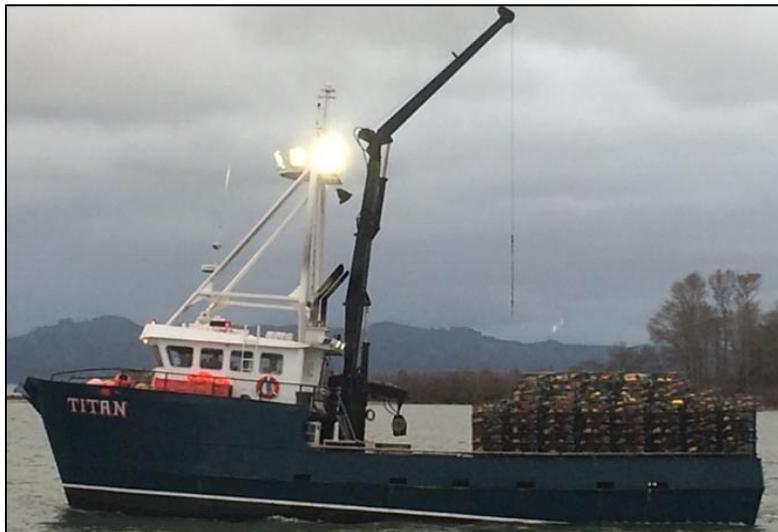
The *Titan* under way with its sodium lights illuminated. (Photo by HD Fisheries)

a course line or preset route. The vessel's seven sodium lights (1,000 watts each) were illuminated while the vessel was under way for the transit out of the Columbia River. This was considered to be a common practice for crab fishing vessels in the area.

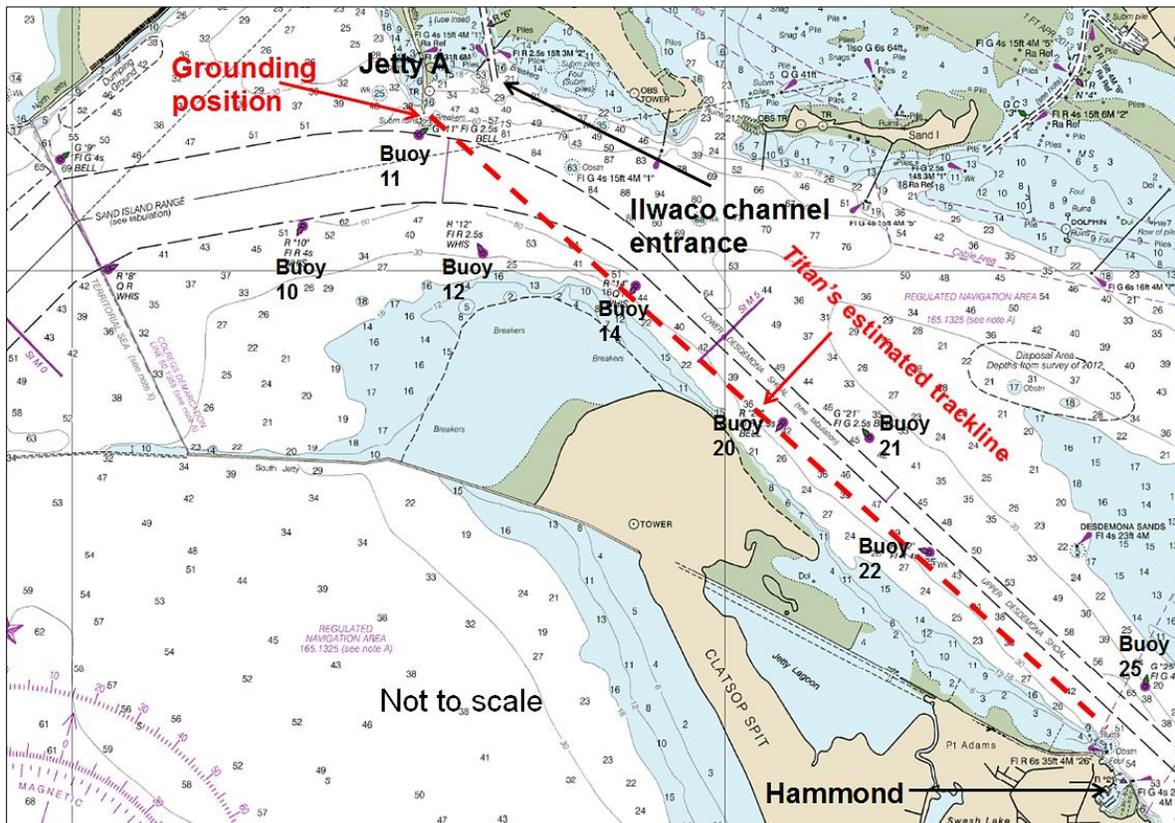
The car carrier *Harmony Leader* was nearby traveling outbound through the main shipping channel of the Columbia River. The Columbia River bar pilot on board that vessel stated that, when he first saw the *Titan*, it was initially favoring the left side of the channel. He noted that, as both vessels continued outbound, the *Titan* appeared to continue straight on its heading across the main channel and looked as if it was headed toward Ilwaco, Washington, a fishing port on the north side of the channel.

As the *Harmony Leader* approached buoy 11, the pilot commented to the bridge team that the *Titan*'s radar target had moved onto Jetty A. The pilot and bridge team then used binoculars to observe the *Titan* and noticed that the sodium lights were shining on the rocks. The pilot tried to contact the *Titan* using the very high frequency (VHF) radio with no success. Shortly afterward, he heard a distress call from the *Titan* to the Coast Guard on the VHF radio. According to the Coast Guard Search and Rescue (SAR) log, the first distress call from the *Titan* was received at 0216.

National Oceanic and Atmospheric Administration chart 18521 with the *Titan*'s estimated trackline, Columbia River shipping channel buoy numbers, and the *Titan*'s grounding position overlaid.

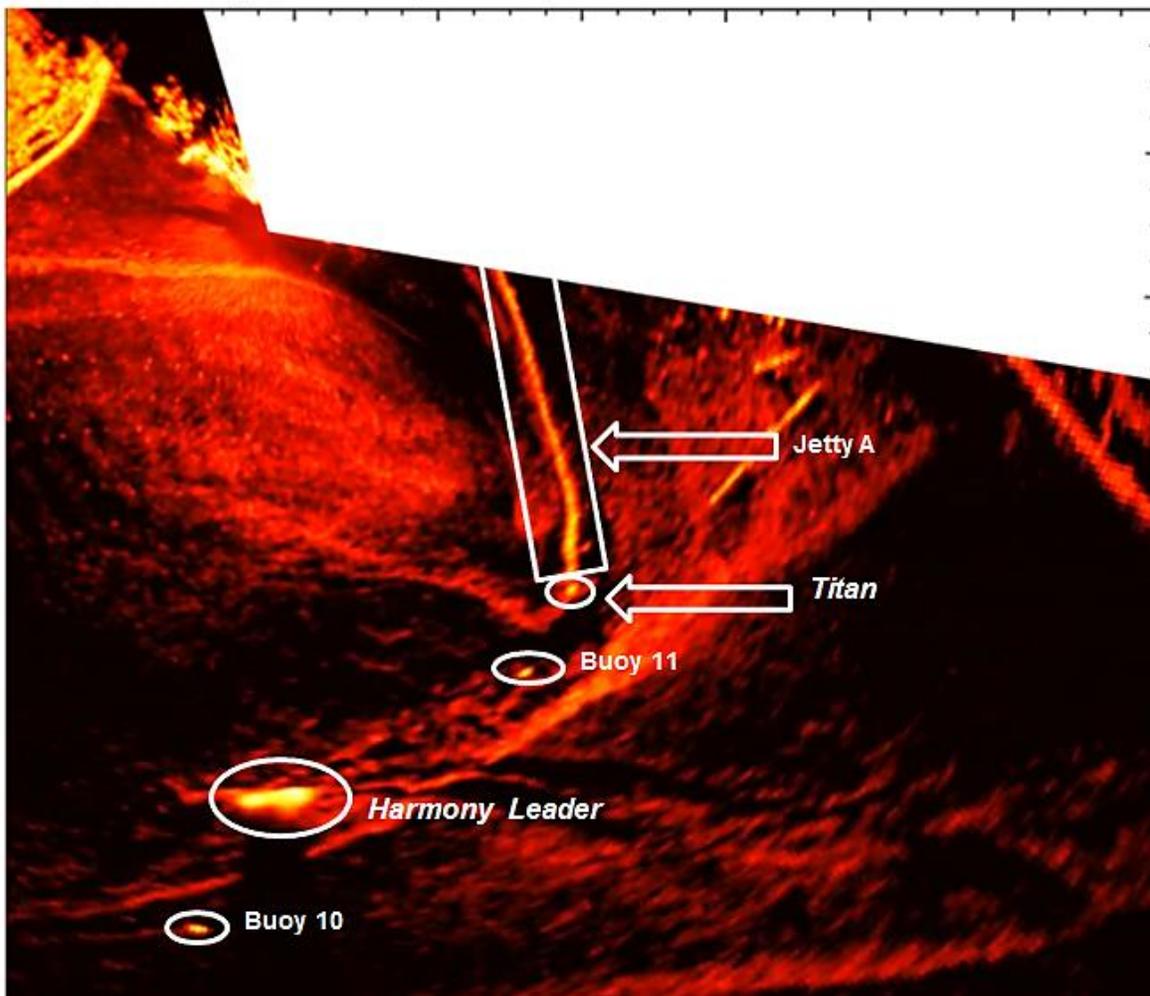
Wave Imaging Radar - 64-Rotation Backscatter Intensity Time Exposure Cape Disappointment, Ilwaco, WA - 2014-12-05 02:18:26 Pacific

Wave imaging radar at 0218. (Image by Haller Research Group, Oregon State University)

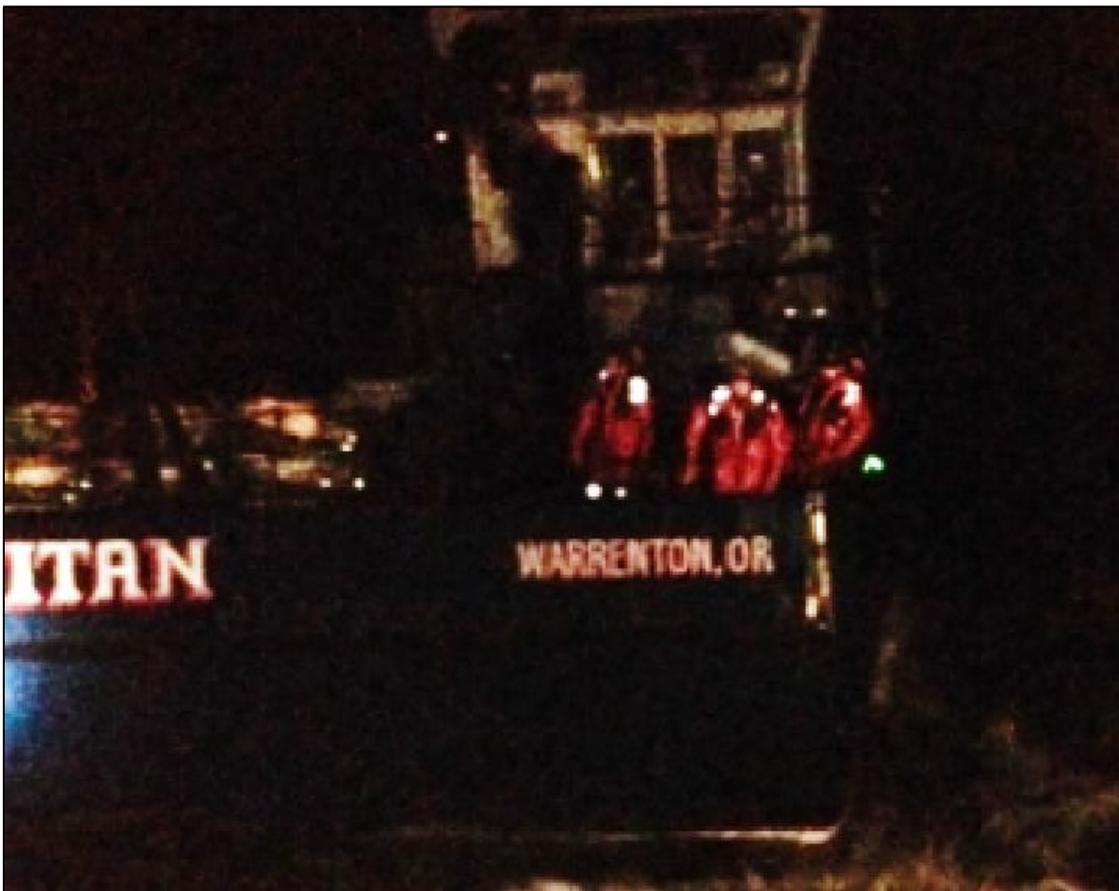
According to the Coast Guard SAR log, the first Coast Guard motor lifeboat arrived on scene about 0241 and provided a dewatering pump to the *Titan*. Crewmembers from the *Titan* connected the pump according to the instructions that were attached but were unsuccessful in getting it started. They continued attempts to start the pump until about 0324 when the captain informed the Coast Guard that the crew would need to abandon the *Titan* because the flooding could not be contained. The motor lifeboat backed up to the *Titan*, and three of the crewmembers jumped onto the stern of the lifeboat. The captain and another crewmember went to the bow of the *Titan* to lower its anchor. Afterward, both crewmembers went to the stern and jumped onto the motor lifeboat. By about 0349, all crewmembers were safely on board the lifeboat. The crewmembers were transported to Coast Guard Station Cape Disappointment, from where they were subsequently released with no reported injuries. Postaccident drug and alcohol testing performed on each crewmember was negative.

Three of *Titan's* crewmembers in cold water immersion suits before boarding a Coast Guard motor lifeboat. Note the absence of power on the *Titan*. (Photo by the Coast Guard)

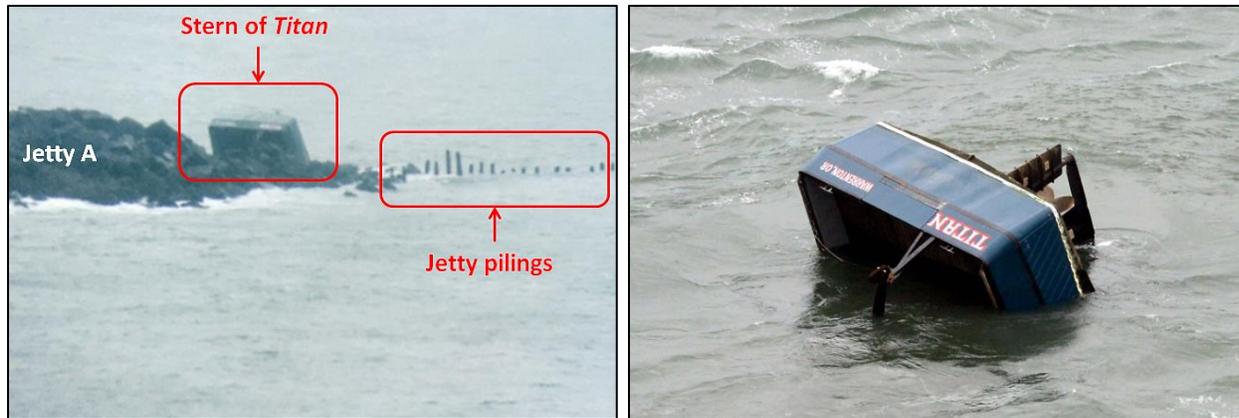
After being abandoned, the *Titan* stayed partially afloat by the stern and remained tethered by its anchor near Jetty A. Throughout the day on December 5, 2014, Coast Guard officials made preparations with local salvage companies to remove the wreckage. Helicopters in the area reported seeing oil sheens on the water, and nearby vessels reported the smell of diesel fuel on the water. About 0830 the following morning (December 6), a salvage tug reported to the Coast Guard that the *Titan* had sunk completely. The vessel was not subsequently recovered.

Jetty A and the stern of the *Titan* on the day of the grounding. (Photos by the Coast Guard)
