National Transportation Safety Board

Marine Accident Brief

Engine Room Fire on Board Commercial Fishing Vessel *Miss Eva*, with Subsequent Sinking

Accident no.	DCA15LM005
Vessel name	<i>Miss Eva</i>
Accident type	Fire and sinking
Location	Gulf of Mexico, Ship Shoal Block 154, about 35 miles southwest of Grand Isle, Louisiana, 28°40.8' N, 91°12.2' W
Date	December 1, 2014
Time	0708 central standard time (coordinated universal time – 6 hours)
Injuries	Three crewmembers received severe burns, and one crewmember was uninjured
Property damage	Total loss of vessel, estimated at \$550,000
Environmental damage	No sheen was reported from the estimated 3,200 gallons of marine diesel fuel and 100 gallons of hydraulic oil on board
Weather	Clear skies, visibility 6.5 miles,* winds from the east-southeast at 10 knots, seas 1 to 2 feet
Waterway information	Gulf of Mexico, open water

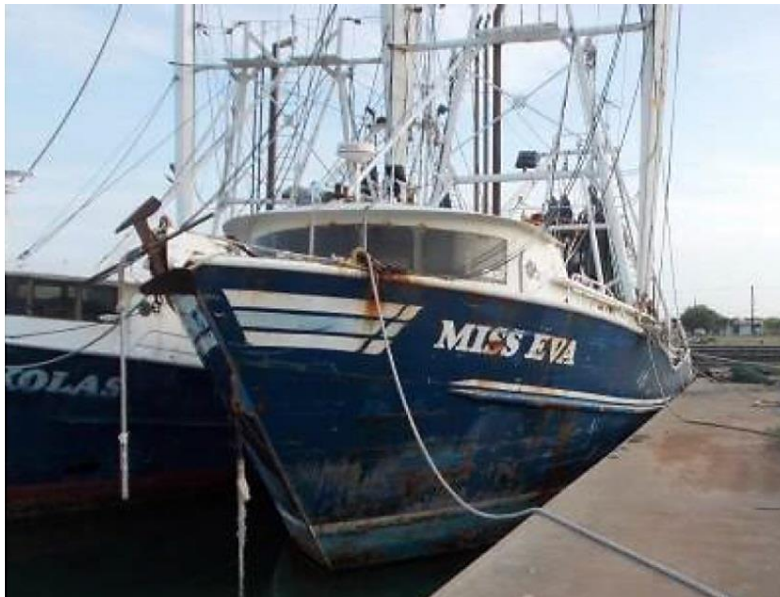
The *Miss Eva* during a condition and valuation survey in July 2014. The *Miss Eva*'s sister vessel, the *Nikolas*, appears in the background. (Photo by K.W. Diers)

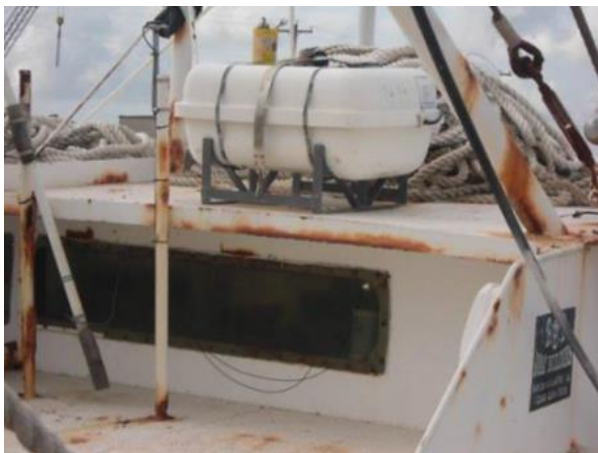
While the deckhand was in the process of manually releasing the six-person liferaft located above the wheelhouse, a second explosion occurred that blew out the wheelhouse windows. The deckhand tossed the liferaft canister over the starboard side and inflated the raft. Flames and smoke exited the location where the wheelhouse windows had been, so the deckhand jumped into the water from the roof of the wheelhouse. He received burns to 6 percent of his body, including his upper extremities and back. The deckhand then righted the liferaft and entered it followed by the junior deckhand, who had been clinging to the fishing rigging. Afterward, the senior deckhand and then the master jumped into the water and entered the liferaft. None of the crewmembers retrieved lifejackets or the vessel's emergency position indicating radio beacon (EPIRB) before entering the liferaft.

The left photo shows the *Miss Eva*'s liferaft located above the wheelhouse. (Photo by K.W. Diers)
The right photo shows the *Miss Eva* on fire with an Era helicopter circling the liferaft and the vessel. (Image from video by Chad Guidroz)

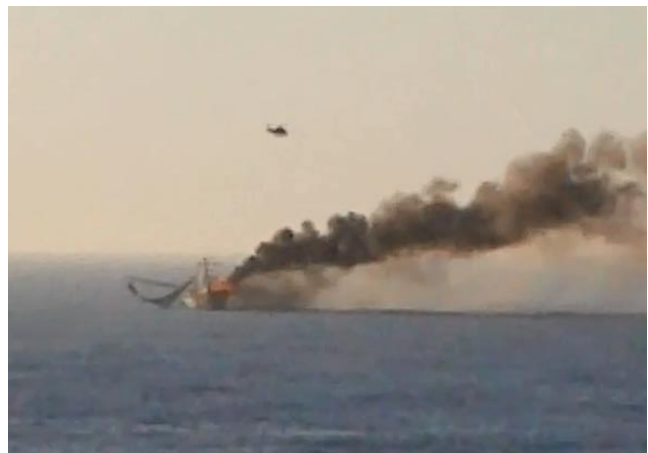
While on his morning rounds, a crewmember on board the Century Exploration platform Ship Shoal 154-E observed the *Miss Eva* on fire. The platform crew notified the Coast Guard and coordinated rescue and first aid with the W&T Offshore Ship Shoal rig 149 and an air medic from the Hercules Offshore rig 214. A helicopter from Era Helicopters arrived on scene about 0732 and circled the liferaft and vessel while maintaining communication with Ship Shoal 154-E and the offshore supply vessel *Dustin Danos* (located at Ship Shoal rig 149), which retrieved the *Miss Eva*'s crew from the liferaft and transported them to Ship Shoal 154-E, where first aid was administered to the crewmembers.

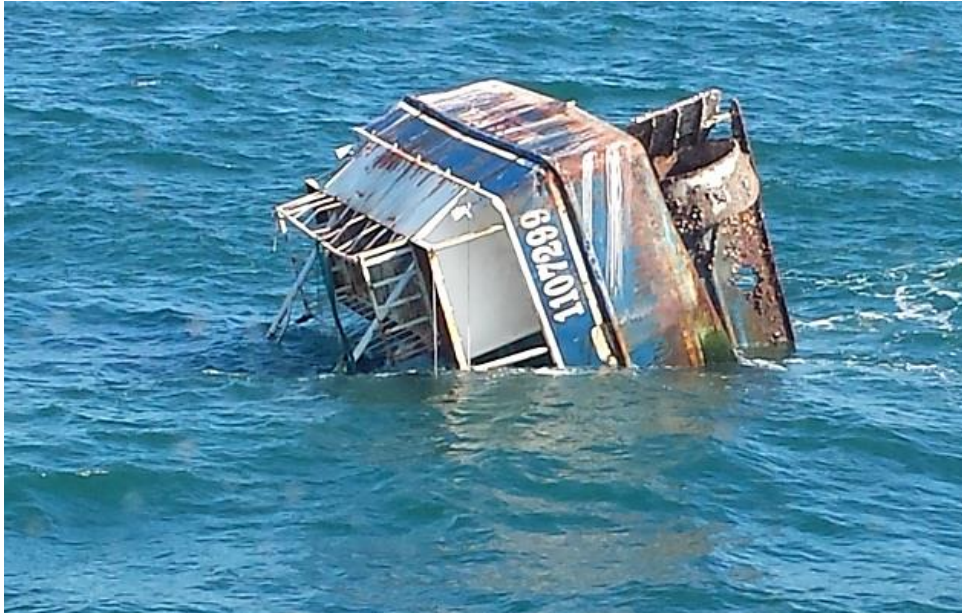
The *Miss Eva* remained afloat and burning. A sister vessel, the commercial fishing vessel *Nikolas*, arrived on scene to attempt to salvage the *Miss Eva*'s cargo. The *Nikolas*' master noticed that the *Miss Eva*'s bulwarks and hull plating were pushed outward, which he believed were signs of an explosion. About 4 to 6 hours after the fire started, the *Miss Eva* sank bow first in water about 60 feet deep near Ship Shoal Block 154. The *Miss Eva* was not salvaged.

The *Miss Eva* sinking bow first. (Photo provided by master of sister vessel the *Nikolas*)
