National Transportation Safety Board

Marine Accident Brief

Grounding of Commercial Fishing Vessel *SeaHawk No. 68*

Accident no.	DCA15LM022
Vessel name	<i>SeaHawk No. 68</i>
Accident type	Grounding
Location	Pala Lagoon, Pago Pago, American Samoa (14°19.46' S, 170°42.02' W)
Date	May 22, 2015
Time	0530 Samoa standard time (coordinated universal time – 11 hours)
Injuries	Some crewmembers received minor injuries
Property damage	Total loss of vessel and cargo, valued at more than \$500,000
Environmental damage	None reported
Weather	Seas about 10 feet, winds from the east about 15 to 25 knots, rain showers, and visibility about 10 miles.* Small craft and high surf advisories were in effect.
Waterway information	Pacific Ocean, southeast coast of Tutuila Island, American Samoa

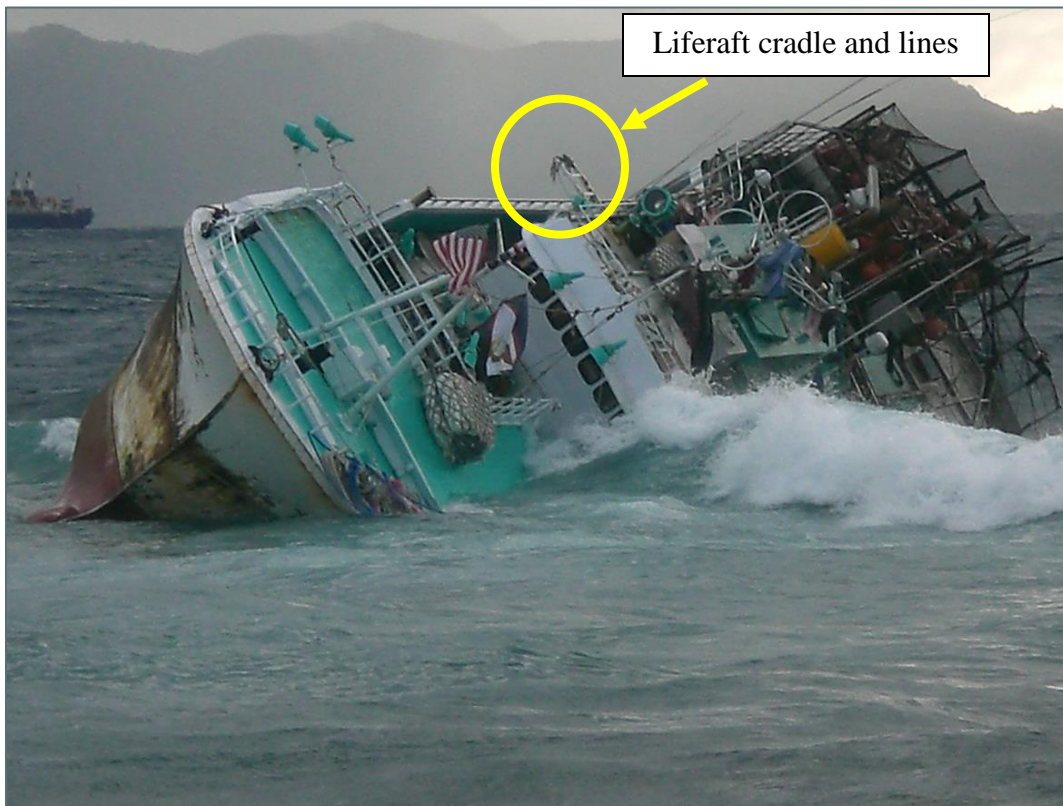
At 0520, a crewmember noted that there was “panic” in the wheelhouse because a large wave came from behind, pushing the vessel forward toward a reef. The captain returned to the wheelhouse and attempted to put the engine astern, but the vessel grounded on the reef. The engineer and some crewmembers then lowered the anchor from the bow, which was ineffective due to the shallow water depth. The *SeaHawk No. 68* rolled to its port side, and the crew decided to abandon the vessel onto an inflatable liferaft. The crewmembers had to first locate a knife to

cut away the lines securing the liferaft to its cradle. The liferaft, with all of the crewmembers inside, then floated safely to shore.

The *SeaHawk No. 68* grounded on its port side. The liferaft cradle and lines are circled. (Photo by the Coast Guard)

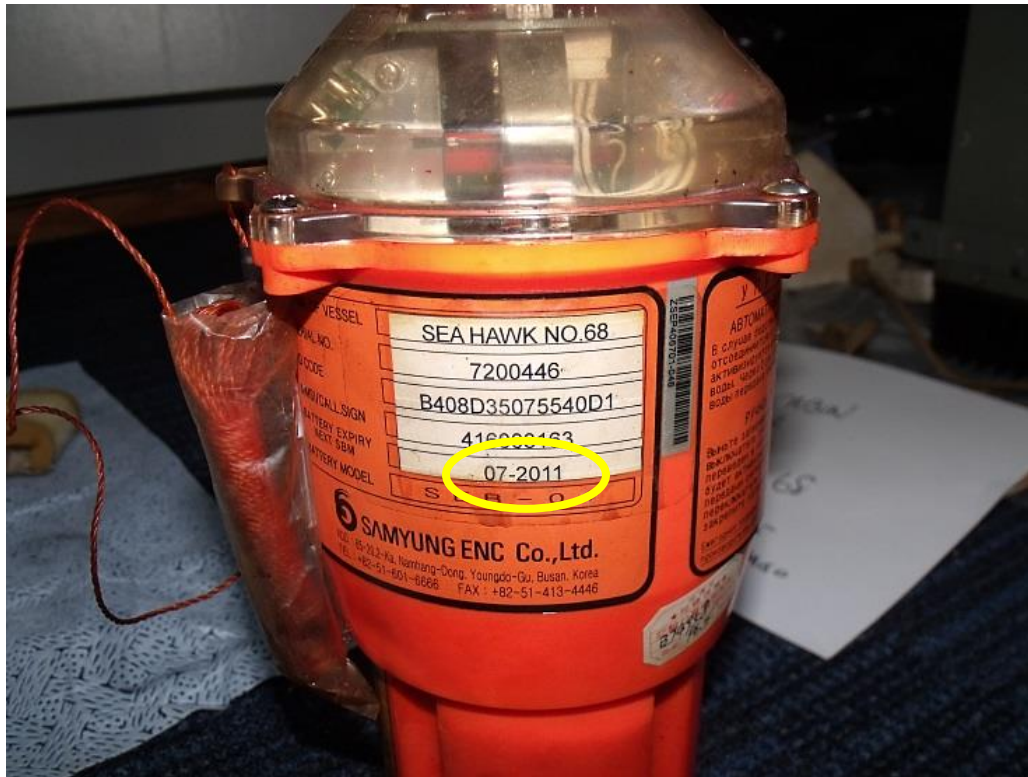
During the investigation of this accident, Coast Guard investigators discovered safety equipment discrepancies from the accident vessel. The investigators found that, according to the label on the *SeaHawk No. 68*'s emergency position indicating radio beacon (EPIRB), the

EPIRB's battery had expired in July 2011. The battery enables the EPIRB to transmit a coded message via satellite to facilitate search and rescue services in an emergency. The investigators also found that the captain was the only crewmember who knew how to operate the EPIRB.

EPIRB from the *SeaHawk No. 68* showing the expiration date of the battery. (Photo by the Coast Guard)

Although not a factor in this accident, the issues with the lifesaving equipment aboard the *SeaHawk No. 68* demonstrated the owner/operator's lack of emphasis on safety, which could have compromised the welfare of the crew. The method of securing the liferaft to its cradle with lines caused a delay in launching the liferaft. Also, at the time of the accident, the PFDs would not have been readily available because they were locked in a storage box. Further, because the number of crewmembers exceeded that allowed by the vessel's inspection certificate, there might not have been enough safety equipment for each crewmember. In addition, the EPIRB's label indicated that the battery had been expired for almost 4 years at the time of the accident. If the vessel had experienced an emergency farther out at sea, rescue efforts could have been delayed or rendered ineffective due to the lack of position information.

Owner/operators and vessel crewmembers should maintain safety equipment so that the equipment would function as designed in an emergency and provide crewmembers with the best chance for survival. Owner/operators should ensure that their vessels carry enough safety equipment for each crewmember.

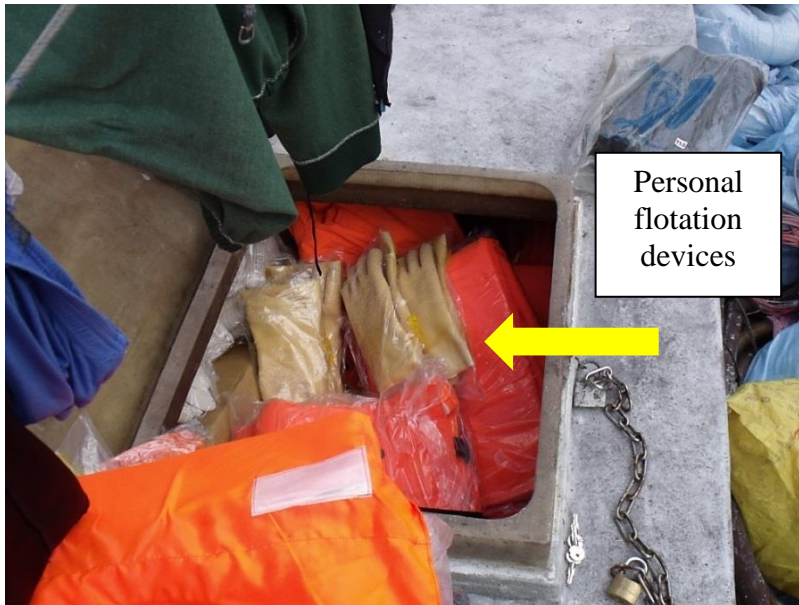
The personal flotation devices (PFD) aboard the *SeaHawk No. 18* were stored in a locked (chain and padlock) fiberglass box above the wheelhouse. The only key to access the PFDs was located away from the storage box. After the crew located the key below deck and opened the box, Coast Guard investigators found the PFDs stowed in clear plastic bags under fishing gear. The investigators randomly selected two crewmembers and asked them to don a PFD. Both of the crewmembers struggled to properly don and fasten the PFDs and needed assistance from the

SeaHawk No. 18 captain. The captain of the *SeaHawk No. 68* stated that the PFDs aboard his vessel were typically kept in the crew's chambers while at sea. However, the *SeaHawk No. 68* captain also stated that, 2 days before the accident, he had the PFDs moved to a locked box above the wheelhouse to prevent them from being stolen while the vessel would be in port.

PFDs stored in a locked fiberglass box aboard the *SeaHawk No. 18*. (Photo by the Coast Guard)

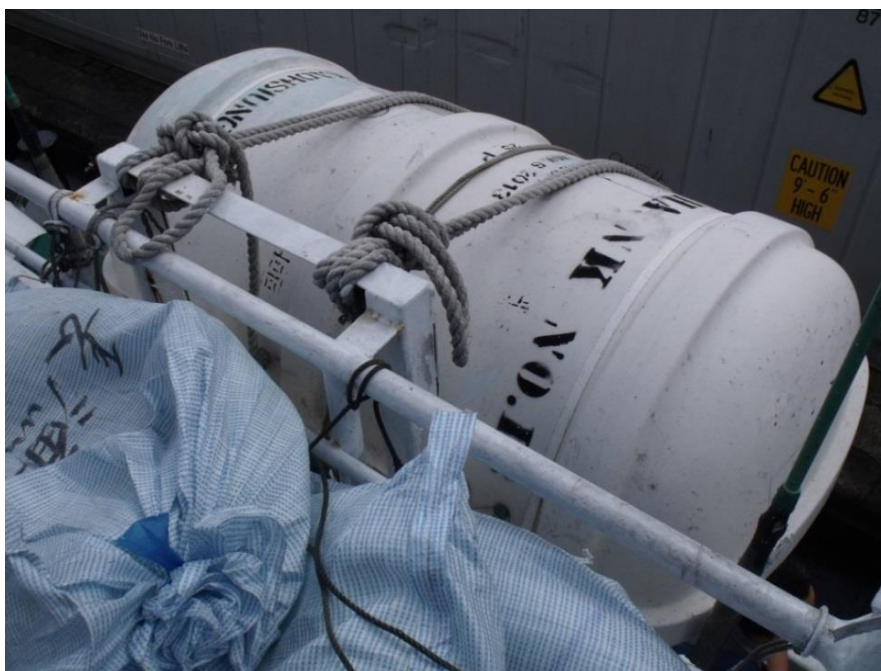
Another finding that concerned investigators while aboard the *SeaHawk No. 18* was that several lines secured the liferaft to its cradle on the starboard side of the vessel. The captain and the engineer of the *SeaHawk No. 68* stated that the liferaft aboard their vessel was secured in the same manner, which is why crewmembers had to use a knife to release the liferaft after the grounding. Neither vessel's liferaft was equipped with a hydrostatic-release device, which is designed to automatically release a liferaft once it becomes submerged.

Liferaft aboard the *SeaHawk No. 18* secured to its cradle with lines. (Photo by the Coast Guard)

The condition of the safety equipment aboard the *SeaHawk No. 18* (sister vessel) further demonstrated the owner/operator's lack of emphasis on safety. The deteriorated condition of the liferings could decrease the effectiveness of their flotation capabilities, and the faded orange color could reduce their visibility if a search and rescue effort were necessary. Also, the time required for crewmembers to access and properly don PFDs along with the lack of a hydrostatic-release device on the liferaft could put the crewmembers' survival at risk in an abandon ship scenario.

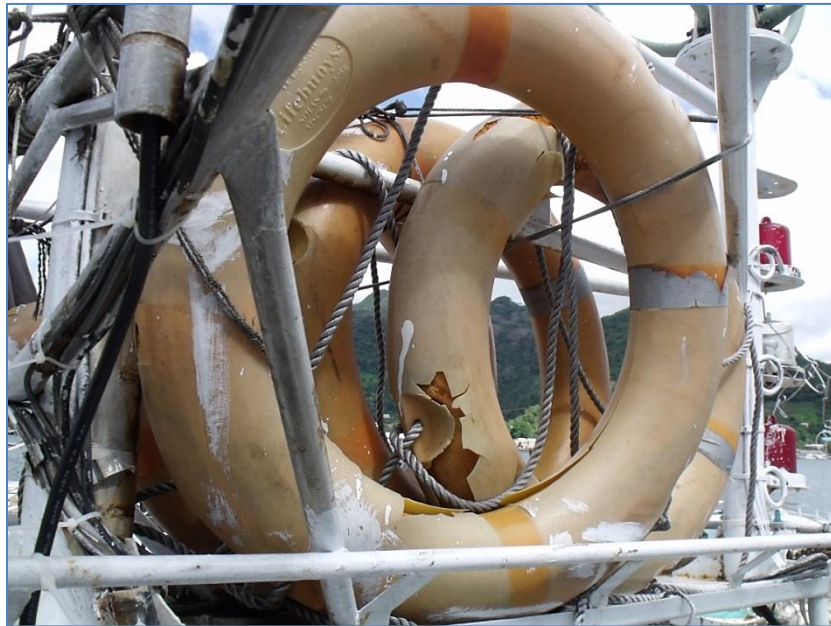
Coast Guard investigators also found that the liferings aboard the *SeaHawk No. 18* were in poor condition as a result of their frequent exposure to sunlight. Specifically, the liferings had faded orange paint, cracked outer casings, missing reflective tape, and deteriorated lines. The captain and the engineer of the *SeaHawk No. 68* indicated that the liferings aboard their vessel were similarly degraded.

Faded and deteriorated liferings aboard the *SeaHawk No. 18*. (Photo by the Coast Guard)
