# National Transportation Safety Board

## Marine Accident Brief

### Allision of Offshore Supply Vessel *Connor Bordelon* with Unmanned Platform South Timbalier 271A

NTSB/MAB-16/03

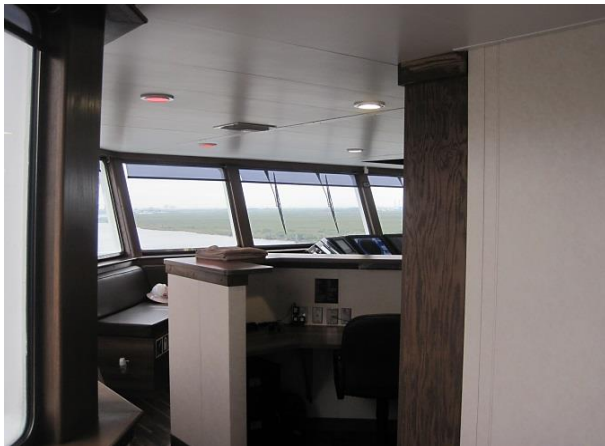
The bridge team on the accident watch consisted of the two mates, an able-bodied (AB) unlicensed sailor qualified to perform routine duties aboard the vessel, and an ordinary seaman (OS) who had less experience than the AB. The AB and the OS performed various duties as directed by the mates, including safety checks of the vessel and, when instructed, lookout duties. The two mates switched out the conn as they deemed appropriate. The mate on watch at the time of the accident took over the conn about 0340, about 50 minutes before the accident. The mate he relieved then went to rest but remained awake on a settee (small couch) located on the starboard side of the bridge below the bridge windows. At that time, the AB was below deck in the galley (with permission from the mate on watch). The OS was on the port side of the bridge in the captain's office, which had a small desk with a privacy wall that would not have allowed a view forward out the windows if he was seated at the desk. According to the AB and the OS, the mate on the settee could perform the lookout duties when called to do so. However, the mate on watch did not ensure that a designated lookout was on the bridge.

The left photo shows the captain's office on the port side of bridge, where the OS was located just before the allision. The right photo shows the settee on the starboard side of the bridge, where a mate was resting just before the allision. (Photos by the Coast Guard)

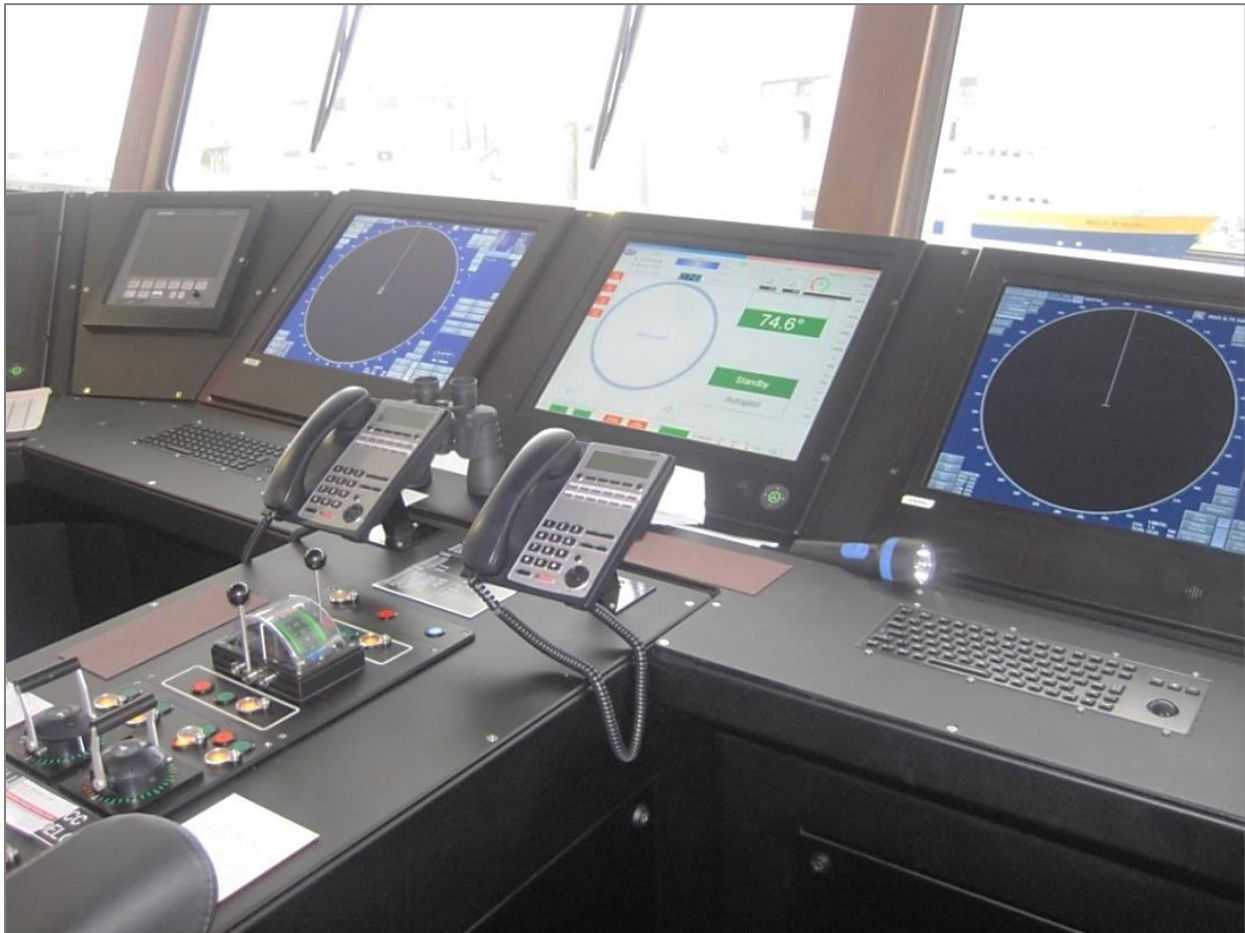
**Conning station, where the mate on watch was located. The autopilot is located in the center, and radars are located on both sides of the autopilot. Manual controls are located on the center console. (Photo by the Coast Guard)**

By not following a plotted trackline, the mate on watch allowed the vessel to drift to the left due to the prevailing winds and currents. By leaving the navigation bridge to get his binoculars after seeing an object of concern, he allowed the vessel to continue to close in on the platform's position. His delay in switching from the autopilot to manual control prevented him from taking action to avoid the platform by steering around it.

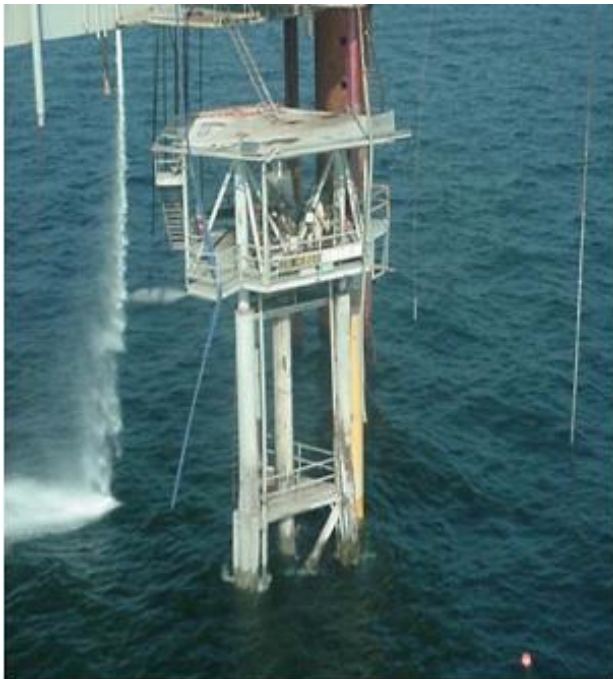
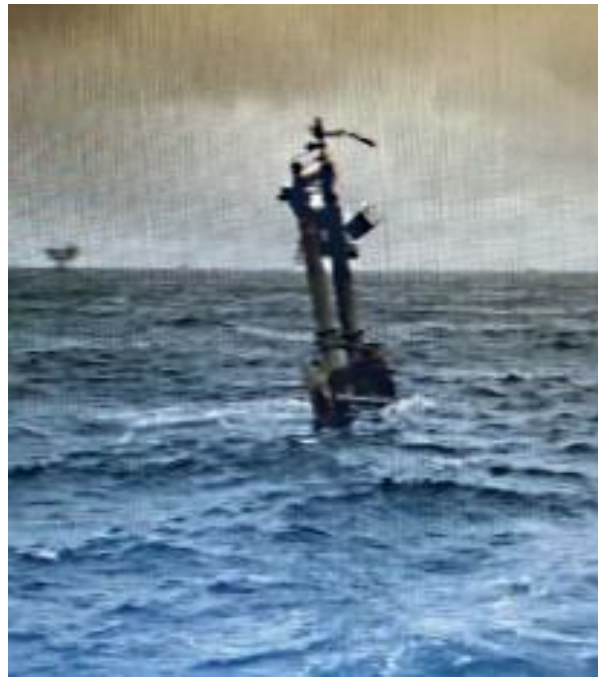
engine rpm but was not able to disengage the autopilot fast enough to maneuver away from the platform. At 0432:00, the video showed the crew on the bridge bracing for an impact and some articles falling off shelves, indicating the point at which the vessel allided with the unmanned platform South Timbalier 271A. The allision occurred at a speed of about 8.7 knots. The allision caused the platform's pipelines to rupture and the released gases to ignite.

The left photo shows the unmanned platform South Timbalier 271A before the accident, and the right photo shows the remains of the platform after the allision and fire. (Photos provided by the Coast Guard)

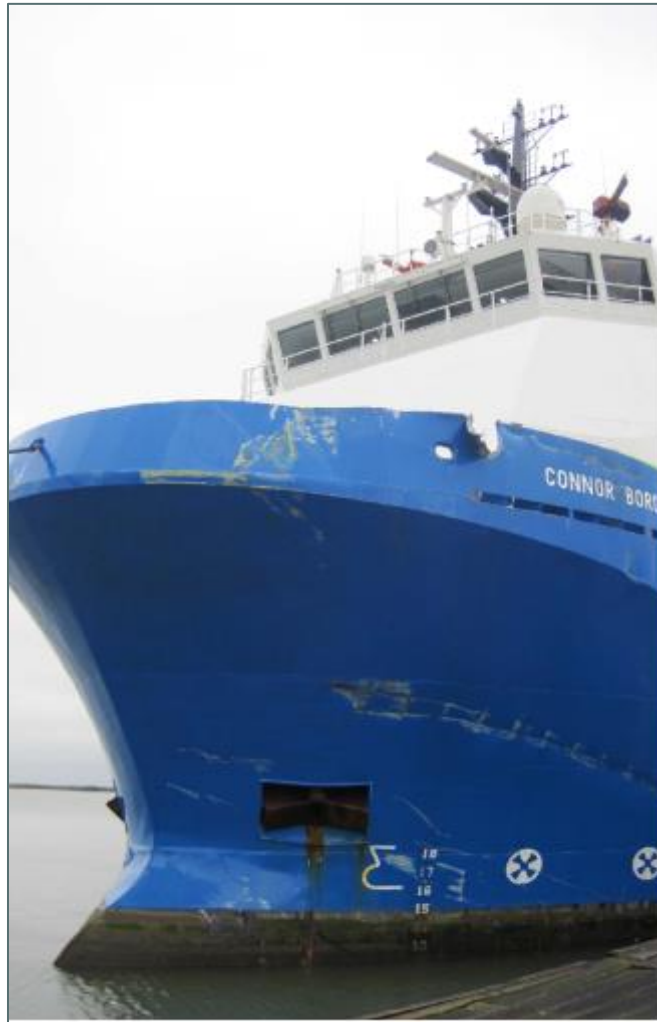
**The damage to the *Connor Bordelon* resulting from its allision with the unmanned platform. The damage included hull scrape marks and a ripped bulwark near the vessel's name. The vessel also sustained damage below the waterline resulting in flooding. (Photo by the Coast Guard)**

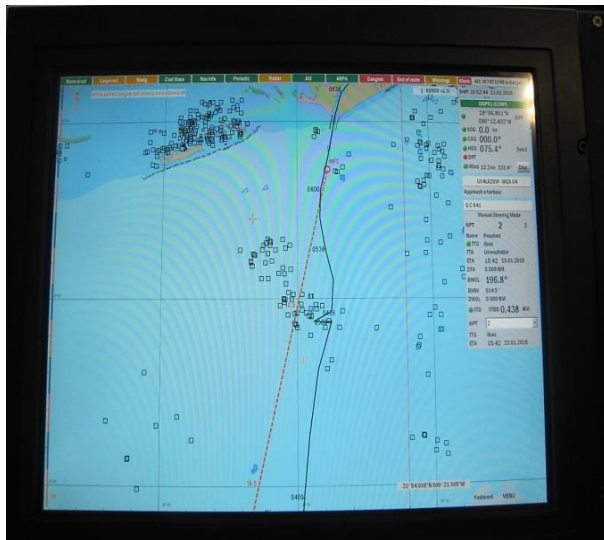
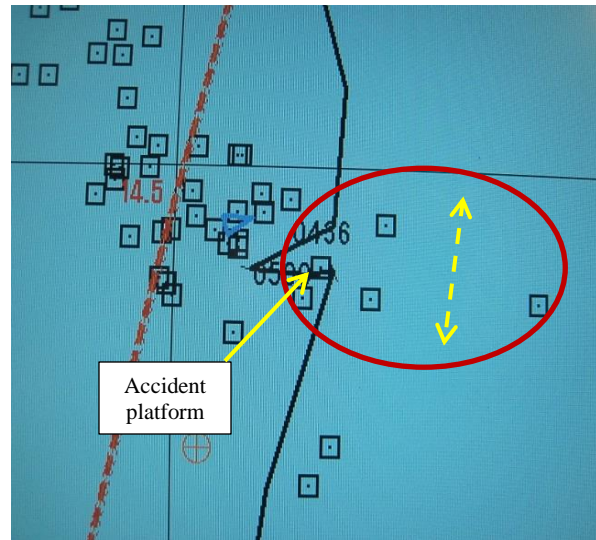
The left photo shows an overall view of the *Connor Bordelon's* ECDIS screen with the transit course to and from the drill ship. The right photo shows a close-up view of the planned transit course (red dashed line) to and from the drill ship, the actual return course (black line), and the accident platform (with a solid yellow arrow pointing to the platform). The red oval and dashed yellow arrow (both inserted by the NTSB) denote the local transit area known as the “hole in the wall.” (Photos by the Coast Guard)

The captain and the mates told investigators that the red dashed course line was used only as a reference because they could not precisely follow the line due to marked obstructions in an area of rig congestion. The captain and the mates also stated that navigating around the entire area would be too much of a diversion for a normal transit, so they would plot one course only through the area, steer near it, and use radar and visual sightings to maneuver through the rigs and other obstructions. The ECDIS had specific programmable features to aid crewmembers in maneuvering the vessel. For example, minimum clearances from the charted rigs could be programmed into the system, and warnings could be programmed to alert the watchstanders if the vessel drifted off the plotted course line by a set amount of feet or meters or was too close to a charted obstruction, including the unmanned platform South Timbalier 271A. Although the watchstanders were familiar with the day-to-day operation of the ECDIS, they were not certified in the use of the system. As a result, the watchstanders did not take advantage of some of the ECDIS features that could have made the transit safer. The watchstanders had been scheduled (before the accident) to take mandatory ECDIS certification courses during the months following the accident. As part of the certification process, the watchstanders would have had to show proficiency with the equipment. Thus, if the watchstanders had been certified in the use of the ECDIS before the accident, they would likely have had a better understanding of the system.

The mate on watch told investigators that he intended to steer the vessel through the “hole in the wall” (dashed yellow arrow in the right ECDIS photo above); however, the course line in the ECDIS was not consistent with the mate’s intention. If the course line had been drawn through the “hole in the wall” and the vessel had been navigated along this intended track, the vessel would have had greater separation from the charted platforms. Instead, the mate on watch picked a point ahead of the vessel and steered toward an opening between the rigs, where less separation existed. Regarding voyage planning, the company’s *Safe Operations Manual* instructed watchstanders to “check the planned route for proximity to hazards.” It is challenging to draw a course line that avoids all of the charted obstructions in and around the oil fields in the Gulf of Mexico.

- **Voyage planning:** The company's safety manual provided instructions on how to execute a voyage plan that would mitigate the risks of navigating through the congested waters of the Gulf of Mexico. It is important for vessel owners and operators to verify that the safety procedures in their manuals, including those for drawing course lines that avoid chartered obstructions and other hazards to navigation, are being followed.

- **Use of electronic chart display and information system:** The *Connor Bordelon* was equipped with state-of-the-art technology, including an ECDIS. The vessel had been operated for more than 1 year before the accident, but crewmembers had not yet taken certification courses in the use of the ECDIS. It is important for vessel owners and operators to ensure that their crews are proficient in the use of all electronic bridge equipment in a timely manner.
