National Transportation Safety Board

Marine Accident Brief

Collision between the Tows of Towing Vessels *Capt. Shorty C* and *Jackie*

Accident no.	DCA15FM027
Vessel names	<i>Capt. Shorty C</i> , Kirby 29116, Kirby 30040B, <i>Jackie</i> , EMS 343, and EMS 344
Accident type	Collision
Location	Gulf Intracoastal Waterway, mile marker 349.5, Port Bolivar, Texas; 29°22.2 N, 094°47.1 W, between buoys 17 and 19
Date	July 20, 2015
Time	0102 central daylight time (coordinated universal time – 5 hours)
Injuries	None
Damage	Estimated \$608,000
Environmental damage	None reported
Weather	Clear night, winds about 10 knots from the west-southwest
Waterway information	Entrance to Gulf Intracoastal Waterway, Galveston Bay, Texas

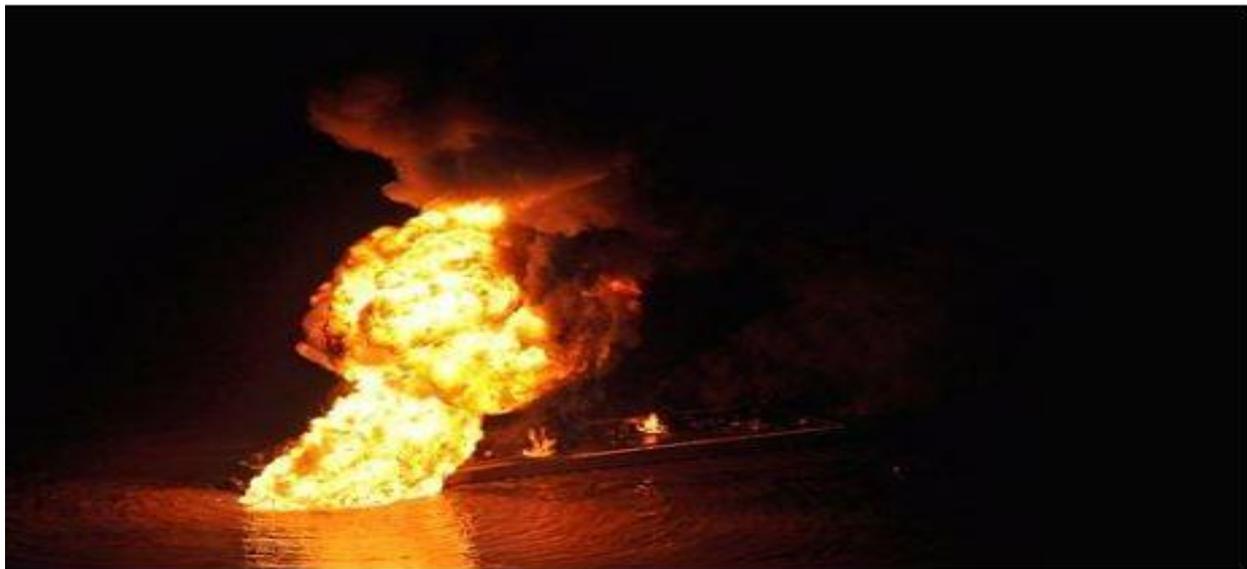
Fire aboard *EMS 343* barge after the collision. (Photo by PennEnergy, July 2015)

The vessels continued on a collision course until the port bow of the *Capt. Shorty C*'s lead barge (*Kirby 29116*) struck the port side of the *Jackie*'s lead barge (*EMS 344*), before colliding with its stern barge (*EMS 343*). The collision caused the EMS barges to separate and a steel deck support to penetrate the overhead of the no. 3 starboard cargo tank of the *EMS 343* barge, allowing naphtha gases to escape. The vapors, combined with the sparks generated from the steel vessels colliding, ignited a fire in the stern box area of the *EMS 343* barge.

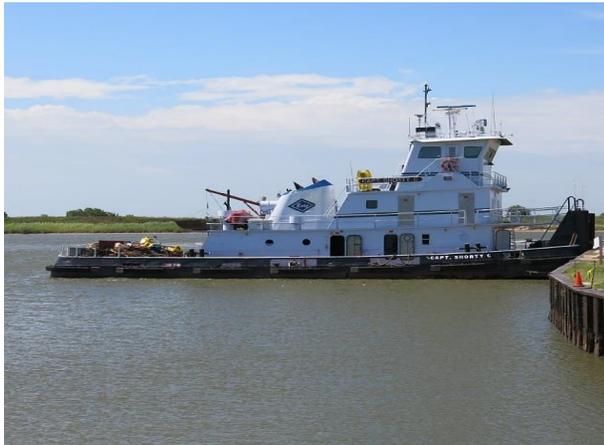
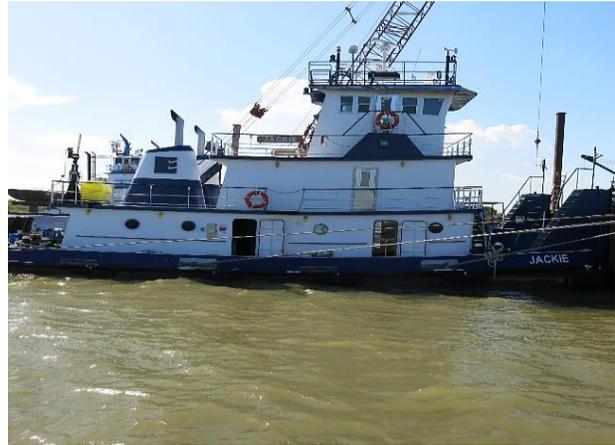
***Capt. Shorty C* (left) and *Jackie* (right) after the accident.**

The towboats *Capt. Shorty C* and *Jackie* were not damaged in the collision. However, the *Kirby 29116* barge sustained about \$119,000 in damage to its forward port void tank at the rake, which was below the waterline when loaded. There was no damage to the *Kirby 30040B* barge. The *EMS 343* barge, on which the fire erupted, sustained about \$339,000 in damage to the stern box area on the starboard side: specifically, multiple piping systems were heat-deformed; both the sludge tank and void tank no. 3 were penetrated; and the diesel engine on the deck of the barge was burned and completely destroyed. The *EMS 344* barge sustained about \$150,000 in damage to the portside piping systems and side shell plating of the void tank.

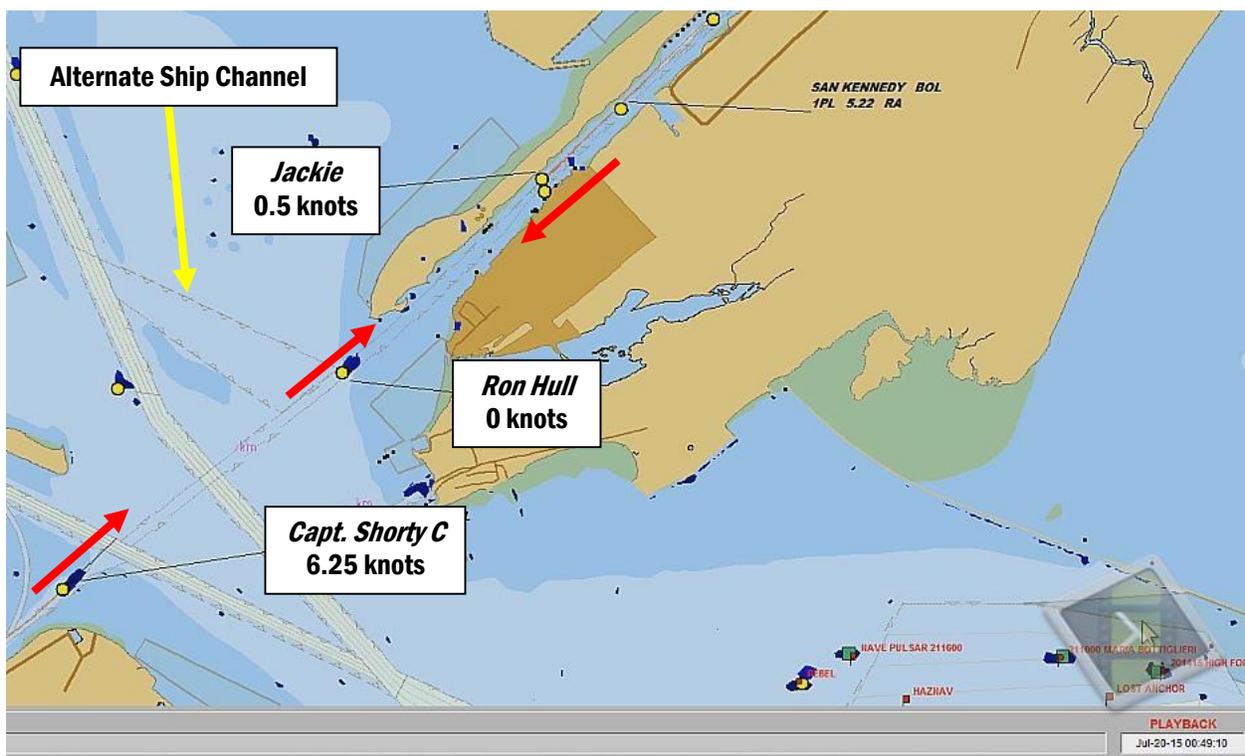
Electronic data showing the speeds and directions of *Capt. Shorty C*, *Ron Hull*, and *Jackie* at 00:49:10. (Image provided by VTS Houston/Galveston)

Ron Hull, which came to a stop at the entrance to the waterway; according to the pilot, the vessel “was having trouble entering the land cut” and consequently could have impeded the *Capt. Shorty C*’s entrance into the narrow waterway. The *Ron Hull*’s unexpected stop about 0045 also raised a concern for the westbound *Jackie* relief captain who, without radio notification, temporarily stopped his vessel in the waterway. Nevertheless, about five minutes later, the *Ron Hull* was able to get under way, the *Capt. Shorty C* proceeded across the channel, and the *Jackie* resumed its speed of about 5 knots while approaching the waterway’s entrance.

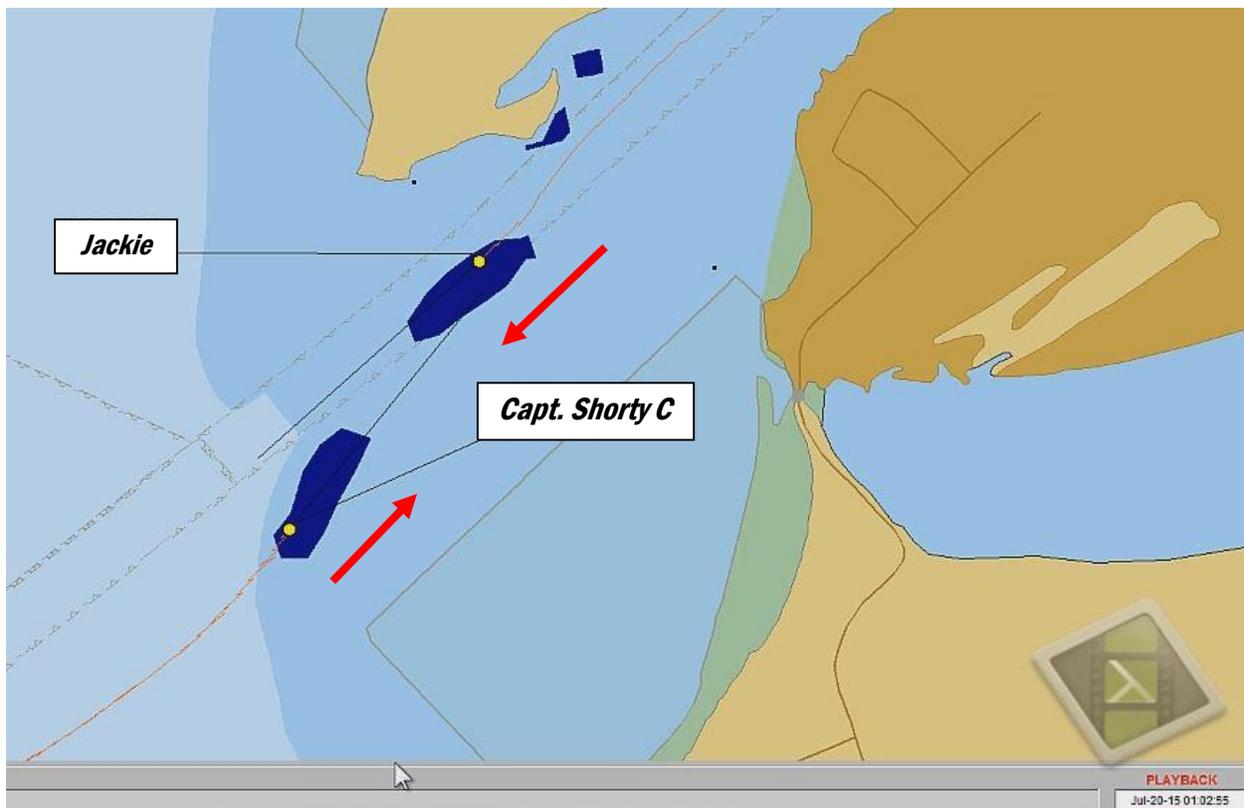
While crossing the channel at 0056, the *Capt. Shorty C* pilot radioed the *Jackie* to inform the approaching towboat that he had two barges and suggest they pass on “one whistle,” portside to portside. In response, the relief captain who was on watch aboard the *Jackie* stated that he also had two barges, was heading westbound towards the Alternate Ship Channel, and agreed on the passing arrangements. But neither operator identified exactly where the vessels would pass each other within the Bolivar buoy line, which was in an area not recommended for meeting by the *United States Coast Pilot 5*.

Electronic data showing *Capt. Shorty C* and *Jackie* at 01:02:55, seconds before colliding. (Image provided by VTS Houston/Galveston)

During the transit across the Houston Ship Channel, the pilot of the *Capt. Shorty C* adjusted his heading about 20 degrees to port to counteract the effect of the tidal current. (This maneuver, which is intended to compensate for external forces, is commonly called “crabbing.”) Suddenly, at 0102, as the vessels were approaching each other near the waterway’s entrance, the *Capt. Shorty C* pilot contacted the *Jackie* relief captain to alert him to “watch me,” because he had “caught shallow” and was trying to “back her down.” The *Jackie* relief captain asked if it would help for him to speed up ahead. The *Capt. Shorty C* pilot replied that he didn’t know and was “sheering right towards” the *Jackie*. He attempted to steer away using his rudders but received no

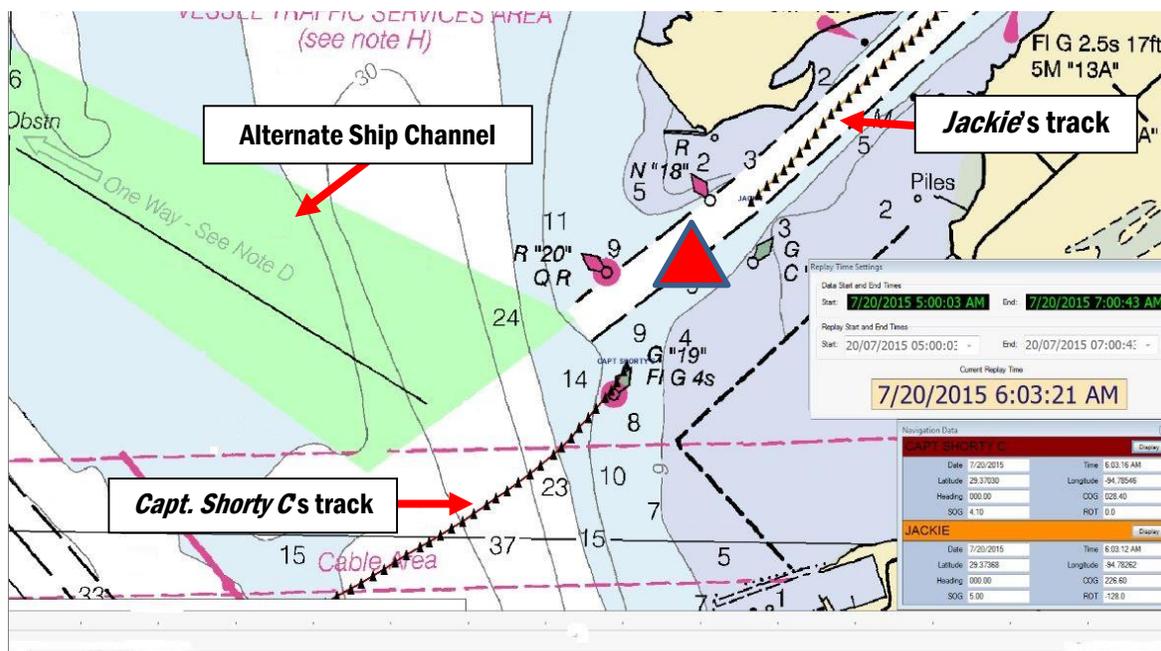
Immediately after the collision, the *Jackie* crewmembers disconnected their towboat from the burning barge. The crewmembers of the *Capt. Shorty C* found that, although their lead barge was taking on water in the bow void tank, there was no breach in the cargo tank behind it; therefore, they believed the barge was not in danger of sinking. They then turned their attention to the barge that broke away from the *Jackie*, grounding it intentionally beyond the green buoys. About seven minutes later, VTS made a broadcast about the collision in the channel.

Electronic data from US Coast Guard NAVCEN (Navigation Center) overlaid onto NOAA (National Oceanic and Atmospheric Administration) chart 11324 showing tracks of *Capt. Shorty C* and *Jackie* at 01:03:21 local time (06:03:21 coordinated universal time).

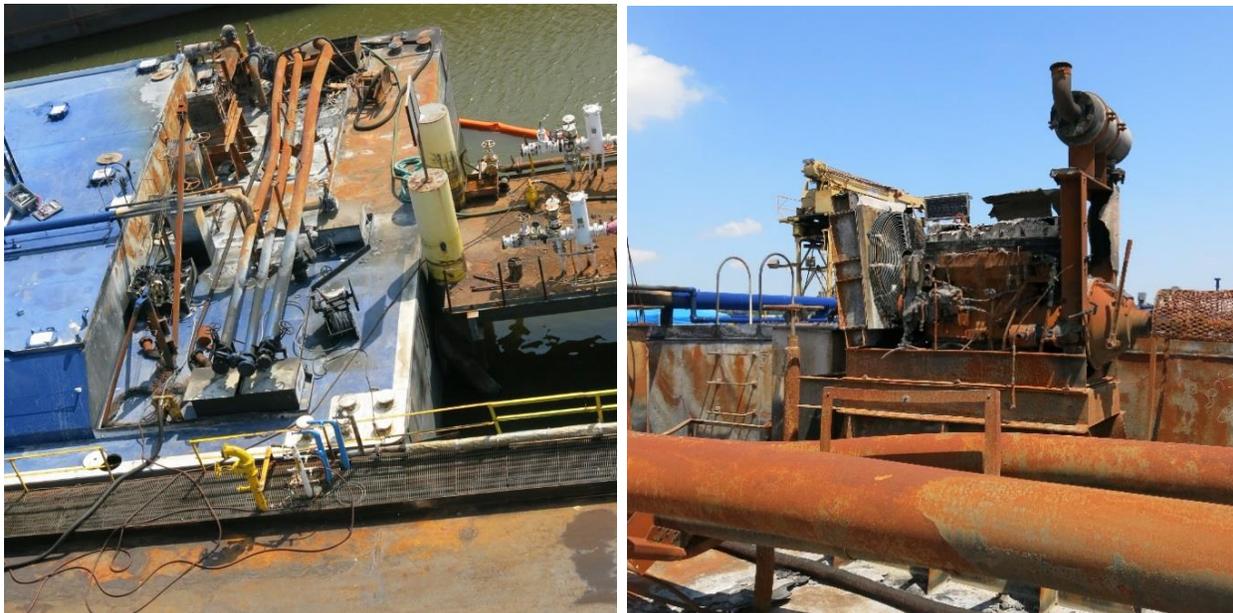
EMS 343 after the accident: at left, fire damage on outboard side; at right, burned diesel engine.

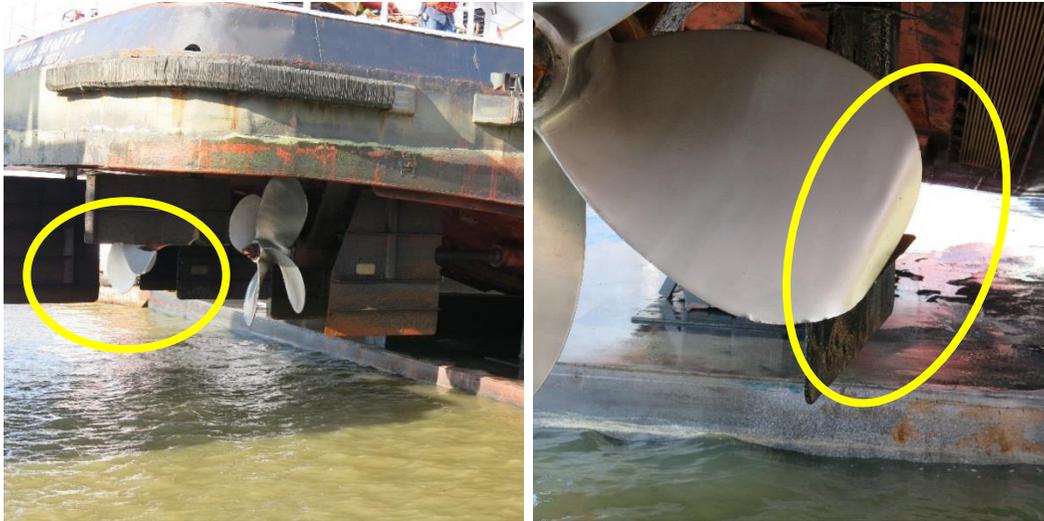
After the accident, a diver inspected the *Capt. Shorty C* and reported that the lower 60 percent of the starboard rudder (about 4 feet by 7 feet) was missing at the “breakaway immediately under [the] rudder strut.” Both propellers had some damage: the port propeller had two bent flukes, and the starboard propeller had one bent fluke. The following day, the *Capt. Shorty C* was drydocked and the propellers along with the starboard rudder were replaced.

Stern of *Capt. Shorty C* in drydock: at left, circled in yellow, missing lower portion of the starboard rudder; at right, bent fluke of the port propeller.

Investigators learned during interviews that there had been two “touch and go” incidents of the *Capt. Shorty C* grounding within two weeks of the accident. Just days before, the pilot and the captain were trying to ascertain the possibility of damage underneath the vessel as a result of these incidents. The pilot acknowledged that the *Capt. Shorty C* had been operating normally in open deep water, but in shallow water it was handling a little sluggishly.
