# National Transportation Safety Board

## Marine Accident Brief

### Capsizing and Sinking of Fishing Vessel *Hawaii Five-1*

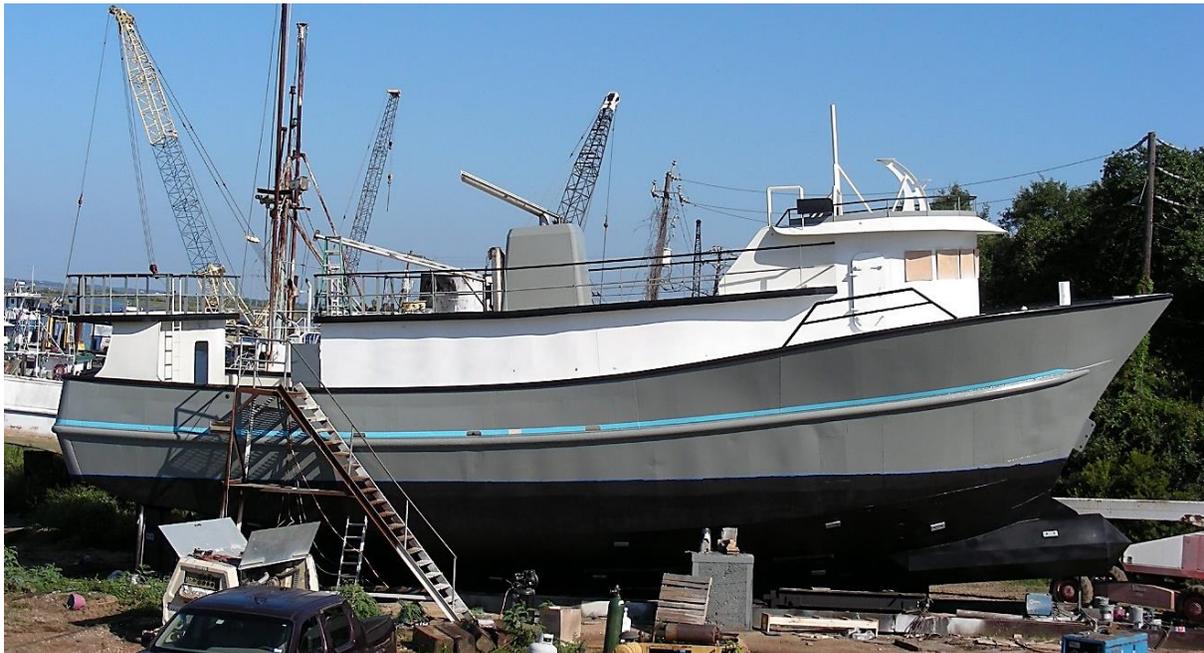
Side profile of *Hawaii Five-1* taken after the conversion at the shipyard located in Pascagoula, Mississippi. (Photo by C. E. Collier & Associates, Incorporated)

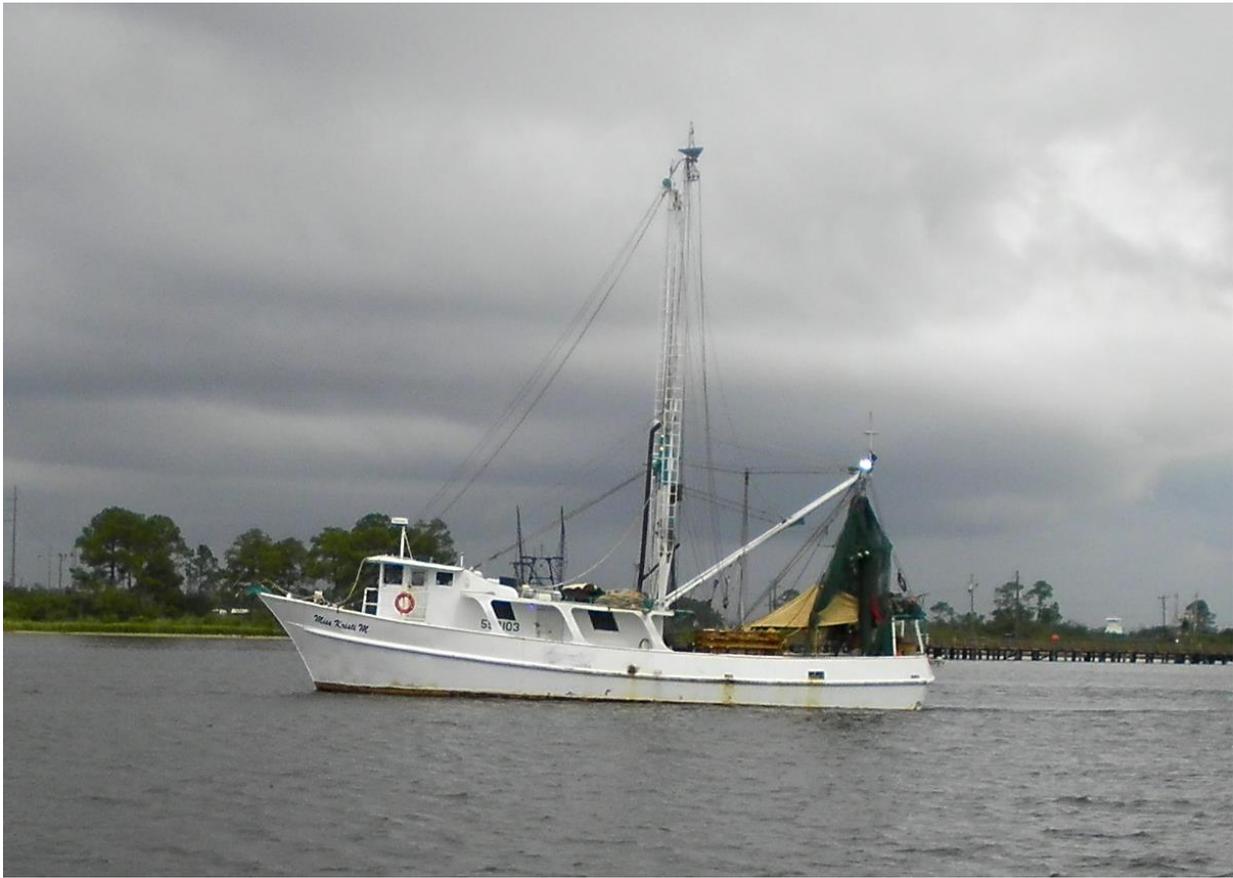
Image of *Hawaii Five-1* before the conversion, when the vessel was known as *Miss Kristi M.* (Photo by Clarence Chavers, 2010)
