National Transportation Safety Board

Marine Accident Brief

Collision between US Coast Guard Cutter *Key Largo* and Fishing Vessel *Sea Shepherd*, with Subsequent Sinking of *Sea Shepherd*

Accident no.	DCA14PM019
Vessel names	<i>Key Largo</i> and <i>Sea Shepherd</i>
Accident type	Collision and subsequent sinking of the <i>Sea Shepherd</i>
Location	Virgin Passage, 9 miles east-northeast of Vieques Island, Puerto Rico; 18°11.12' N, 65°07.87' W; about 65 miles southeast of San Juan, Puerto Rico*
Date	September 23, 2014
Time	0635 Atlantic standard time (coordinated universal time – 4 hours)
Injuries	None
Property damage	Total loss of the <i>Sea Shepherd</i> , valued at \$200,000
Environmental damage	None reported; an estimated 250 gallons of diesel fuel and 2 gallons of lubricating oil sank with the <i>Sea Shepherd</i>
Weather	Visibility 6 miles, east winds at 11 knots gusting to 16 knots, seas at 2.6–3 ft
Waterway information	Open waters of the Caribbean Sea

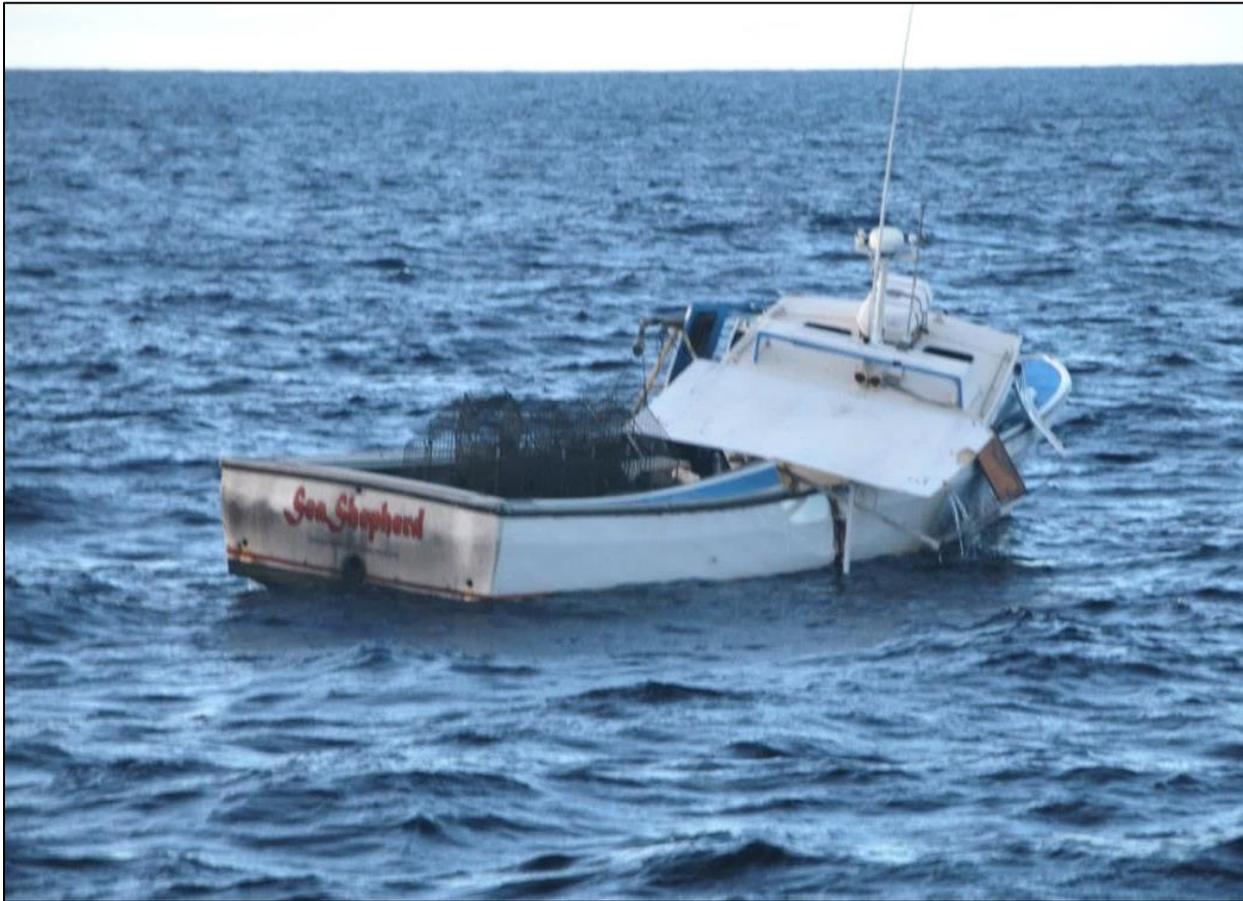
The *Sea Shepherd* sustained a 4-inch-wide vertical fracture on the starboard side just aft of the raised cabin, running from the top of the deck to below the waterline. A *Key Largo* machinery technician was sent over to assess the damage and found that all of the *Sea Shepherd*'s compartments were flooded. About 2 hours after the collision, the *Sea Shepherd* sank.

Postaccident photo of *Sea Shepherd* with the vertical hull fracture visible on the vessel's starboard side. (Photo by Coast Guard)
