National Transportation Safety Board

Marine Accident Brief

Fire on board Fishing Vessel *Northern Pride*, with Subsequent Capsizing

NTSB/MAB-16/12

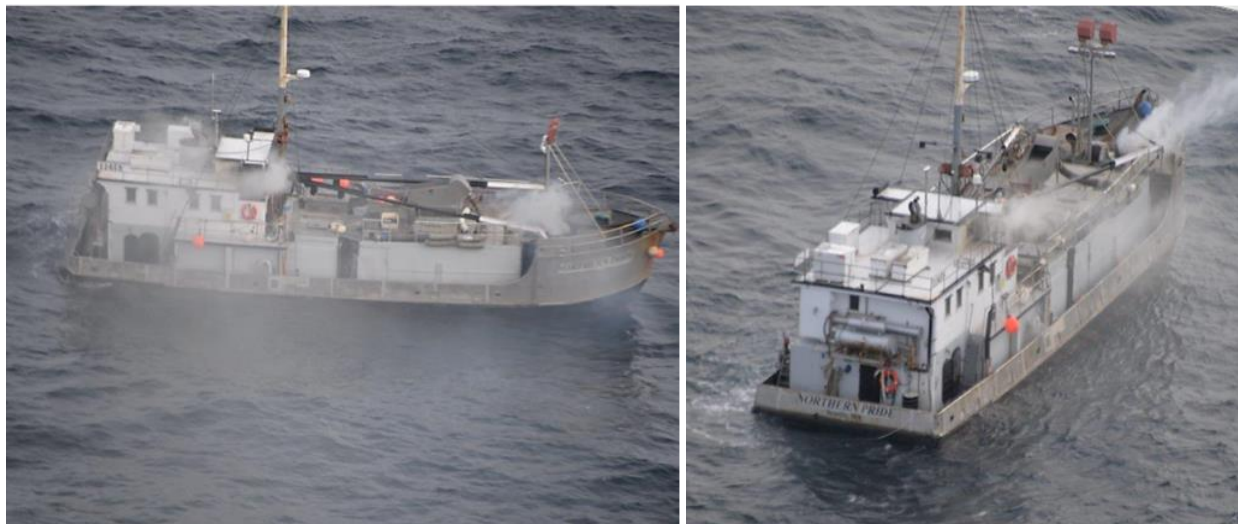
***Northern Pride* with smoke exiting forward and from the wheelhouse. (Photos by US Coast Guard)**

About 1200, the *Northern Pride* generators ceased functioning, resulting in the vessel's complete loss of power, including battery power (the main propulsion engines continued to operate). About 30 minutes later, the captain noticed smoke exiting the starboard vent of the forepeak machinery space where the generators were located. When the engineer and deckhand went forward and opened the forepeak hatch to investigate, they noticed thick billowing dark smoke that smelled like burning electrical wiring. They could not see anything in the space, so they closed the hatch and reported their findings to the captain. The crew determined the fire could not be fought or extinguished.

About five minutes later, smoke and fire had spread to the main cabin and wheelhouse. The captain broadcast the international distress signal Mayday over VHF radio and prepared to abandon ship. He then activated the emergency position indicating radio beacon (EPIRB) and ordered the crew to manually launch the inflatable liferaft and don their survival suits.¹ Once their suits were on, the crew abandoned the vessel about 1300.

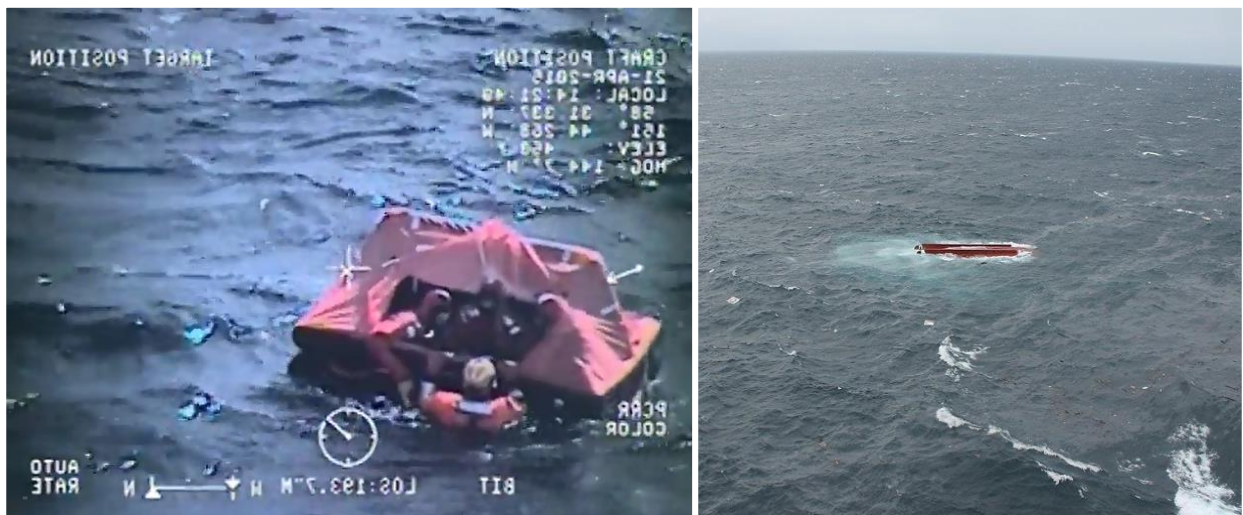
Coast Guard rescue, left, and capsized *Northern Pride*, right. (Photos by Coast Guard)

About 1445, the *Northern Pride* capsized but did not sink. The overturned vessel drifted northwest towards the Shakun Islets as depicted in the chart image below. On May 7, the *Northern Pride*'s splintered hull washed ashore at Cape Chiniak within Katmai National Park, Alaska. All superstructure above the main deck was missing. Planking and vessel debris extended south of the wreck several hundred yards along the shore. A hull examination by a salvage company found all that remained attached were the main propulsion engines and fuel, potable water, and chill water tanks. All tanks were inspected through tank fittings, manhole covers, or piping. They were found to be either empty or have trace amounts of fuel mixed with seawater. Residual lubrication and diesel oil remained in the engine.

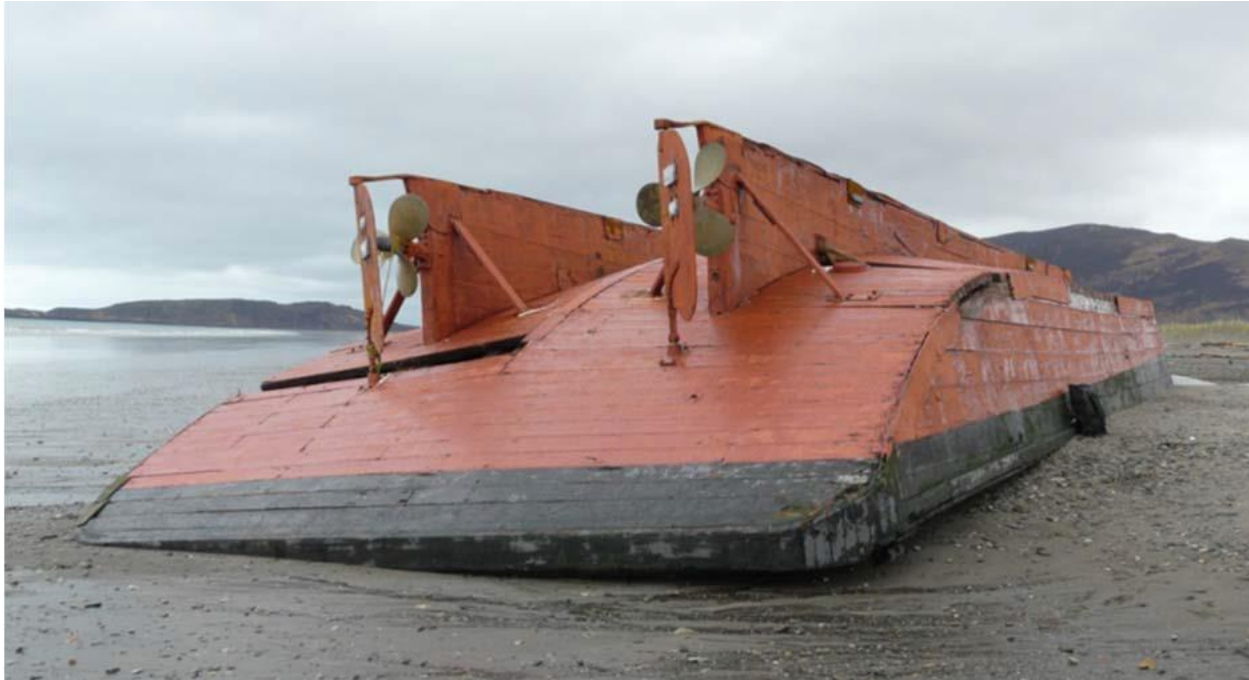
***Northern Pride* hull washed ashore at Cape Chiniak within the Katmai National Park, Alaska. (Photo by Global Diving & Salvage, Inc.)**
