# National Transportation Safety Board

## Marine Accident Brief

### Sinking of Fishing Vessel *Capt Richie Rich*

NTSB/MAB-16/14

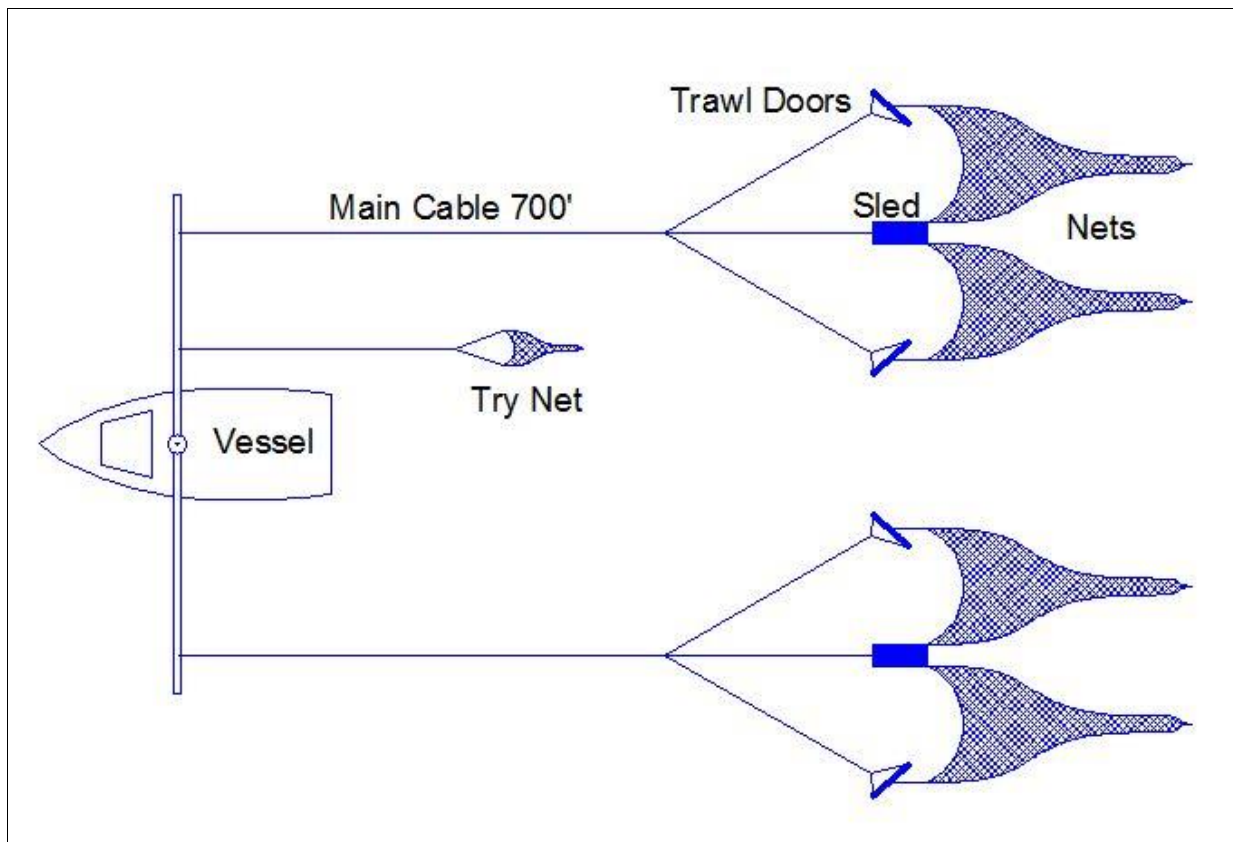
**Trawling configuration similar to the one aboard *Capt Richie Rich*.**

On double-beam shrimp trawlers, such as the *Capt Richie Rich*, the tow wire used to deploy the fishing gear is paid out from the port and starboard deck winches through towing blocks located at the outermost end of each respective outrigger. This configuration allows the trawl boards, sled, and catch nets to be deployed independently of each other on the seafloor. To offset the tension on the outrigger that results from the tow wire and fishing gear being dragged on the sea floor, each outrigger deployed is held in place by stay wires that are made fast to the vessel's gunwale and mast. Based on images of the partially sunken *Capt Richie Rich*, it appears as if the outrigger frame fractured and failed just outboard of those securing points. Because of the language difficulty, investigators could not determine whether the failure was caused by poor maintenance, the fishing gear becoming snagged on a bottom obstruction, or a combination thereof.

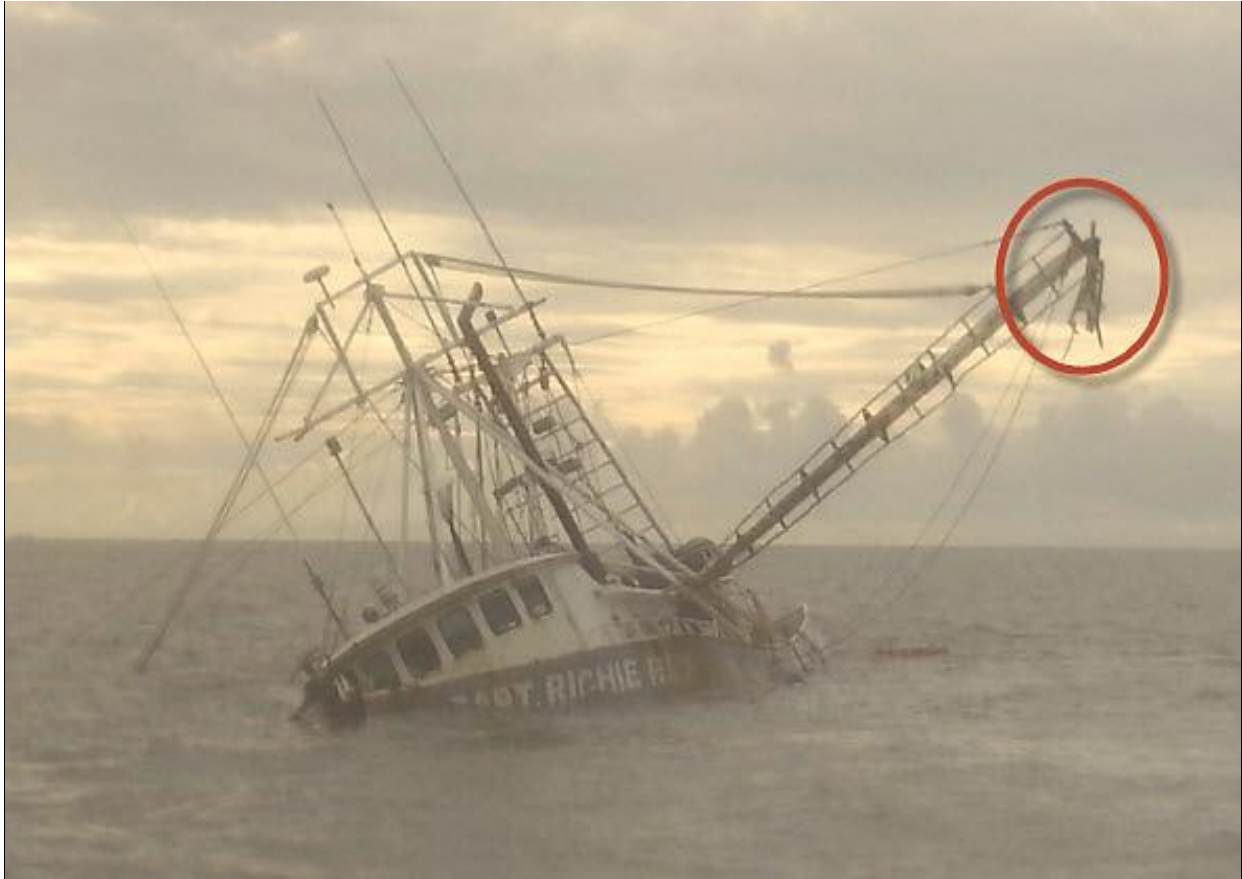
Partially sunken *Capt Richie Rich* resting on mud in 10–12 feet of water. The broken port outrigger is overlaid by a red circle. (Photo by US Coast Guard)

The National Transportation Safety Board determines that the probable cause of the sinking of fishing vessel *Capt Richie Rich* was a collapse of the port outrigger and a hull penetration resulting in uncontrolled flooding in the engine room.

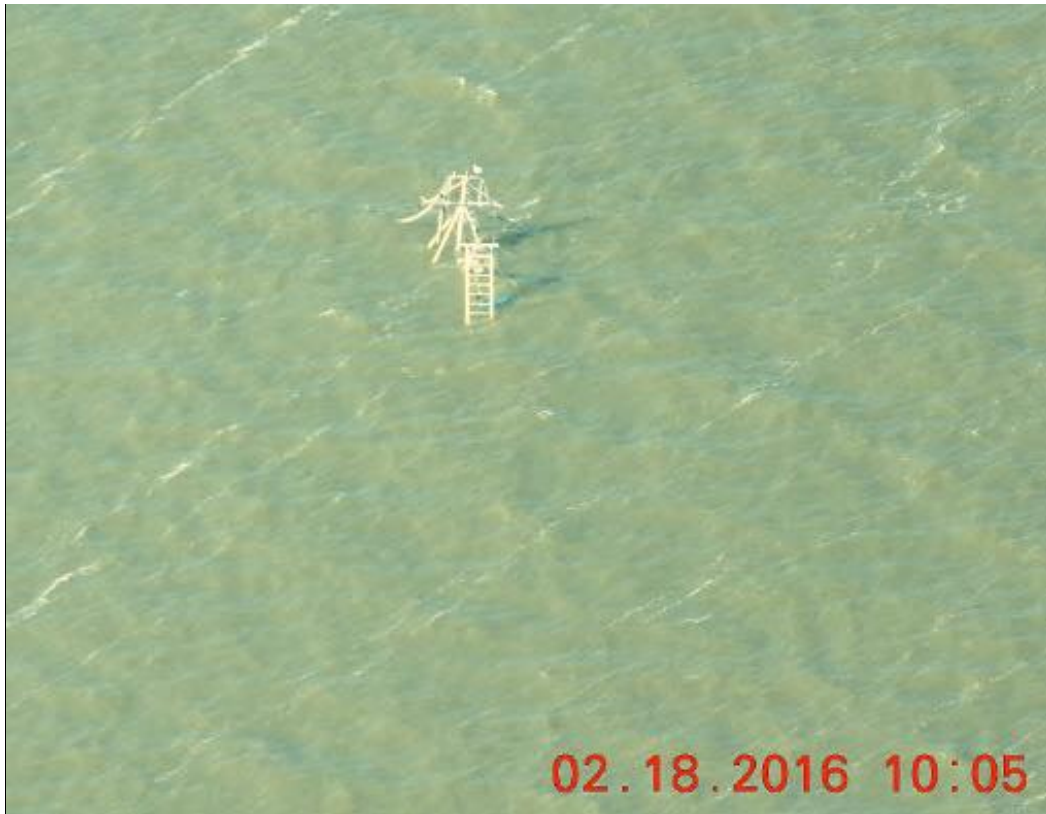
A Coast Guard overflight in February 2016 confirmed that *Capt Richie Rich* was still partially sunken in the same position. (Photo by Coast Guard)
