National Transportation Safety Board

Marine Accident Brief

Sinking of Deck Barge *Margaret*

Accident no.	DCA15LM032
Vessel name	<i>Margaret</i>
Accident type	Sinking
Location	Mississippi River, near Convent, Louisiana, 30°01.9'N, 90° 50.1'W
Date	August 31, 2015
Time	0330 central daylight time (coordinated universal time – 5 hours)
Injuries	None
Property damage	\$2 million
Environmental damage	A light oil sheen was reported at the incident location
Weather	Darkness with clear skies, 5 miles visibility, calm winds, air temperature about 75°F
Waterway information	Left descending bank of the Lower Mississippi River, near mile marker 159.5 ¹

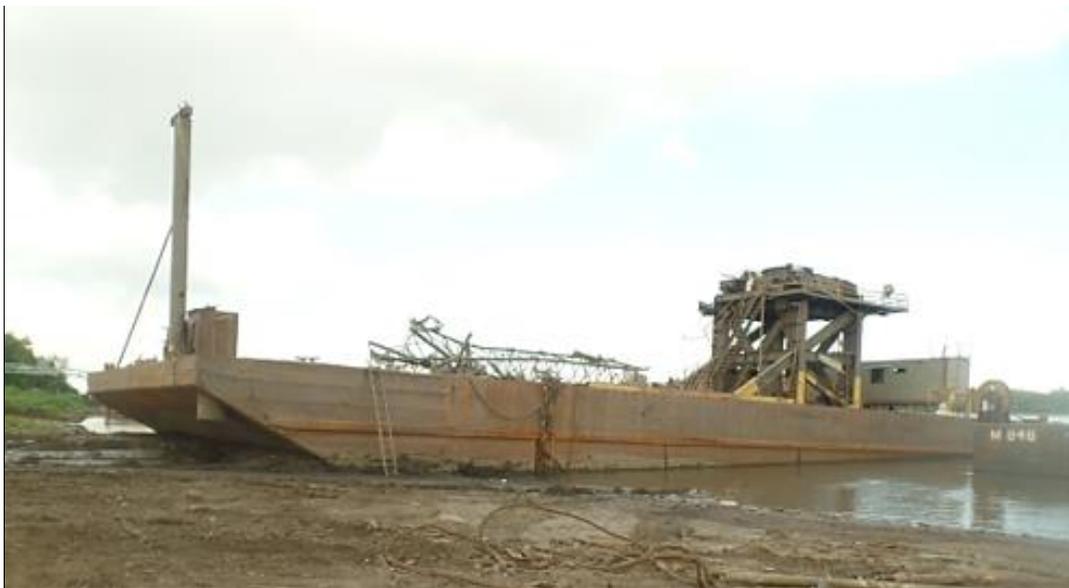
The *Margaret* beached after salvage, awaiting destruction. (Photo by US Coast Guard)

The *Margaret* was raised on October 3, 2015. An investigator from Coast Guard Sector New Orleans who examined the barge noted no obvious location of the water ingress into the port stern void; however, the void was filled with 2 feet of river mud. The investigator also noted significant structural damage, including tearing of the hull in several locations by the salvage lifting lines attached to the barge. The barge was subsequently transported to a nearby company for destruction.

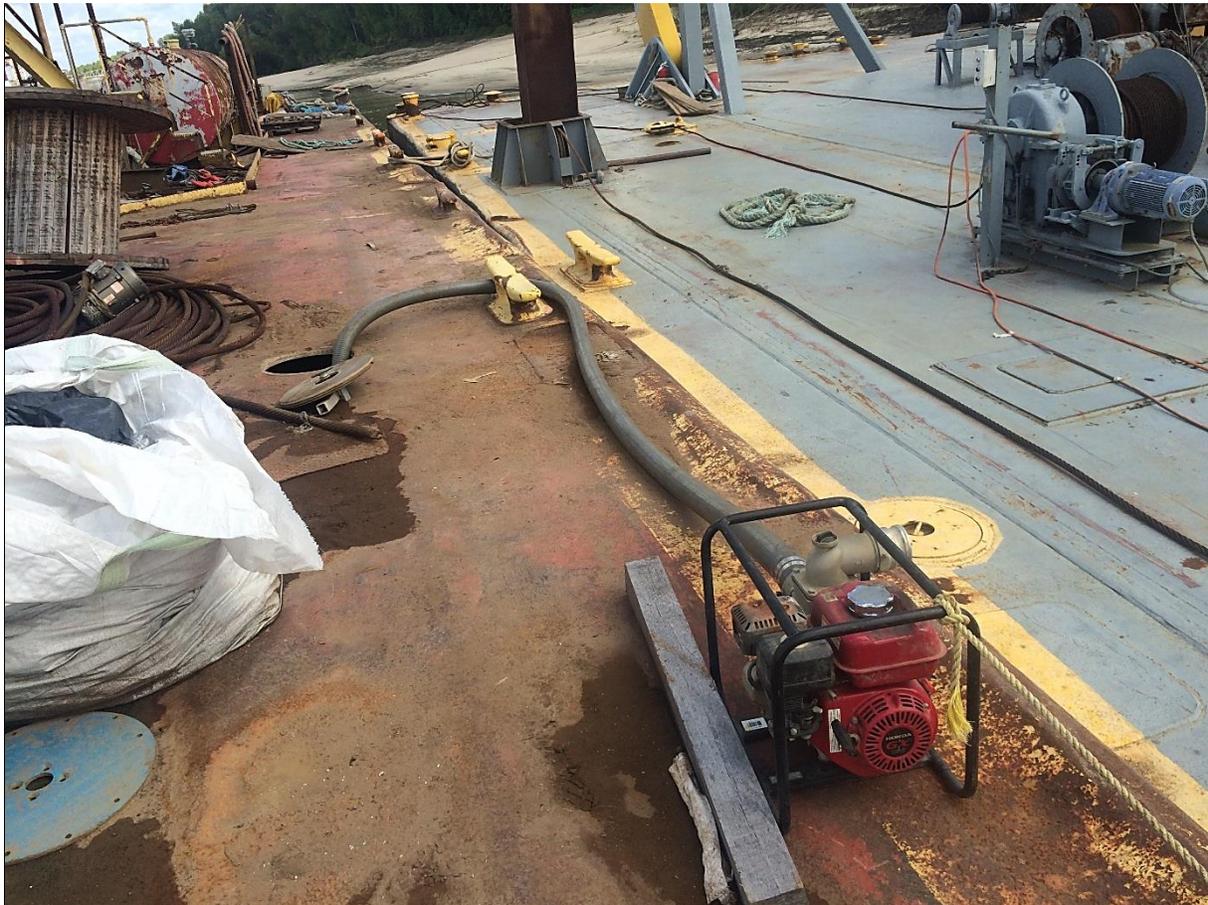
The production managers were also responsible for dewatering the barges as needed. They used four pre-staged portable submersible gasoline-powered pumps on the main deck, putting a dropdown hose through the manholes. When fully fueled, the pumps would run until the voids were pumped dry, the pumps lost suction, or until they ran out of fuel, for a maximum pumping time of about 2.5 hours. The regular day-shift production manager stated that the *Margaret*'s normal freeboard was about 3 feet and that he would wait until there was about 4 feet of water in the void before pumping.⁴ Associated Marine Terminals did not have formal reporting procedures or response actions for adverse conditions involving their vessels.

Portable pump and hose rigged to dewater a void on deck barge *Bulk Crane 3*.
