# National Transportation Safety Board

## Marine Accident Brief

### Collision and Sinking of Towing Vessel *Miss Natalie*

<b>Accident no.</b>	DCA15LM023
<b>Vessel name</b>	<i>Miss Natalie</i> , <i>George W Banta</i> tow
<b>Accident type</b>	Collision and sinking
<b>Location</b>	Lower Mississippi River, mile marker 162, Romeville, Louisiana
<b>Date</b>	May 30, 2015
<b>Time</b>	0755 central daylight time (coordinated universal time – 5 hours)
<b>Injuries</b>	One fatality
<b>Property damage</b>	Total loss of vessel, estimated at \$1.8 million
<b>Environmental damage</b>	None
<b>Weather</b>	Clear, visibility 10 miles, winds calm, air temperature 76°F, dew point 75°F, humidity 96%, pressure 30.06 inches.
<b>Waterway information</b>	The navigable channel in the Lower Mississippi River from Baton Rouge at mile marker 232.4 to New Orleans is 45 feet deep and 500 feet wide. Based on historical data, high-water surface currents may have ranged from 3.6 to 5.5 mph.

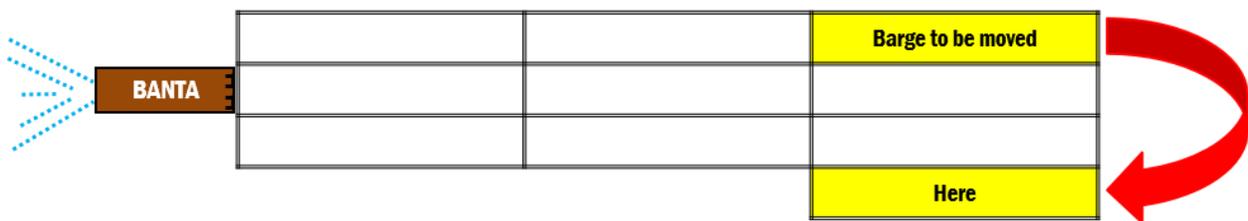
*Miss Natalie* intended to move the port lead barge to the outboard of the starboard lead barge of *George W Banta* tow.

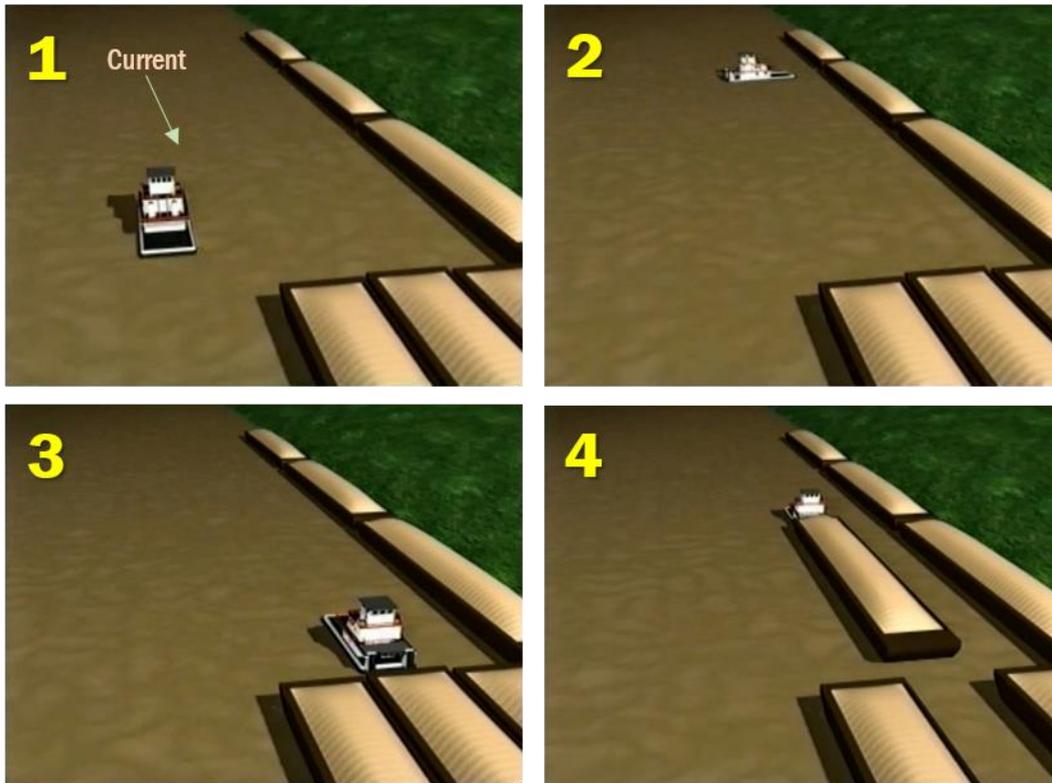
In still images from a video on downstreaming by the Coast Guard and the American Waterways Operators, the fleet boat (1) moves up river against the current before (2) turning around to (3) face up to the barge and (4) remove it.

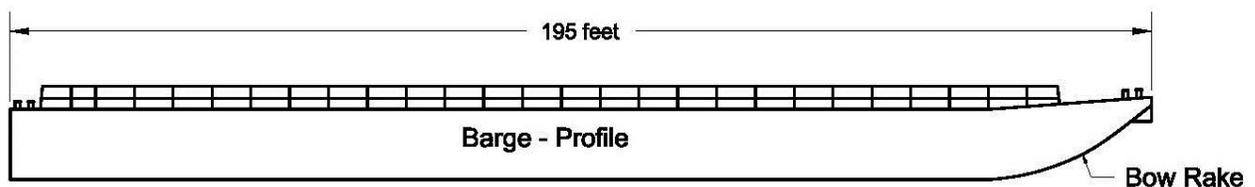
Starboard-side profile of the port lead barge in *George W Banta*’s tow with the rake forward.

The *Miss Natalie* captain told investigators that he intended to approach the barge facing up on its raked end. At 07:53:30, as the vessels were 650 feet apart, the *Miss Natalie* captain began approaching the port lead barge of the *George W Banta* tow, drifting with the current with the engines astern. (AIS data confirms the reduction in speed of the *Miss Natalie* from 3.68 mph at 07:53:18 to 1.04 mph at 07:53:58, seconds before the collision.) Deckhand no. 2 said that he and deckhand no. 4 noticed that the tow, however, was still moving toward them as the *Miss Natalie* was beginning to face up to it. Deckhand no. 4 alerted the captain, who then backed down the vessel. But when they reached within about 2 feet of the port lead barge with the rudders amidships, the stern swung quickly to port, pinning the portside of the tugboat across the head of the *George W Banta*'s tow. The *Miss Natalie* captain responded by placing all four engines full ahead and moving his rudders back and forth. Next, he put all four engines in reverse to separate his vessel from the barge but was unsuccessful. (The captain claimed he had no issues with the engines or steering equipment during the accident.)

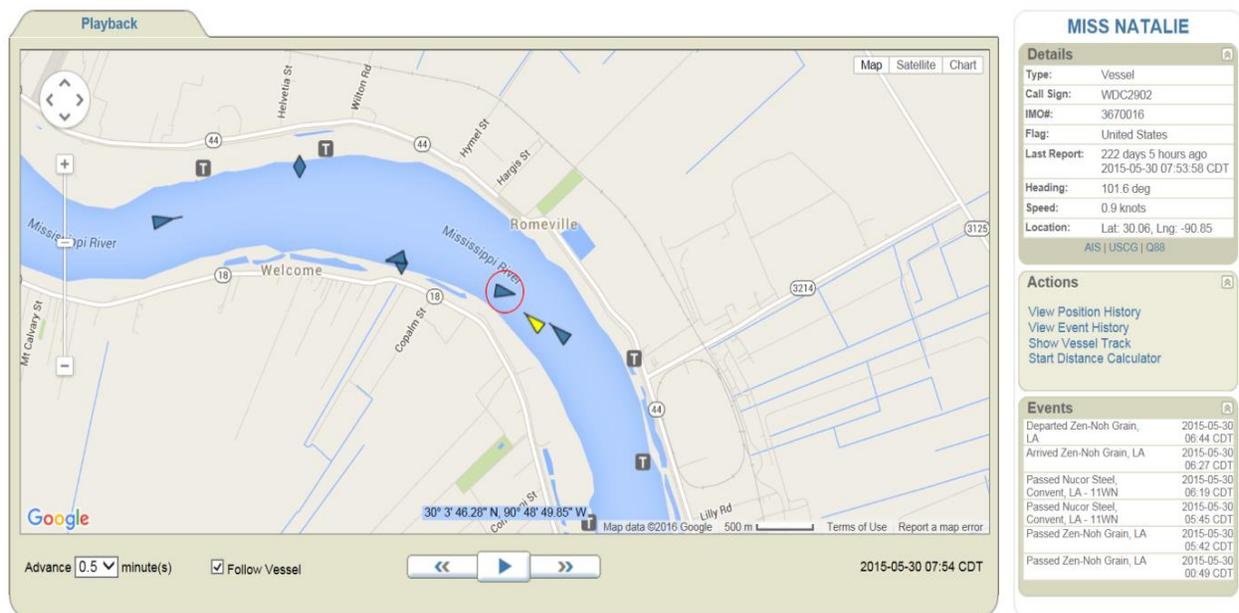
PortVision AIS data of *Miss Natalie* (circled in red) and *George W Banta* tow (in yellow) at 07:54.

After the *Miss Natalie* became pinned sideways in front of the *George W Banta* tow at about 07:54:47, the captain said his vessel started listing to starboard at a 45-degree angle. (AIS data also reveals that the *Miss Natalie* was moving at nearly the same speed and direction as the *George W Banta*, which was traveling at 2.42 mph, indicating that the *George W Banta* was pushing the *Miss Natalie* after it became pinned.) The force of the river current on the starboard side below the main deck combined with the force from the forward movement of the tow on the port side—specifically, where the top of the barge's rake contacted the *Miss Natalie* above the main deck—together caused the *Miss Natalie* to capsize. As the *Miss Natalie* was pinned under the barge rakes, water entered through two open doors on the main deck flooding the hull and consequently sinking the vessel. (A photo taken during the salvage of the *Miss Natalie* shows these two portside doors were open. Investigators could not determine if the two doors on the starboard side were also open at the time of the accident.)

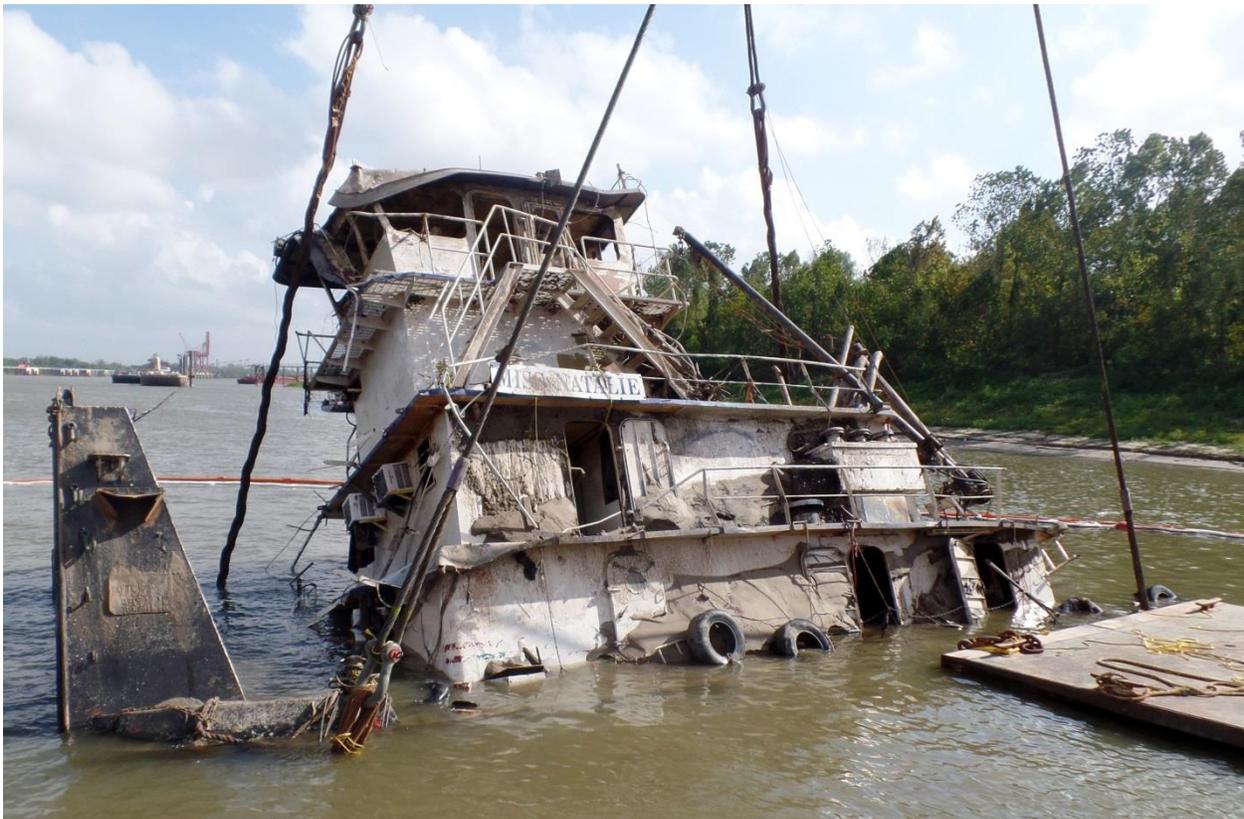
Salvage of *Miss Natalie*, October 20, 2015. (Photo by Coast Guard)

The *Miss Natalie* sank at approximately 0756, based on the last AIS position information recorded at 07:56:18. When the vessel was salvaged five months later on October 20, 2015 (a delay due to the high-water conditions), the remains of the deceased crewmember (deckhand no. 3) were found on the second deck, one deck above the accommodation deck and one deck below the wheelhouse.
