National Transportation Safety Board

Marine Accident Brief

Grounding of Fish-Processing Vessel *Gordon Jensen*

Accident no.	DCA16FM013
Accident type	Grounding
Vessel	<i>Gordon Jensen</i>
Location	Bella Bella, British Columbia, Canada, about 250 nautical miles (nm) northwest of Vancouver Approximately 52°10'12.91"N, 128°07'12.67"W
Date	December 19, 2015
Time	About 1810 Pacific standard time (coordinated universal time – 8 hours)
Damage	\$583,376
Injuries	None
Environmental damage	None reported
Weather and sea conditions	Darkness, light rain, visibility about 8 nm, winds 9–24 mph, air temperature 35°F
Waterway information	Channel in the Inside Passage (a coastal route for oceangoing vessels along a network of passages that weave through the islands on the Pacific coast of North America), Canada's southwest coast, east side of Campbell Island.

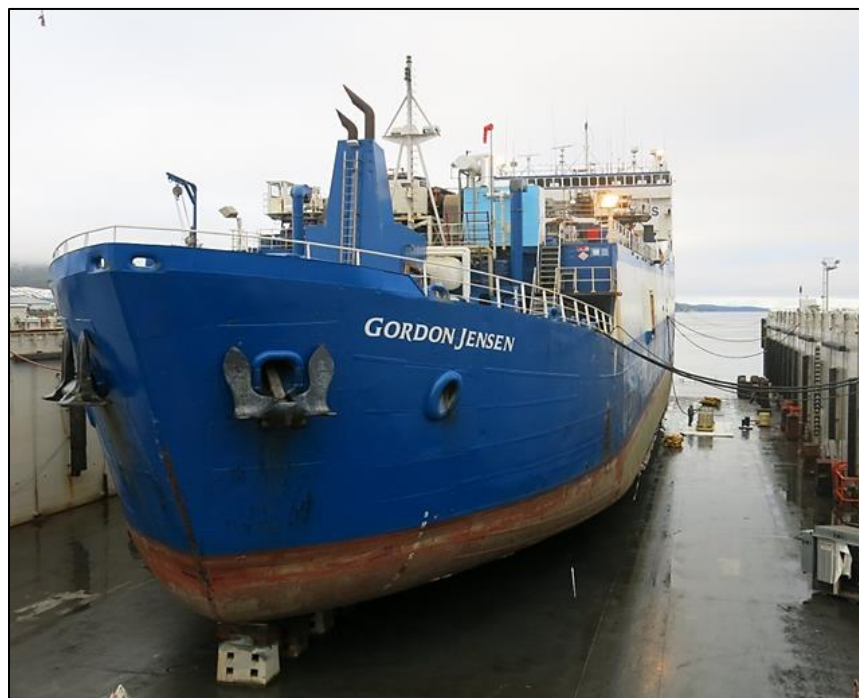
Gordon Jensen undergoing postaccident repairs in Ketchikan, Alaska.

After the accident, about 1900, the ship's crew notified the Canadian Coast Guard, who allowed the vessel to divert to Ketchikan, Alaska, to undergo repairs. The US Coast Guard, who was notified by the company after the grounding, inspected the vessel after its arrival in Ketchikan.

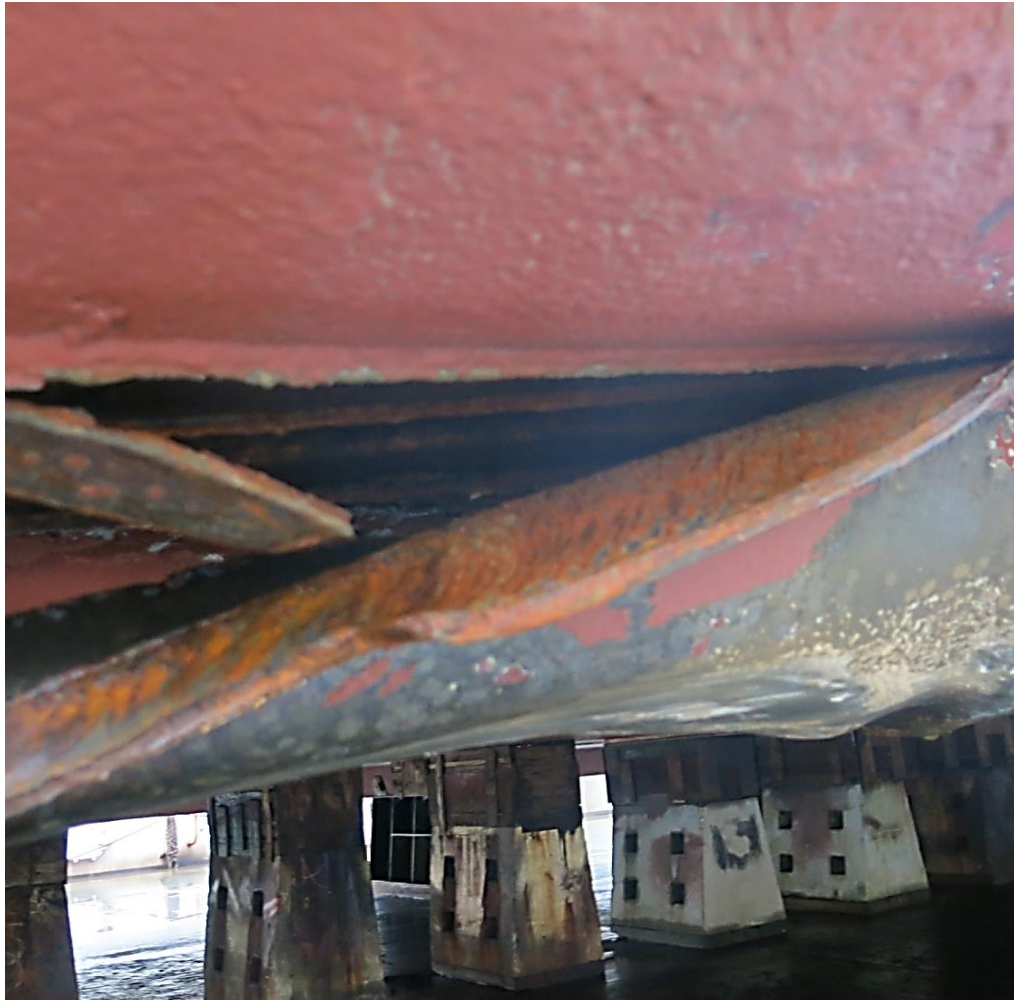
On December 19, 2015, about 1810 local time, the US-flag fish-processing vessel *Gordon Jensen*, en route from Seattle, Washington, to Dutch Harbor, Alaska, grounded in Canadian waters near the town of Bella Bella, British Columbia, about 250 nm northwest of Vancouver, Canada. As a result of the grounding, the forward-most portside ballast tank was breached, costing \$583,376 in repairs. There were 165 persons aboard the vessel. No injuries or pollution were reported.

Breached hull on the *Gordon Jensen*'s port side.

The National Transportation Safety Board determines that the probable cause of the grounding of fish-processing vessel *Gordon Jensen* was the combined effects of prescription pain medication, over-the-counter cold medication, alcohol, and sleep deprivation, which led to the master's impaired cognitive performance, preventing him from recognizing that he could not effectively perform the duties and responsibilities of master.
