National Transportation Safety Board

Marine Accident Brief

Sinking of Fishing Vessel *Kupreanof*

Accident no.	DCA15LM025
Vessel names	<i>Kupreanof</i>
Accident type	Sinking
Location	Gulf of Alaska, about 50 miles* west-northwest of Cape Spencer, Alaska, 58°19.54' N, 138°14.99' W
Date	June 10, 2015
Time	0540 Alaska daylight time (coordinated universal time – 8 hours)
Injuries	None
Property damage	\$875,000
Environmental damage	Potential release of more than 7,300 gallons of diesel fuel and other petroleum products
Weather	Raining, visibility 2 miles, winds southeast at 25–35 knots, seas 15–20 feet, air temperature 46°F
Waterway information	Gulf of Alaska, open ocean

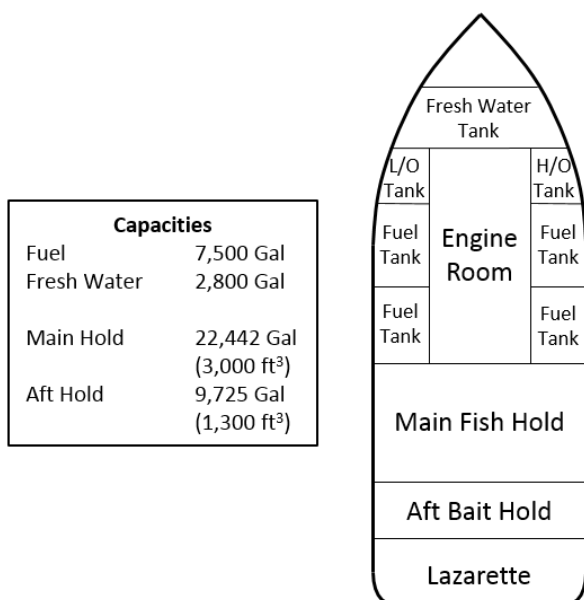
Diagram of *Kupreanof* below deck spaces and holds (not to scale) based on captain's description and 2014 survey. Tank capacities from survey.

In an attempt to resolve the list, the captain checked the engine room for water accumulation and pumped out the space, along with the shaft alley. He then began pumping out the lazarette, the aft-most space on the vessel. A single pump was used to remove water, with a valve manifold in the engine room controlling which space was being pumped. The captain did not find a significant amount of water in the engine room spaces, but he could not check the lazarette because equipment was stowed atop the access hatch.

Both the main fish hold and the aft bait hold were completely filled with water before the *Kupreanof* left Petersburg. The captain stated that he did not attempt to pump out the water in these spaces, fearing that free surface effect in the holds would make the vessel less stable.² Both the captain and the engineer were aware that the

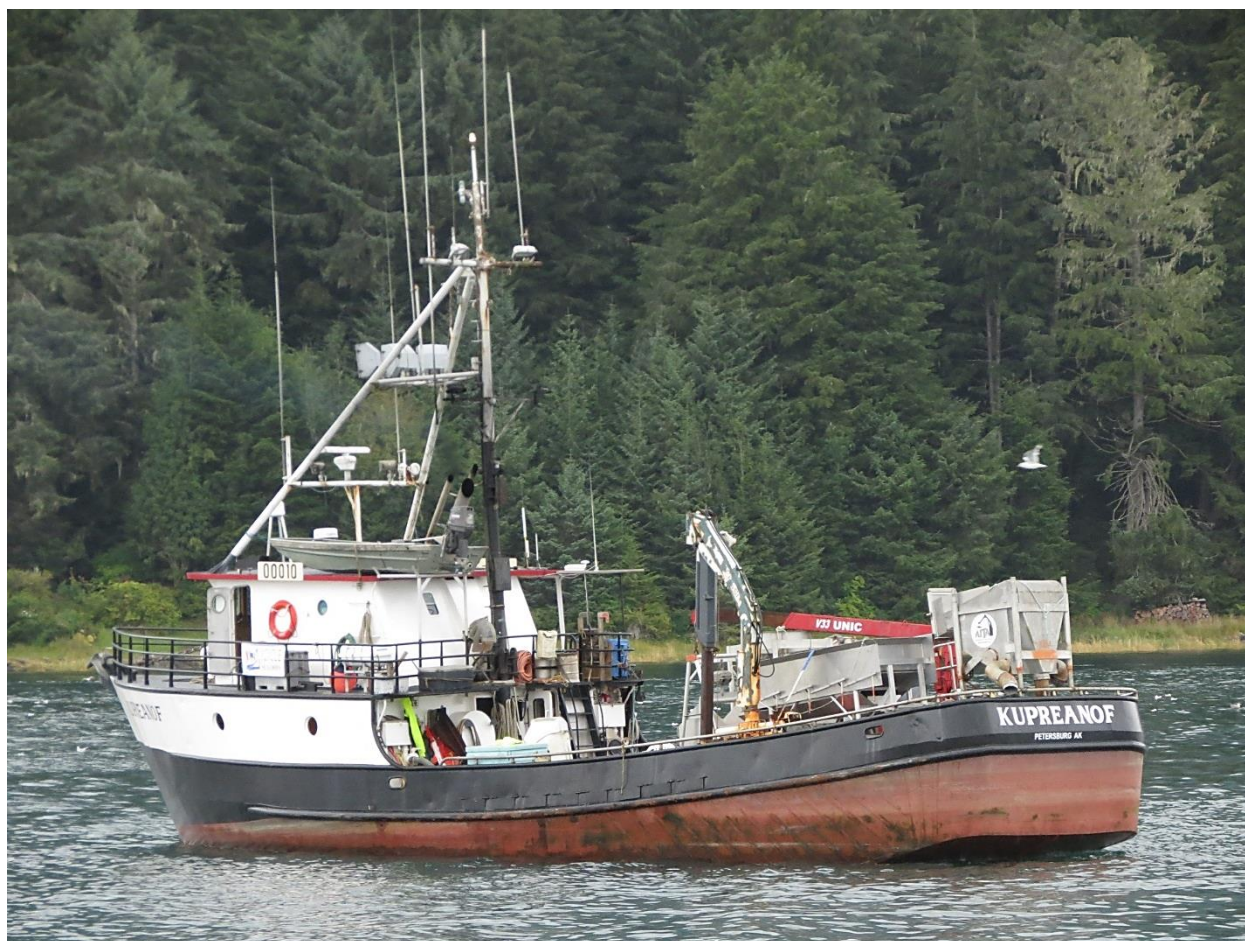
Crewmembers stated that none of the vessel's bilge alarms sounded prior to abandoning the vessel. The captain told investigators that he had satisfactorily tested all bilge alarms prior to leaving Petersburg, with the exception of the lazarette. He could not test the lazarette alarm because the access was blocked by equipment on deck.

***Kupreanof* under way prior to the accident. Note equipment lashed to the aft deck that blocked access to the lazarette. (Photo courtesy of Lana Parker)**

Blocking access to high-risk spaces, such as the lazarette on the *Kupreanof*, is a safety hazard. Without access, operators cannot be sure of the condition of the space, nor can they respond when emergencies, like flooding, affect those spaces. In this accident, access to the lazarette—the space containing the steering machinery and one or more hull penetrations—was obstructed, which prevented crewmembers from determining if it was the source of flooding and, if so, possibly addressing the hazard.

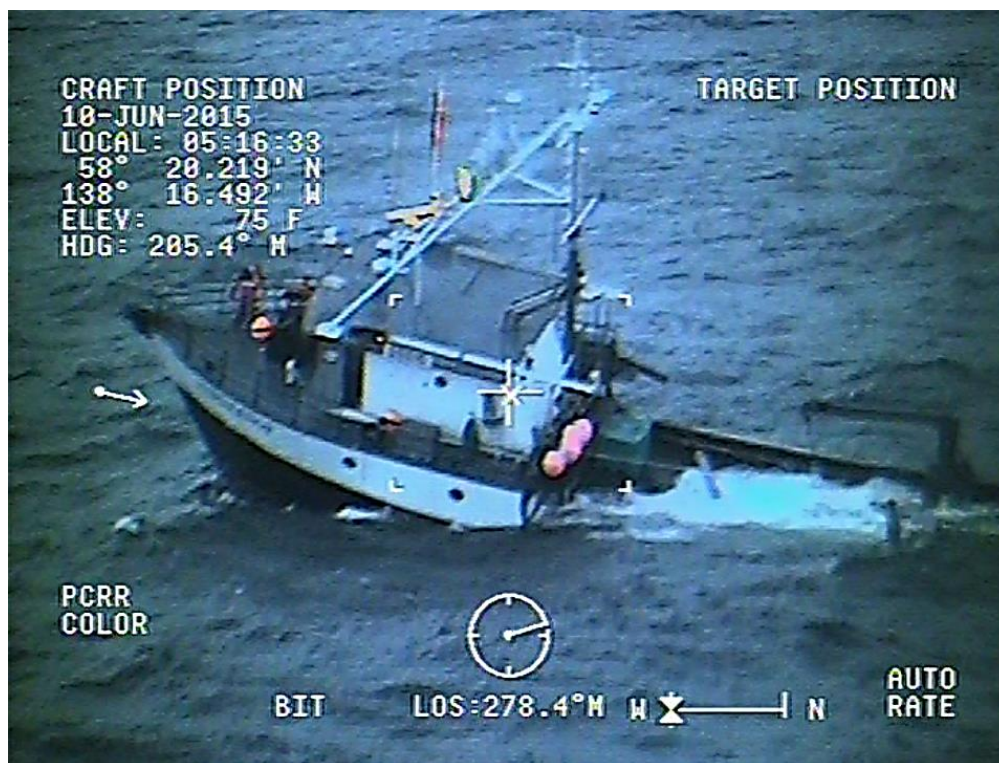
Coast Guard video image of the sinking *Kupreanof* soon after the arrival of the rescue helicopter.

The National Transportation Safety Board determines that the probable cause of the sinking of the fishing vessel *Kupreanof* was the flooding of an aft compartment, likely the lazarette.
