# National Transportation Safety Board Marine Accident Brief

## Grounding of Fishing Vessel Day Island

Accident no. DCA16FM016

Vessel name Day Island

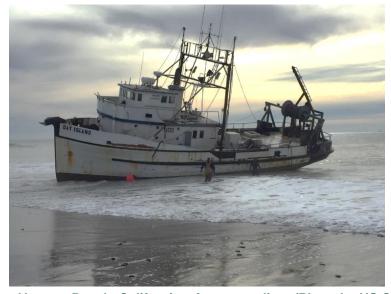
On January 10, 2016, at 2035 Pacific standard time, the uninspected commercial fishing vessel *Day Island* ran aground on Ventura Beach, California, in light seas. At the time of the accident, the vessel was en route to the commercial docks in Ventura Harbor, about a mile and a quarter south of the grounding location. The captain, who was operating the vessel, told investigators that he had fallen asleep about 30 minutes before the grounding and was awakened when the vessel ran up on the shore. After an unsuccessful attempt to refloat the vessel, the three crewmembers abandoned the *Day Island* and waded ashore with the help of local rescuers. None of the crewmembers were injured, and no environmental damage was reported. The vessel was intentionally destroyed during its removal from the beach.

Day Island on Ventura Beach, California, after grounding. (Photo by US Coast Guard)

The captain should not have operated the vessel because he was not fit for duty, either from lack of sleep alone or combined with the effects of a potentially impairing medication. The captain's acute fatigue caused him to fall asleep while operating the vessel, which led to the vessel running aground.

The National Transportation Safety Board determines that the probable cause of the grounding of the fishing vessel *Day Island* was the captain falling asleep while operating it due to the effects of his acute fatigue. Contributing to the grounding was the captain's use of medication that may have been sedating.

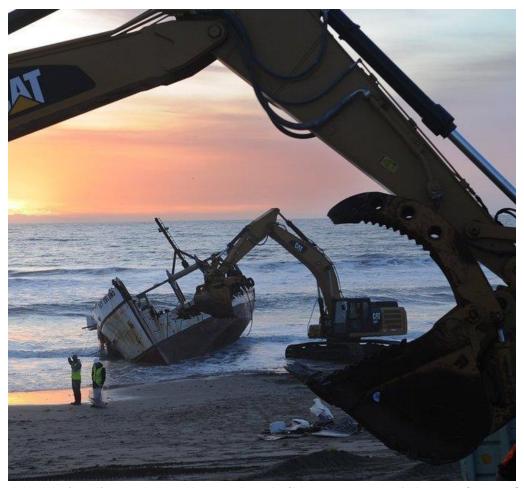
Because the *Day Island* grounded on a beach within a California State Park, state officials informed the vessel owner that he would be responsible for the cost of its removal. The owner, who had not insured the vessel, was unable to cover the cost. Consequently, the owner agreed to transfer ownership to the state, which then arranged for the vessel's removal. In order to reduce environmental damage from the vessel, it was dismantled and removed in pieces.

Day Island being dismantled on Ventura Beach. (Photo courtesy of Ventura County Star)
