National Transportation Safety Board

Marine Accident Brief

Collision of *Crimson Gem* Tow with Bulk Carrier *Yangtze Ambition*

NTSB/MAB-17/02

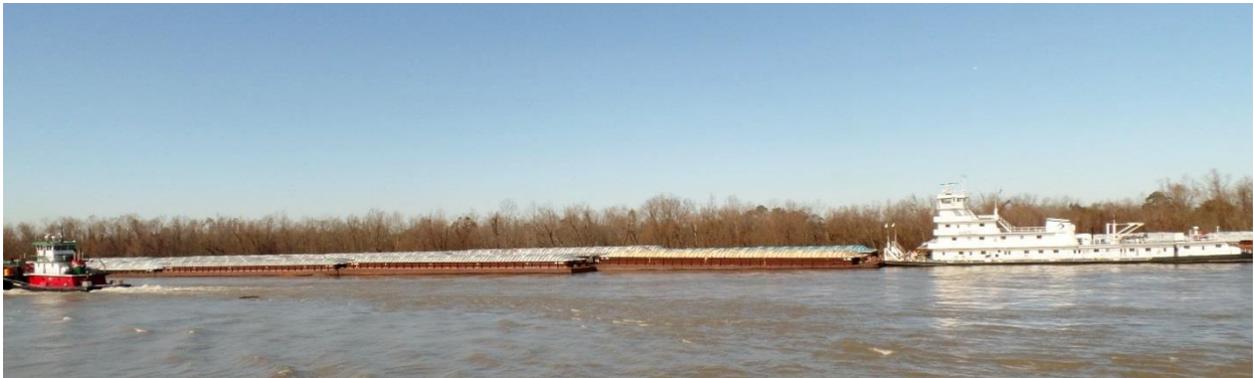
Towing vessel *Crimson Gem* with the remaining barges following the collision.
(Photo by US Coast Guard)

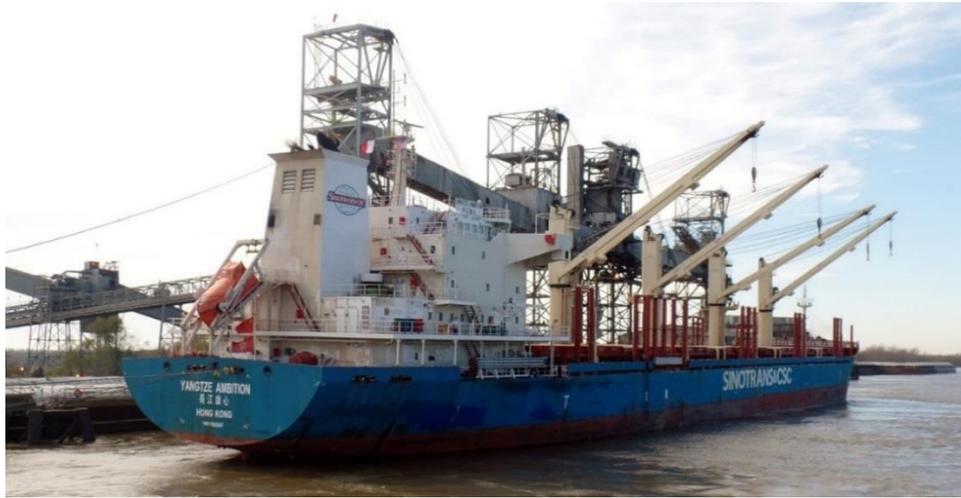
Bulk carrier *Yangtze Ambition*. (Photo by Coast Guard)

The *Yangtze Ambition* sustained a 12-inch-by-16-inch hole on the port side of the bulbous bow, costing an estimated \$25,000 to repair. On the barges, steel plates had to be replaced on the bows of the lead barges *ART 35184* and *XL 359* for an estimated \$150,000 each and on the stern of the aft barge *RRS 7946* for an estimated \$100,000.

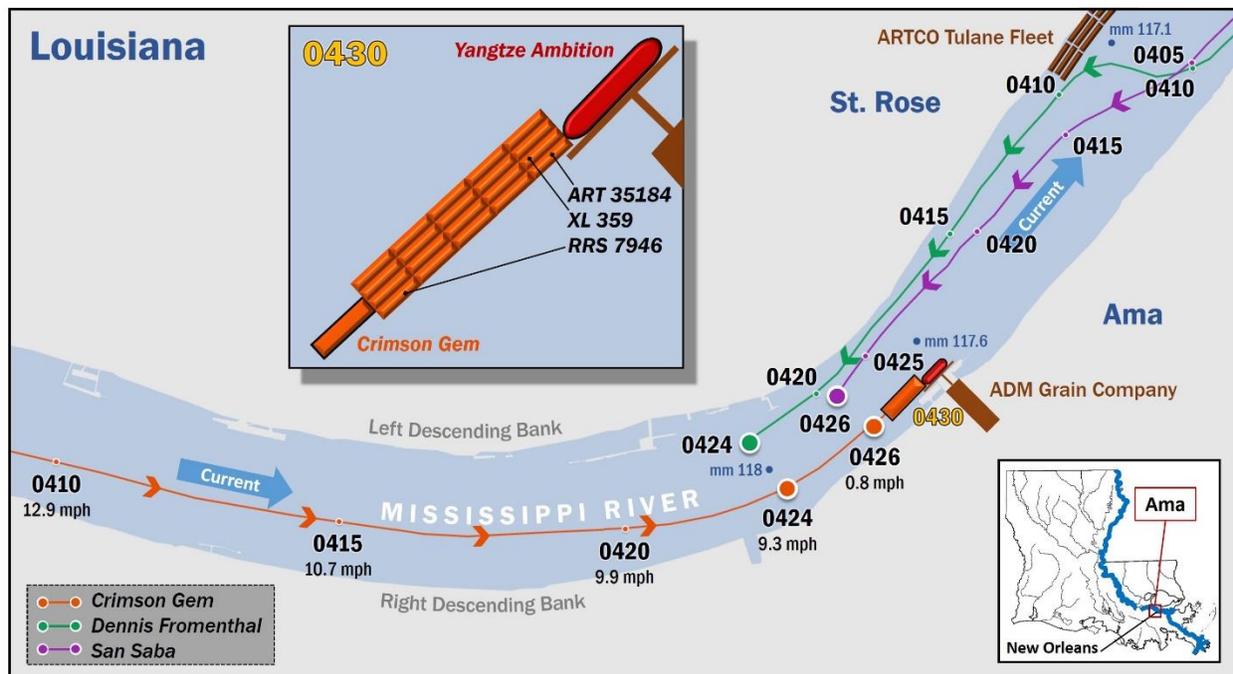
While transiting at night through the bend at Ama with a following current, the pilot on the *Crimson Gem* had to meet two towing vessels traveling upriver, the *Dennis Fromenthal* without a tow and the *San Saba* pushing two barges.² After meeting them, he planned to stop his tow in time to berth at the ARTCO fleet area less than a mile away. Based on automatic identification system (AIS) data, at 04:23:32, the *Crimson Gem*, traveling 9.3 mph (speed over the ground), passed the *Dennis Fromenthal* on its port side in the bend at mm 118. The *San Saba* tow was less than one-half mile downriver on the port quarter of the *Dennis Fromenthal*.

After passing the *Dennis Fromenthal*, yet before meeting the *San Saba*, the pilot put the *Crimson Gem* engines astern to slow the tow in order to land at the terminal. By the time the *Crimson Gem* met the *San Saba*, the vessel's engines were full astern. At 04:26:58, the *Crimson Gem* passed the *San Saba*, again on its port side, in the bend at 0.8 mph, two-tenths of a mile from the *Yangtze Ambition*. The pilot told investigators that, as he attempted to maneuver through the bend, the current was pushing him sideways. "[I] should have started backing down earlier," he said. "I almost had the tow stopped [from sliding across the bend], but the current was too strong." Had his destination not been so close, the pilot added, he would not have backed down at all.

Based on automatic identification system data, the tracklines of the vessels *Crimson Gem*, *Dennis Fromenthal*, and *San Saba*, along with the position of the moored *Yangtze Ambition* in the river bend in Ama, Louisiana, leading up to the collision at 0430.

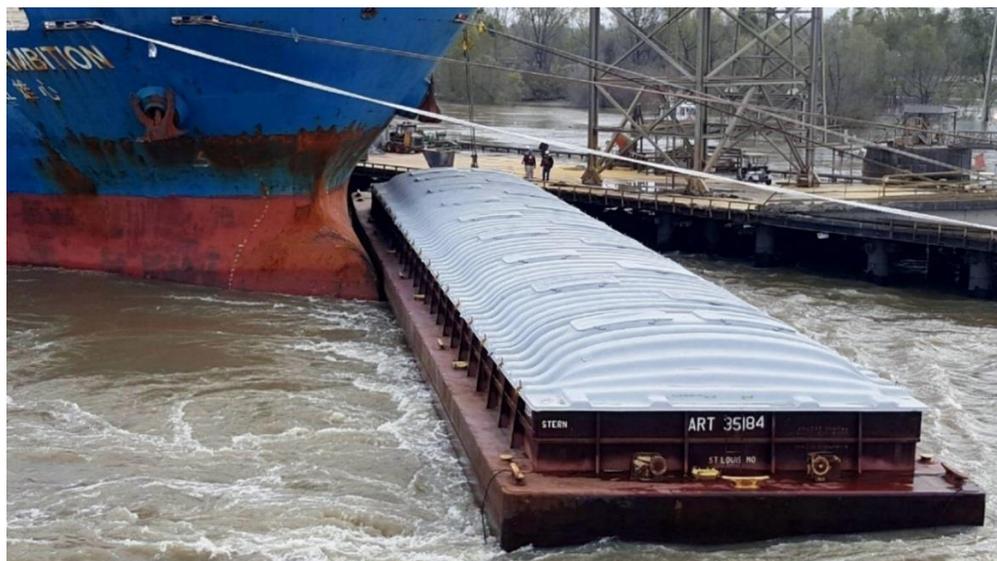
At 0430, the *Crimson Gem* tow collided with the *Yangtze Ambition* moored at the ADM Grain dock on the right descending bank in the river bend. The starboard two barges at the head of the tow were damaged when they made contact with the bulbous bow of the *Yangtze Ambition*. The barge on the starboard corner became wedged under the dock and broke free from the tow.

Barge *ART 35184* wedged under the dock after the *Crimson Gem* tow collided with the bulk carrier *Yangtze Ambition*. (Photo by Coast Guard)

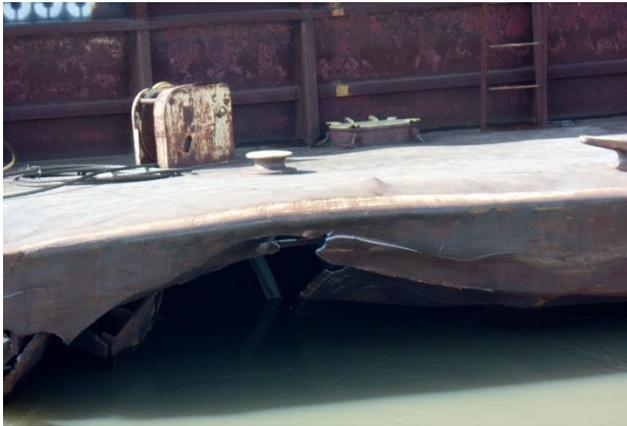
Damaged starboard bow of barge XL 359 from the *Crimson Gem* tow. (Photo by Coast Guard)

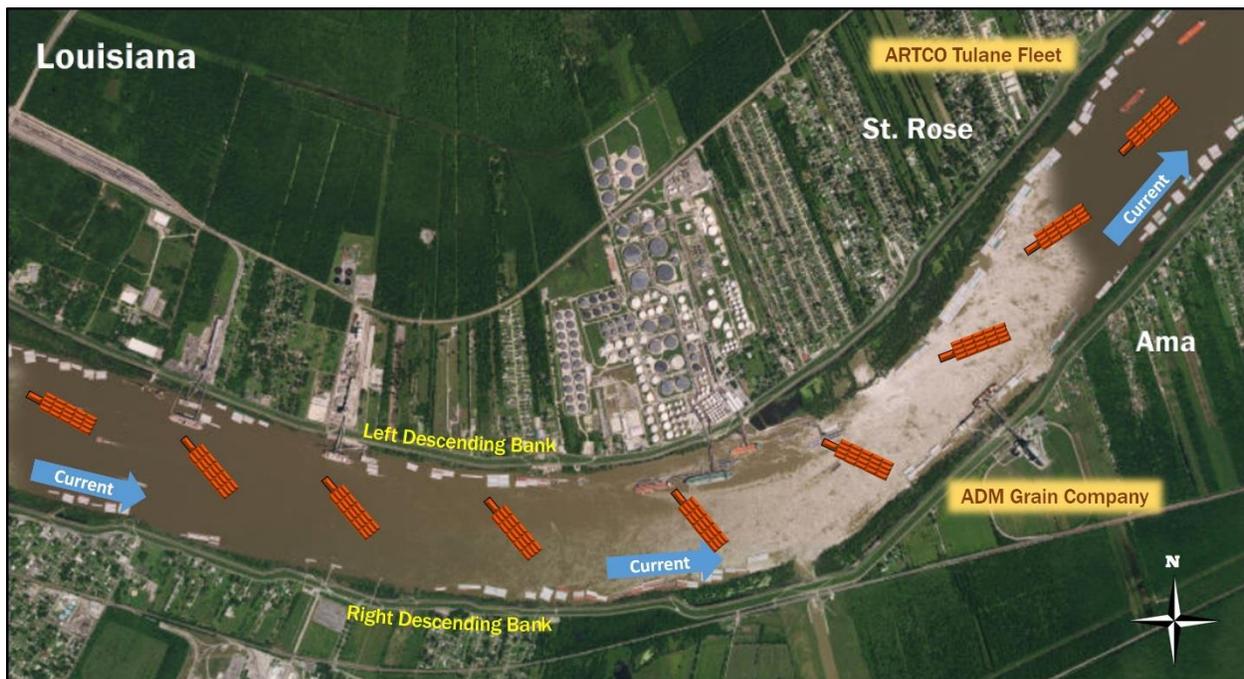
The pilot would have preferred to have “flanked” the bend, as he told investigators. Flanking allows tows to pivot around the point of a bend, similar to how a large log might drift downriver. A vessel operator may decide to flank around a bend if the combined forward speed of the vessel and the current might otherwise push the tow onto the outside riverbank before the turn can be completed. Compared with steering around a bend, flanking requires more time to navigate

The flanking maneuver the *Crimson Gem* pilot would have preferred to do while transiting through the bend to mitigate the risk of the swift current. Vessel proportion is for illustration only. (Background by National Geographic MapMaker Interactive)

through relatively short stretches of the river (as the forward speed is slower) but reduces the risk of running aground. Flanking is possible only when the current pushes the vessel from astern and carries the vessel through the turn. As the *Crimson Gem* approached the bend in Ama, the river current was pushing the tow from astern at as much as 6.7 mph.

The *Mississippi River Crisis Action Plan*—a joint project of the marine industry, the Coast Guard, and the US Army Corps of Engineers—suggests using the flanking maneuver to mitigate the risk of a fast current in river bends: “Relative speed through the water can approach zero when southbound, making normal control of a vessel impossible. To continue to operate in high currents, the flanking maneuver was developed to use, rather than fight, the current to navigate around the many points on the river systems.” Despite having used the maneuver earlier during the voyage from St. Louis, the *Crimson Gem* pilot did not flank the bend in Ama because of the increased risk of collision stemming from the vessel traffic congestion and fleeting operations, along with having to meet both a towboat and a tow. The captain of the *Crimson Gem* called the bend in Ama the “worst part of the river.”
