National Transportation Safety Board

Marine Accident Brief

Collision between Cargo Vessel *Manizales* and Bulk Carrier *Zen-Noh Grain Pegasus*

NTSB/MAB-17/03

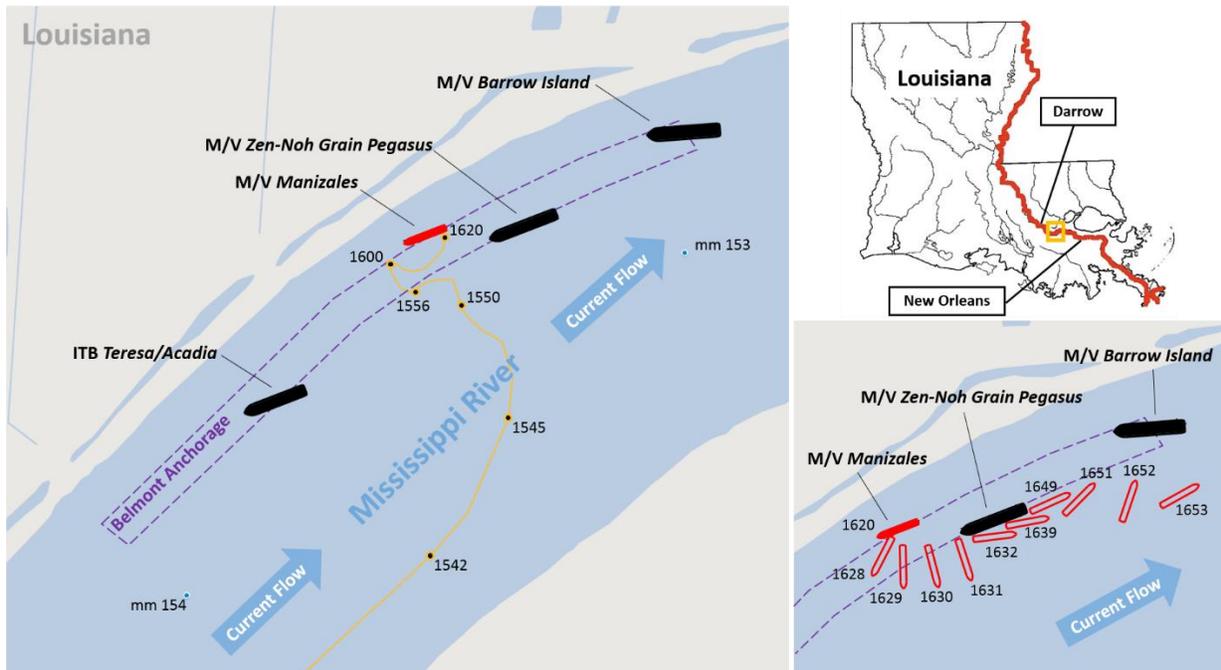
Image on the left shows AIS data of *Manizales*'s approach to the anchorage until it appeared to be holding anchor at 1620. Lower right image shows the path of *Manizales* as it dragged anchor and collided with *Zen-Noh Grain Pegasus*. Upper right image shows the accident area, outlined in yellow, in the Louisiana section of the Lower Mississippi River. (Background by Google Maps)

About 1617, the pilot (as recorded on the VDR) reported that the anchor chains had become taut. At this time, the stern of the *Manizales* was about 500 feet from the bow of the *Zen-Noh Grain Pegasus*. The pilot remained on the bridge of the *Manizales* until 1626, when the crew boat that was to take him ashore approached. Just as the pilot was going to board the crew boat, the *Manizales*'s bow swung into the river. AIS data showed that the *Manizales*'s initial

heading change occurred at 1628, with the bow swinging 33 degrees in 90 seconds. The pilot returned to the bridge soon after.

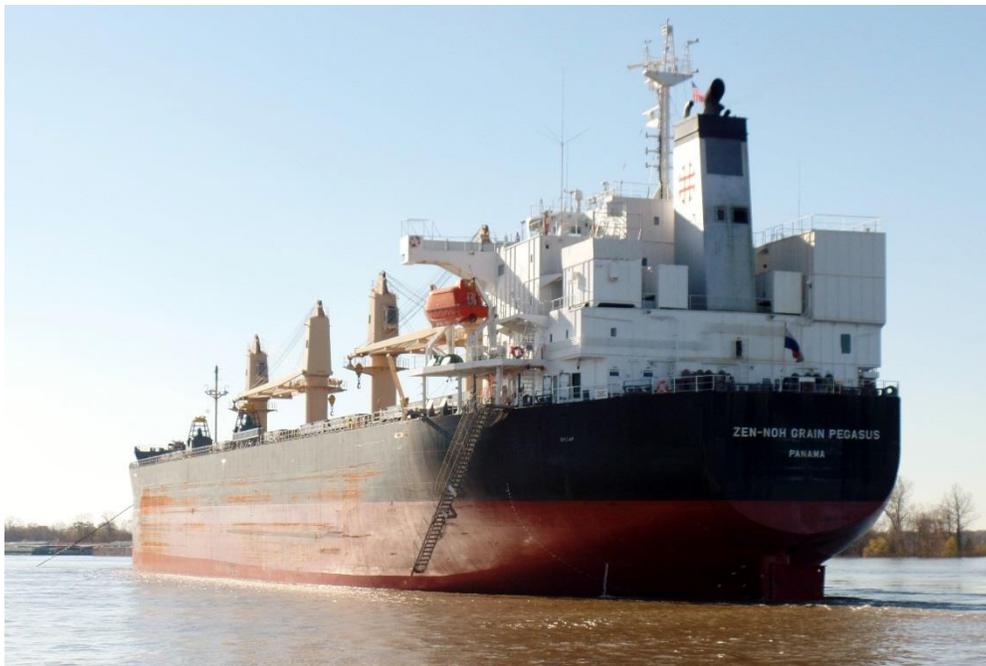
***Zen-Noh Grain Pegasus* at Belmont anchorage. (Photo by Coast Guard)**

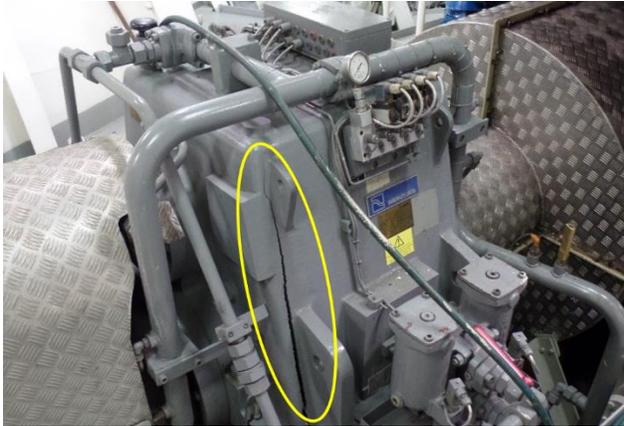
At 16:31:24, carried by the current, the *Manizales* reached a speed of 5.5 knots on a course over the ground of 94.7 degrees. The vessel continued to drift until its propeller caught the starboard anchor chain of the *Zen-Noh Grain Pegasus*. The entanglement pulled the *Manizales*’s propeller shaft outward 6 inches, damaging reduction gears and cracking the gear box.

Left image shows *Manizales* cracked gear box. Right image shows *Zen-Noh Grain Pegasus* port anchor chain draped across *Manizales* crane and lifeboat. (Photos by Coast Guard and *Zen-Noh Grain Pegasus* crew)

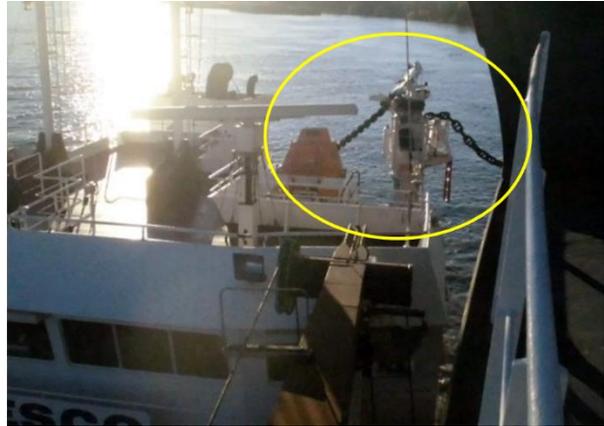
Subsequently, the *Manizales* drifted toward the port anchor chain and bow of the *Zen-Noh Grain Pegasus*. The *Zen-Noh Grain Pegasus*'s port chain caught and then wrapped around the *Manizales*'s stern crane, holding the vessel in place as the current pivoted it around the bow of the bulk carrier. The highest point on the *Manizales*'s aft deckhouse was well below the main deck of the *Zen-Noh Grain Pegasus*, and at some point as the ships collided, the bridge wing of the smaller vessel was torn off.

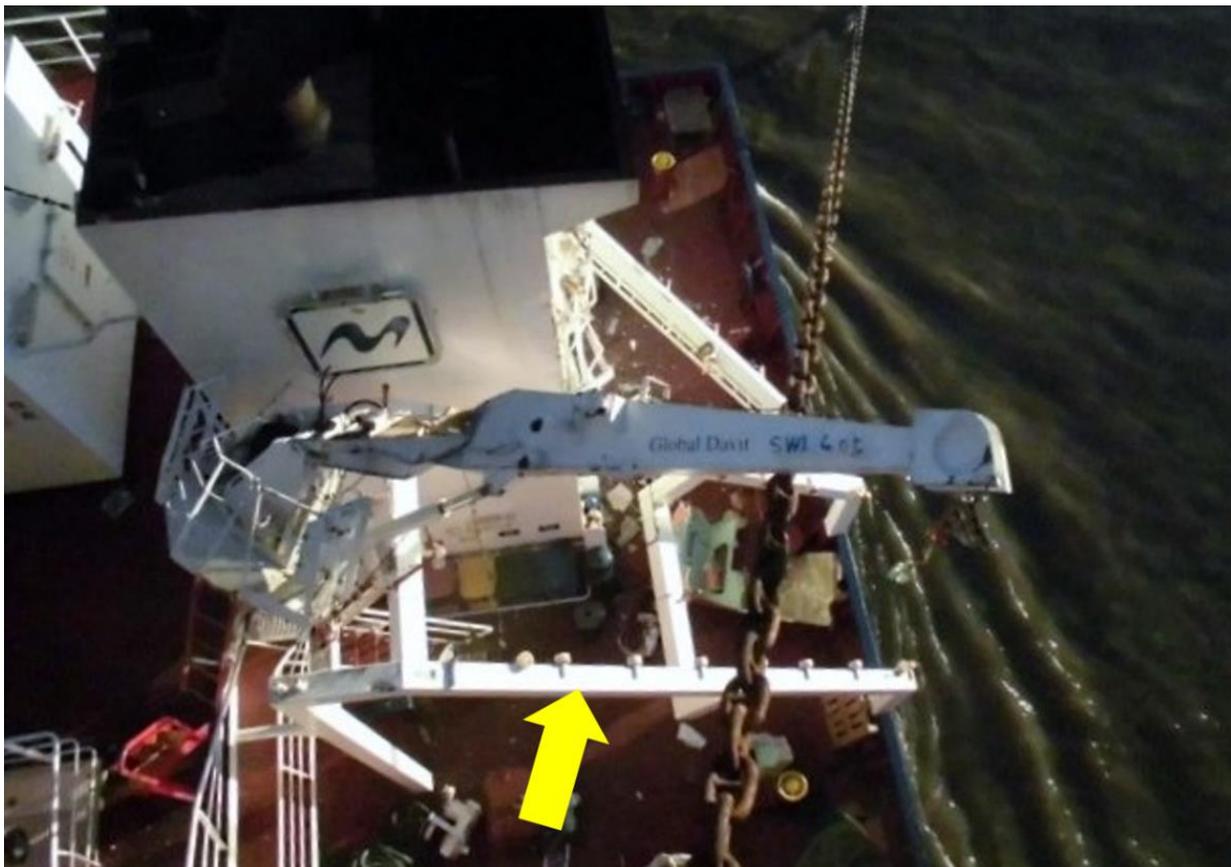
Zen-Noh Grain Pegasus port anchor chain draped across the stern of *Manizales*. The yellow arrow points to the empty free fall lifeboat cradle below the stern crane. (Photo by *Zen-Noh Grain Pegasus* crew)

Additional damage to the *Manizales* included the destruction of the free fall lifeboat and other steel fixtures on the deck aft of the wheel house. The anchor chain of the *Zen-Noh Grain Pegasus* was severed, resulting in the loss of the starboard anchor.

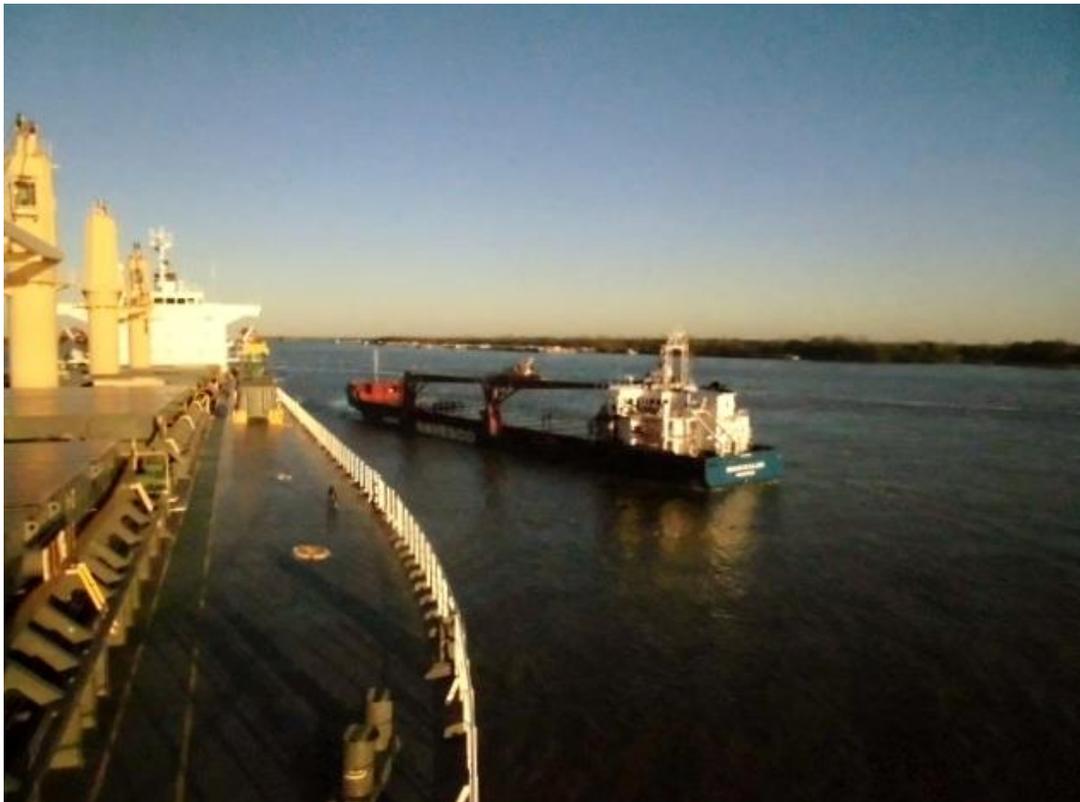
With no propulsion, the bridge wing torn off, the ship listing, and the *Zen-Noh Grain Pegasus* anchor chain still wrapped around the stern, the *Manizales* crew mustered on their vessel’s main deck near the cargo hatch covers. The list became so great that the decision was made to abandon the ship, so the crew stepped onto one of the tugboats. About 1 to 2 minutes later, the *Manizales* came free of the anchor chain when its crane broke from the deck. Once released from the chain, the *Manizales* floated free, and the crew returned to their ship as it drifted down the port side of the *Zen-Noh Grain Pegasus*. The vessel continued to drift downriver for 2300 feet until it was corralled by five towing vessels.

Manizales drifting down the port side of the anchored *Zen-Noh Grain Pegasus*. (Photo by *Zen-Noh Grain Pegasus* chief mate)
