# National Transportation Safety Board

## Marine Accident Brief

### Sinking of Commercial Fishing Vessel *Orin C*

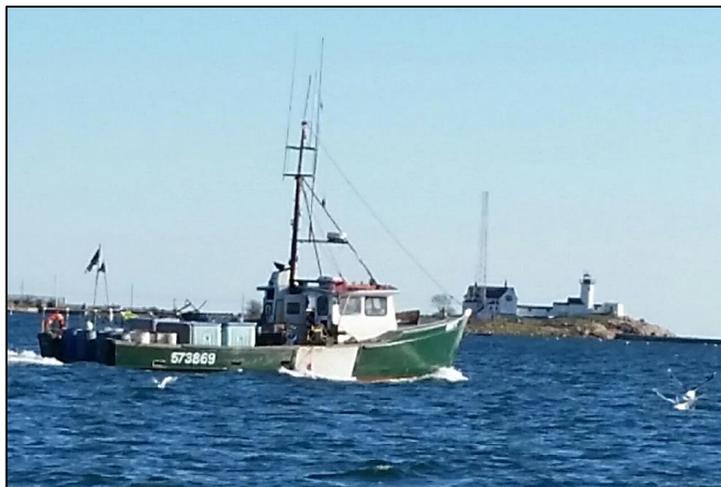
*Orin C* on the day the vessel departed Gloucester, Massachusetts, December 1, 2015. (Photo by M. Ring)

Surviving crewmembers estimated they had about 6,500–10,000 pounds of hagfish (slime eel) on board at the time the engine problems were discovered. About 5,000 pounds were located in the main fish hold below deck with the remainder evenly distributed in vats; two on each side of the boat. The crewmembers said that there was nothing unusual with the load distribution on the boat. They also noted that the deck was mostly clear, with any loose items secured in preparation for the oncoming weather. The vessel had a low freeboard and its deck scuppers were close to the water (see photo page 1). The aft deck was awash most of the time during the tow.

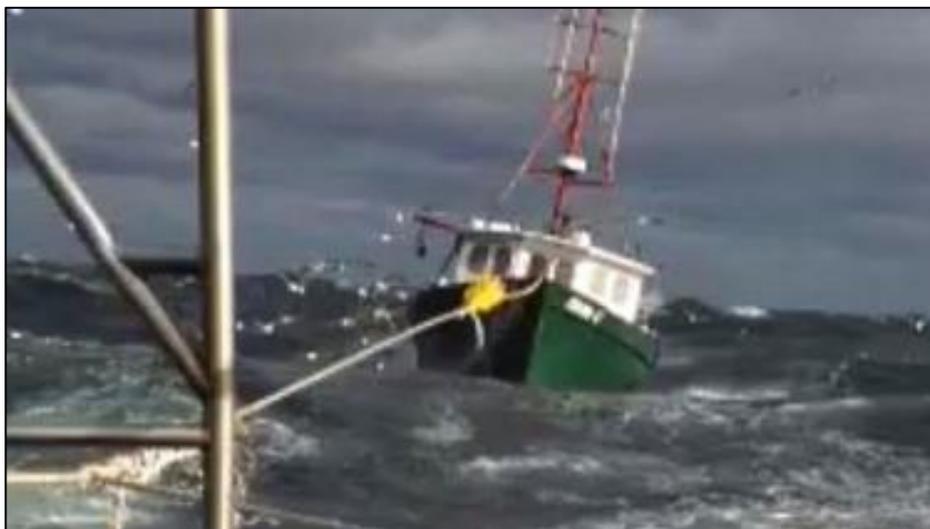
Photo of the *Orin C* taken at 1324 from the aft deck of the *Foxy Lady*.  
(Photo by *Foxy Lady* captain)

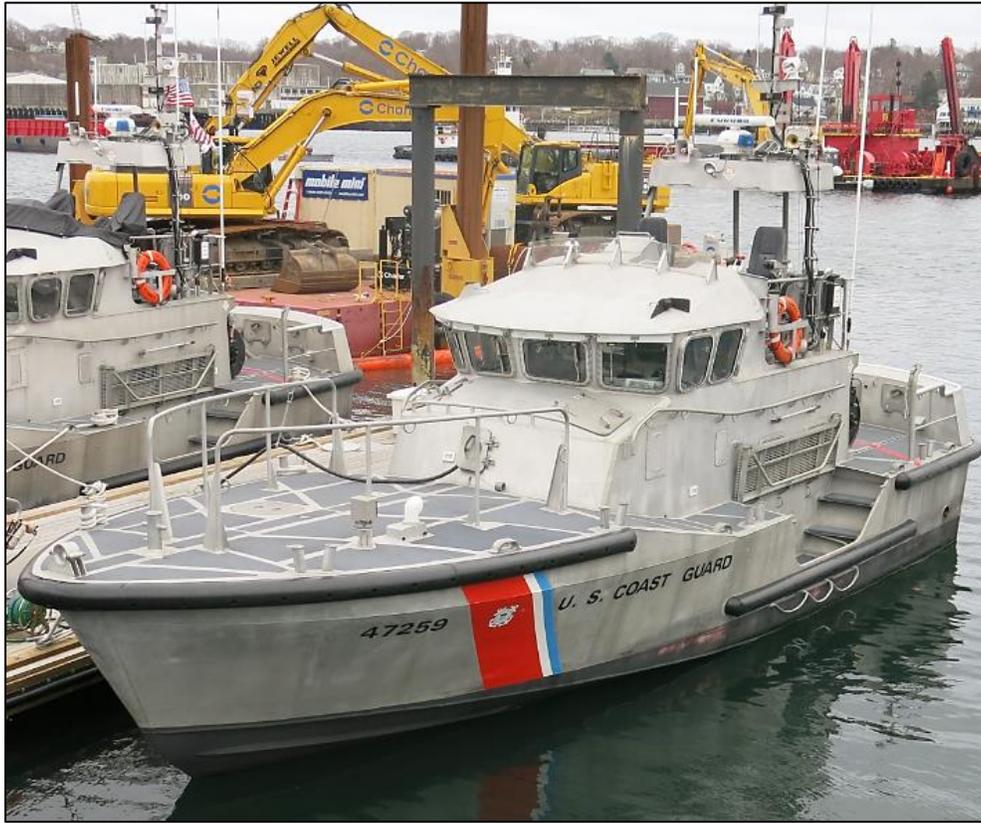
**Motor lifeboat 47259 in Gloucester Harbor.**

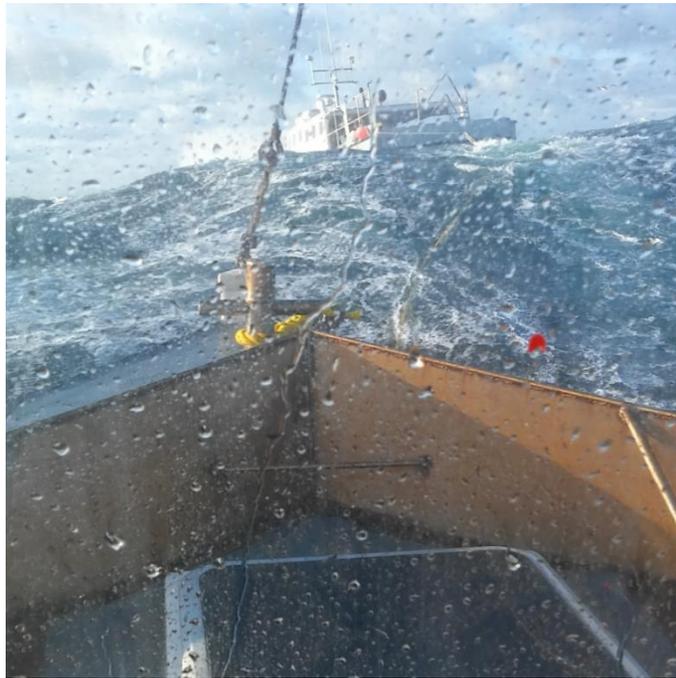
The tow was rigged with a bridle attached to both aft corners of the *Foxy Lady*, with the tow line extending to the *Orin C* from the middle of the bridle. The other end of the tow line was attached to the forward bow post of the *Orin C*. According to the *Foxy Lady* captain, the *Orin C* had no cleats on its forward deck, and the attachment using the forward bow post allowed the tow line to constantly move back and forth across the *Orin C*'s bow. The *Foxy Lady* captain expressed concern because the movement caused the line to chafe, lose strength, and eventually break. After the tow commenced, he communicated to the *Orin C* crewmembers that they needed to take measures to prevent the line from chafing. Each time the tow line parted, materials such as rubber hose, rain gear, and duct tape were added around the line to prevent it from chafing.

Photo taken from the *Orin C*, while being towed by the *Foxy Lady*, moments before the *Orin C* was hit by the wave that caused damage. Note the yellow tow line on the bow post, the bow stem with guy wire, and the lead of the tow line off the starboard bow into the water.

The *Foxy Lady* captain told investigators that they initially used a 4-inch nylon line that was on board for towing purposes. Although suitable for towing, the line was not an ideal length—too short—for the sea conditions and the vessel being towed. The *Foxy Lady* captain commented that the *Orin C* was heavier than his fiberglass boat and the type of line was all they had for the tow. He noted that the line would get shorter each time it parted and was repaired. Eventually, they were forced to use a 2-inch line because nothing else longer was available. The *Orin C* had only mooring lines on board and no lines for towing.
