National Transportation Safety Board

Marine Accident Brief

Allision of Bulk Carrier *Star of Abu Dhabi* with Louisiana Sugar Refinery Unloading Dock

Accident no.	DCA16FM034
Vessel name	<i>Star of Abu Dhabi</i>
Accident type	Allision
Location	Lower Mississippi River at mile marker 146.1 near Gramercy, Louisiana
Date	March 25, 2016
Time	0256 central daylight time (coordinated universal time – 5)
Injuries	None
Damage	Damage to vessel and dock, over \$4.8 million est.
Environmental damage	None reported
Weather	Cloudy skies with visibility 7 miles, winds north 7-10 knots, air temperature 64°F
Waterway information	The Mississippi River has a project depth of 45 feet from Southwest Pass, near the entrance to the Gulf of Mexico, to mile marker 233.4, about 135 miles above New Orleans at Baton Rouge, Louisiana. On the accident date, the river was at high water (15 feet at the Carrollton Gauge) with a current reported at 2.3 knots.

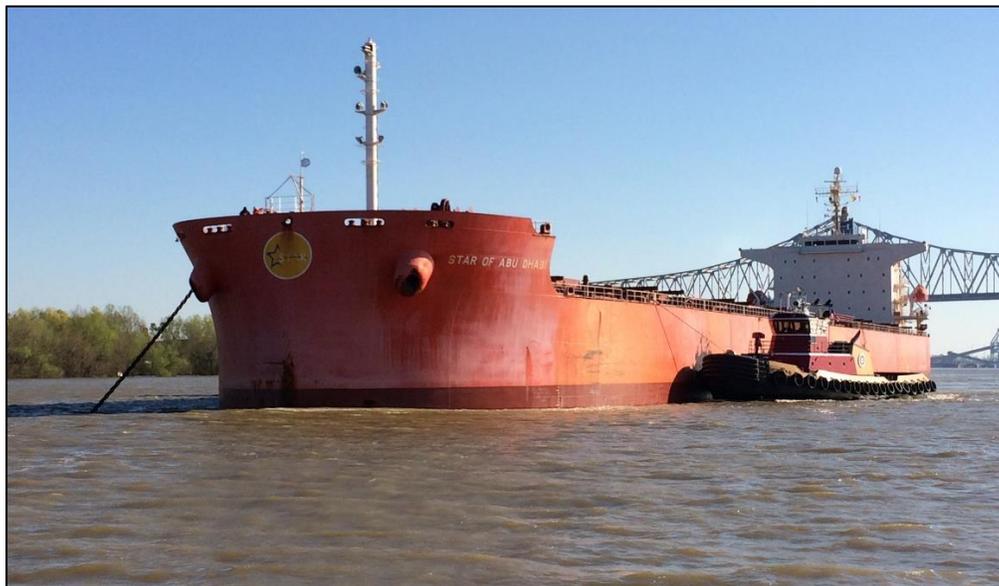
Star of Abu Dhabi after the accident, with missing port anchor. (Photo by US Coast Guard)

The *Star of Abu Dhabi* sustained about \$232,210 in damage, including a 14-foot-by-7-foot hole and heavy internal structural distortion on the starboard side between frames 190 and 195 above the water line. The port anchor and 4.5 shots (about 405 feet) of anchor chain were lost, but they were later salvaged and reattached. Damage to the LSR raw sugar unloading dock was estimated at \$4.6 million.

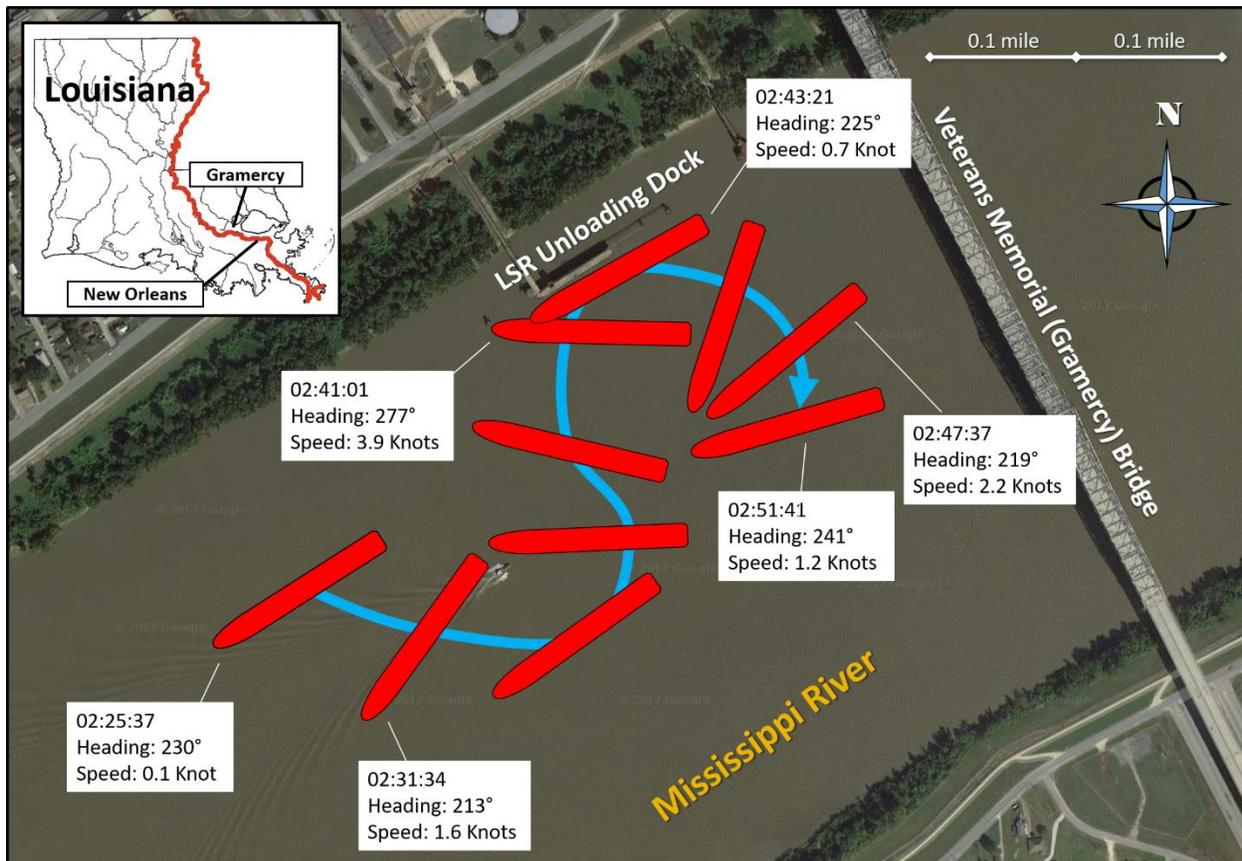
Sometime between 0228 and 0230 (based on automatic information system [AIS] data of the vessel’s motion), the port anchor chain parted at the 35th link from the kenter shackle (detachable link) on the 4th shot.⁵ The vessel’s heading swung to port, and the bulk carrier began dragging the starboard anchor at 1.7 knots. At 0236 the second officer called the master to report that the anchor was dragging. The master arrived on the bridge two minutes later and directed the second officer to call the engine room to give a 10-minute notice to bring the main engine on line. The vessel initially moved out toward the center of the channel before drifting back towards the left descending bank of the river.⁶ As the ship drifted, its speed over ground increased, eventually reaching 3.9 knots, while its heading shifted back to starboard.

Track of *Star of Abu Dhabi*, compiled from AIS data, as it dragged anchor, allided with the LSR raw sugar unloading dock, and was brought under control 0.1 mile from the Veterans Memorial Bridge. (Background by Google Maps)

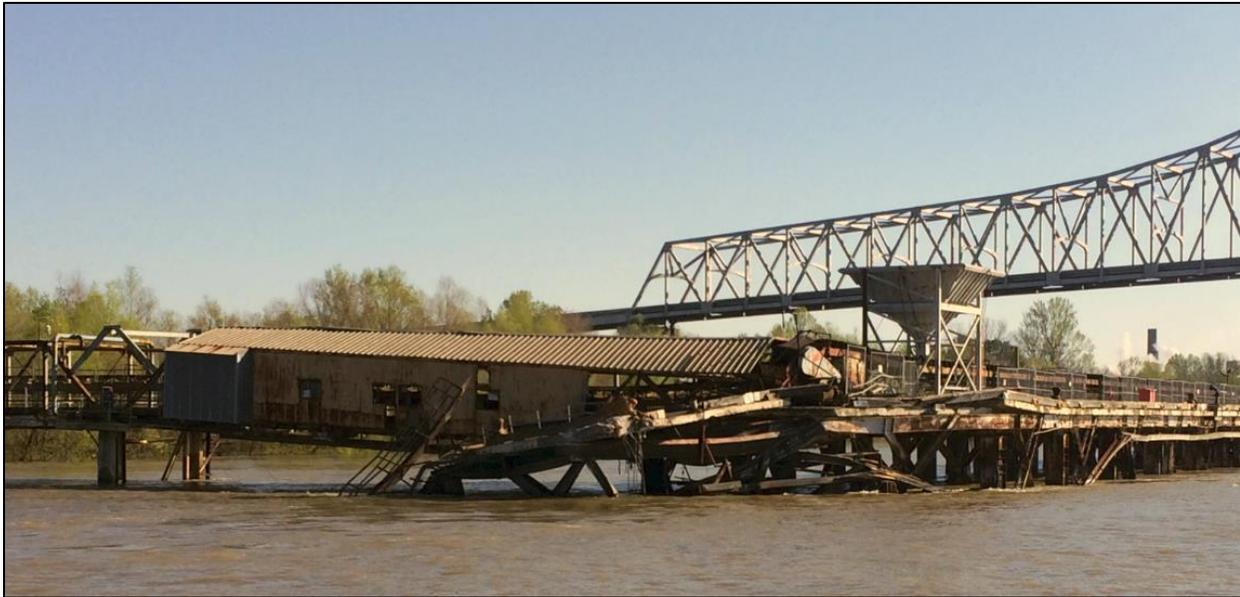
Damaged LSR raw sugar unloading dock. (Photo by Coast Guard)

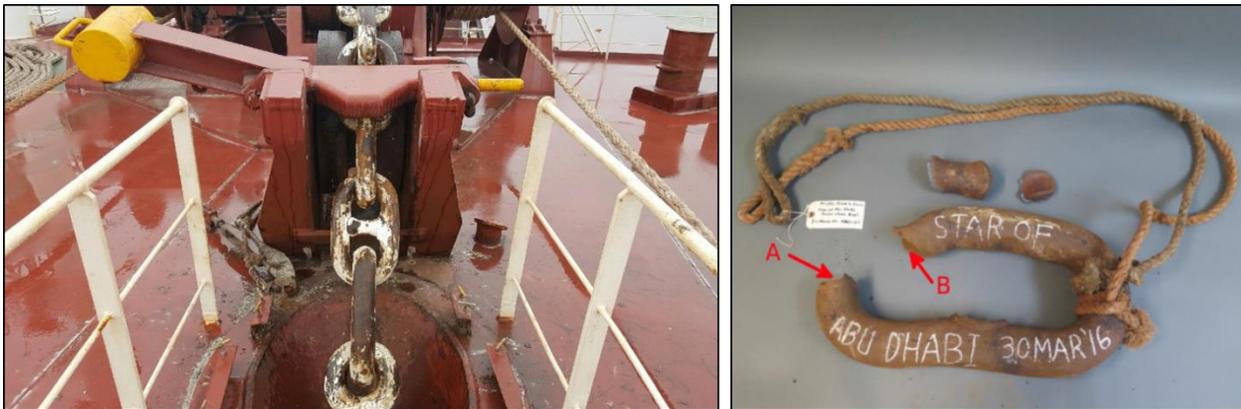
Photo left shows the roller-bar-type anchor chain stopper, handle painted yellow, in the engaged position. (Photo by *Star of Abu Dhabi* crew) Photo right shows the broken anchor chain link with the fractured mating surfaces labeled “A” and “B.” (Photo by Bartlett Engineering)

Following the accident, a third-party metallurgist was commissioned to conduct a non-destructive exam of the failed chain link. Records of the October 2014 anchor chain survey, when the linkages were last gauged, were examined. The mean diameters of all linkages were within acceptable wastage limits for the original 3.2-inch nominal diameter.⁹ Wastage was measured again after the accident and was likewise within acceptable limits. Ratchet marks, which indicate multiple microscopic crack initiation sites, were observed along the edge of the extradados.¹⁰ When it failed, the link was in contact with a roller-bar-type anchor chain stopper.¹¹ During the exam,

flattened indentations on the extrados of the fractured chain link were observed, which indicated that the link had been bearing against the anchor chain stopper.¹²

Smooth texture along most of the fracture surface, along with the presence of a “final fracture” area and ratchet marks on the opposite end of the fracture surface from the final fracture, demonstrated that a microscopic crack propagated across the link due to cyclical loading. The dynamic loading on the ship’s anchor chain caused motion between the extrados of the chain link and the anchor chain stopper bar. The motion led to fretting, a known initiator of microscopic fatigue cracks, which explains the observed ratchet marks. Multiple microscopic fatigue cracks, once initiated in a high tensile stress area such as the extrados of the chain link, would propagate rapidly enough to lead to the observed failure of the link.¹³

In summary, the metallurgist determined that the fracture was caused by fatigue initiated by the chain link rubbing on the anchor chain stopper, and not an overload failure caused by a material deficiency or abnormal loading condition.
