National Transportation Safety Board

Marine Accident Brief

Equipment Failure on Bulk Carrier *Asia Zircon II*

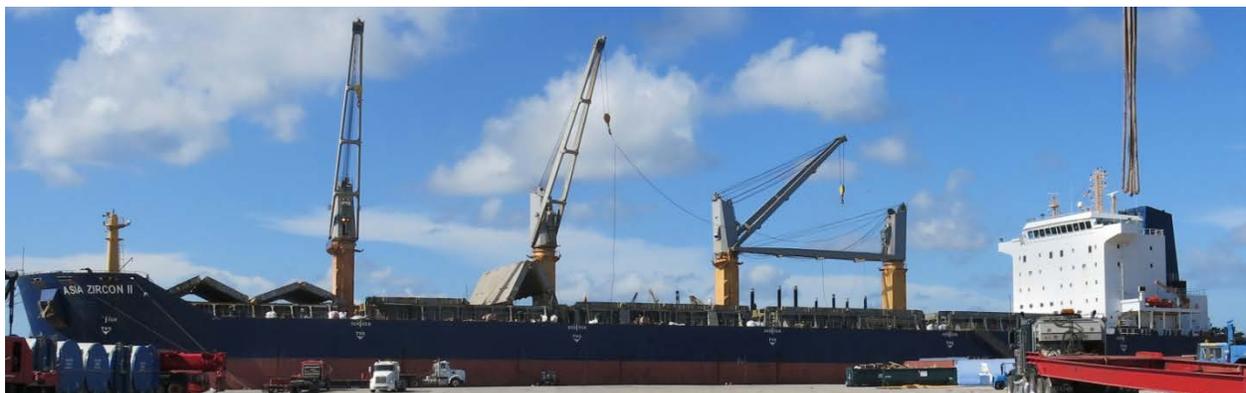
Asia Zircon II in the Port of Galveston, Texas, postaccident.

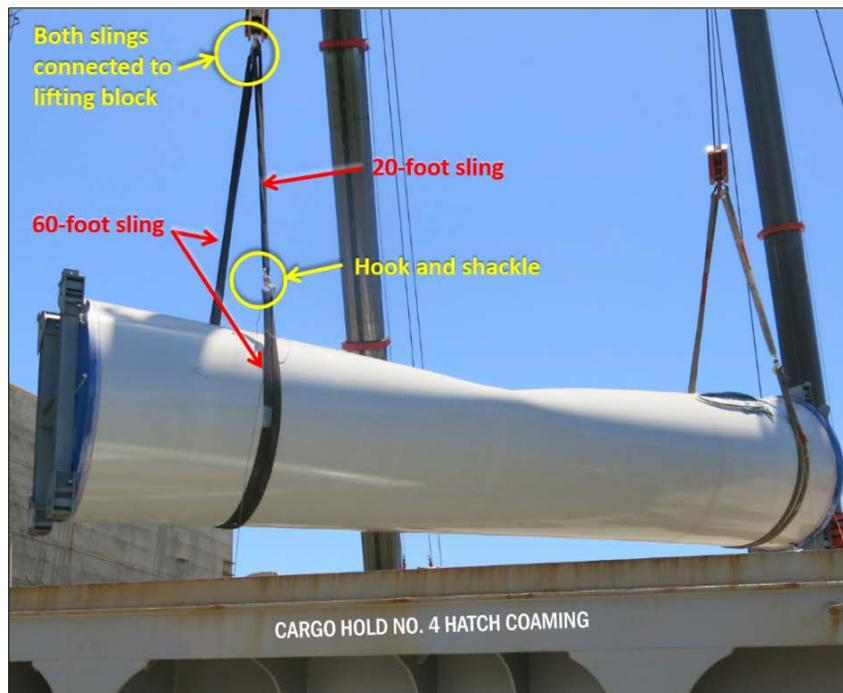
Removal of the damaged tower base section by a shore-based crane mirrors the lifting arrangement used by the vessel's cranes at the time of the accident.

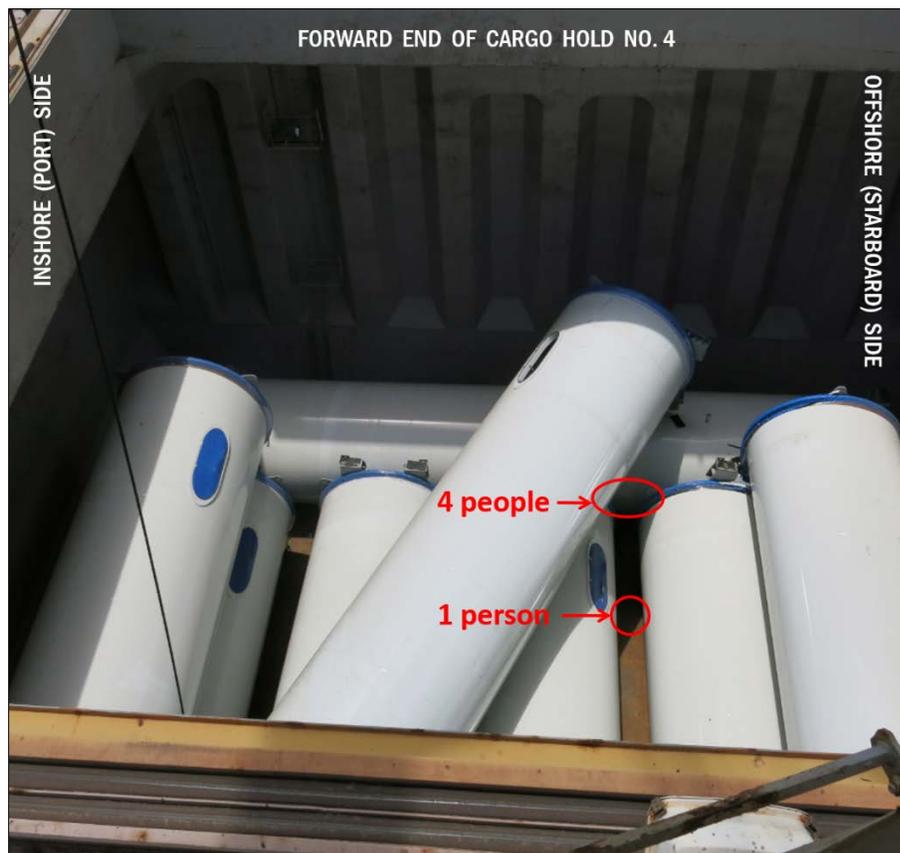
Approximate location of the five-man gang inside cargo hold no. 4 when the cargo was dropped.

The longshoremen in cargo hold no. 4 were between sections on the lower tier, which absorbed the impact from the falling cargo, and were thus protected. Numerous items of debris were ejected from the lower tier sections as a result of the impact and the compression forces from the falling section. The debris was mostly broken pieces of metal, sheered nuts and bolts, parts of the towers' footings, and securing structures. One of the men in the cargo hold reported he was hit by the flying debris; another said he was injured while taking cover. Both injuries were non-life threatening. According to the port log maintained by the ship's crewmember at the gangway, the accident took place at 0857 local time.

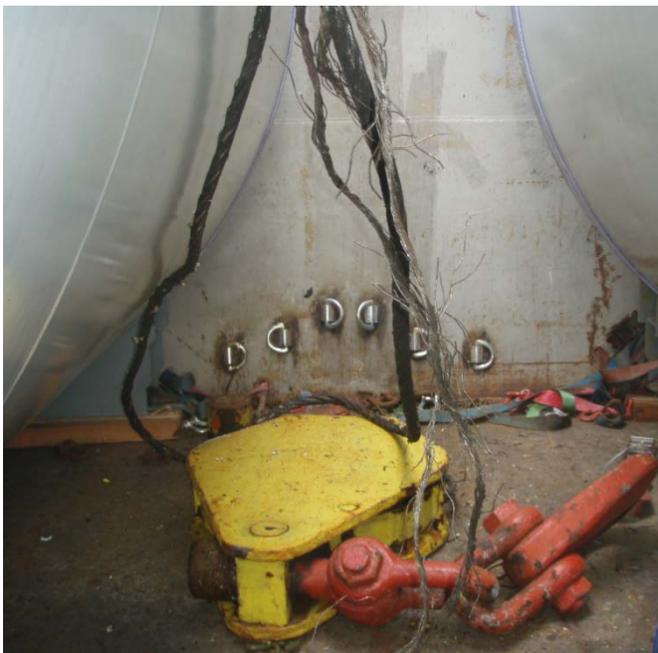
Lifting block, with hook and broken wire rope, for crane no. 4 that fell to the bottom of cargo hold no. 4.

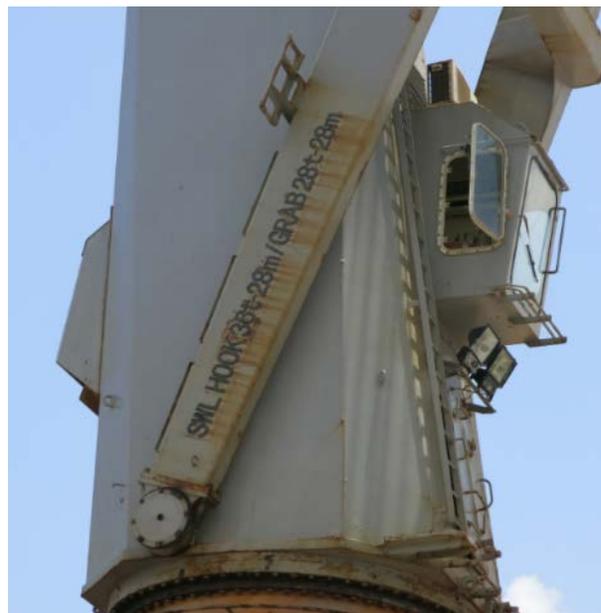
Crane no. 4 with its jib left in position after the cargo was dropped.

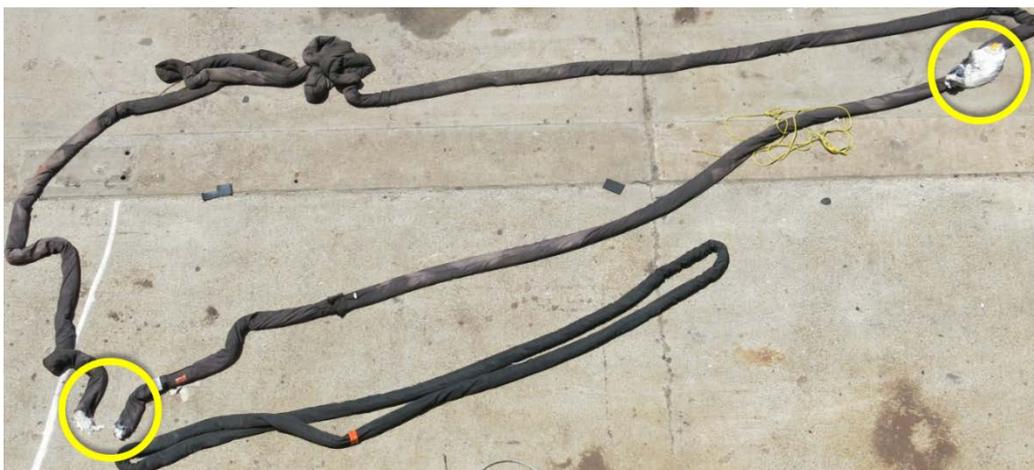
The long and short polyester round slings were owned by the stevedore company. Shortly after the accident, the stevedores removed the broken cargo sling that was attached to the load block for crane no. 3 and placed it on the dock to be inspected by investigators. The shorter sling, used to connect to the crane hook and the longer sling, was intact, with no visible signs of breakage or abrasion. The longer sling, which was last inspected on April 27, 2014, had parted entirely at one location and was frayed with abrasion and tears in both the jacket and the rope fibers at another location. The shorter, unbroken sling had a vertical capacity never to exceed 90,000 pounds (40.8 tons) and a basket capacity of 180,000 pounds (81.6 tons). The longer, broken sling had a vertical capacity never to exceed 100,000 pounds (45.4 tons) and a basket capacity of 200,000 pounds (90.7 tons). None of the shackles or hooks that were used showed any signs of damage or deformation. The foreman for cargo hold no. 4 stated that he and the gang were physically handling each sling and that no one noticed any damage or problems in the time leading up to the accident.

The long and short slings from crane no. 3. The area where the long sling separated is circled on the lower left; the section that sustained the abrasion and tears is in the upper right corner.

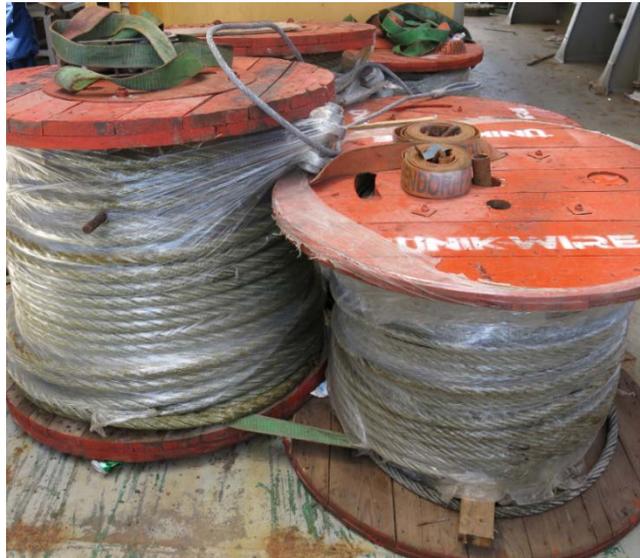
Coils of wire rope found on deck, photographed on July 9, 2015: at left, larger coil for the lifting wire; at right, smaller coil for the luffing wire.

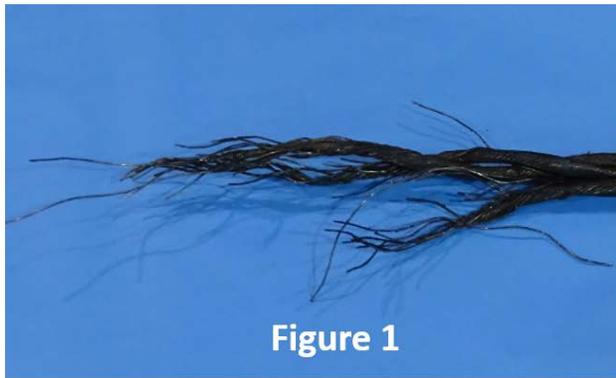
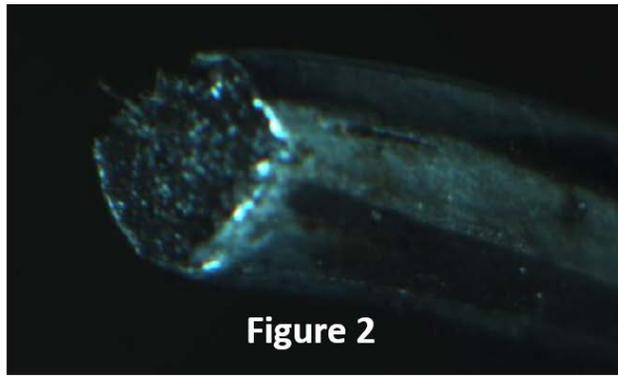
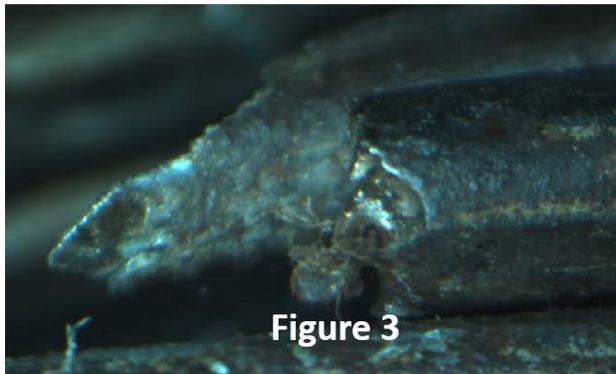
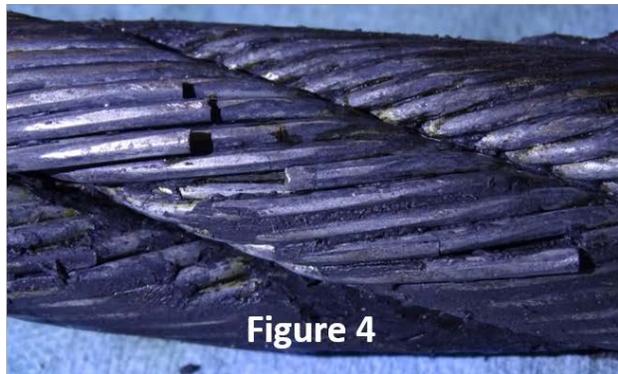
- The wire rope that failed showed signs of inadequate lubrication—that is, the lubricant applied was not distributed down into the inner wire surfaces. This [lack of lubrication] resulted in excessive wear on the wire contact surfaces, particularly those not near the surface where the lubricant was applied. The areas of excessive wear become centers of nucleation for cracks that propagated in the individual wire strands creating stress concentrations that lead to wire failures gradually reducing load capacity of the rope, until it failed on July 8, 2015.

- Examination of the free end of the failure (the end that was not pulled through the lifting block) verified that the interior surfaces of the wire-to-wire contact showed many signs of inner strand wear (exhibited by typical inner strand wear notches—flattened areas on the wire that become centers of failure initiation), and these locations were the places where the failure occurred.

- Further evidence of inadequate attention to maintenance of the wire rope was found in the condition of the wire rope surface in the working portion of the cable provided that had not been pulled through the lifting block components. The wire showed evidence of multiple broken surface strands at the maximum stress locations consistent with normal wear and tear that should have been observed as a part of a proper routine maintenance process. The surface failures are persuasive in the preserved wire rope and are evidence that the wire rope was near or beyond its recommended useful life.

S-E-A report captured the following images of the wire rope from crane no. 4: (1) the failed point of the free end of the wire rope; (2) the wire strand from the failed end indicating a tensile overload; (3) the outer-surface strand indicating fatigue failure; and (4) an area where the surface wire failures were found. (Photos courtesy of S-E-A)

The National Transportation Safety Board determines that the probable cause of the failure of the lifting wire rope of crane no. 4 on the bulk carrier *Asia Zircon II* was inadequate lubrication due to ineffective maintenance resulting in excessive wear of the wire rope.

- Inspection, maintenance, and management of wire ropes are essential to the prevention of accidents.
- A deteriorated wire rope directly affects the ability to safely and reliably handle loads up to the rated capacity of the crane.
- Crane operators, signalmen, riggers, safety observers, and crewmembers should adhere to manufacturer operating guidelines, design limitations, safety precautions, and inspection and maintenance procedures.
