# National Transportation Safety Board

## Marine Accident Brief

### Collision of Cargo Vessel *Ocean Freedom* with Tank Barges

<b>Accident no.</b>	DCA16FM003
<b>Vessel names</b>	<i>Ocean Freedom</i> and Kirby barges 28044, 29103, and 29125
<b>Accident type</b>	Collision
<b>Location</b>	Port of Corpus Christi, Texas 28°48.8' N, 97°24.7' W
<b>Date</b>	October 29, 2015
<b>Time</b>	2226 central standard time (coordinated universal time – 5 hours)
<b>Injuries</b>	Minor
<b>Property damage</b>	\$750,000 est.
<b>Environmental damage</b>	None reported
<b>Weather</b>	Visibility clear, winds southeast at 10–13 knots
<b>Waterway information</b>	Located in the western Gulf of Mexico, the Port of Corpus Christi has a main shipping channel maintained to a 45-foot depth. The inner harbor's main turning basin has a maximum width of 800 feet.

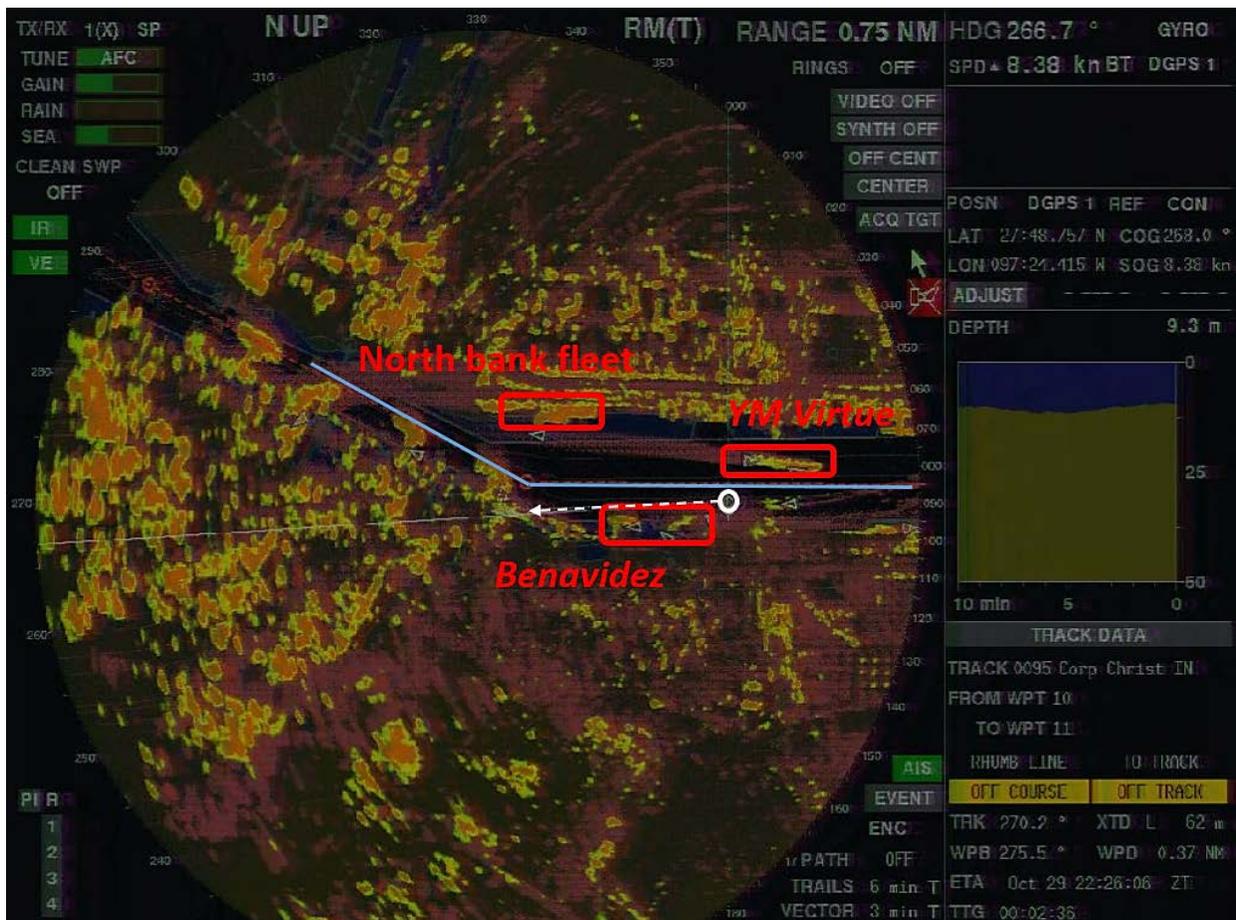
With the vessel's speed at about 6 knots, the pilot ordered full ahead at 2223, which was about the same time the *Ocean Freedom* passed the *YM Virtue*. Recognizing the *Ocean Freedom*'s position on the south side of the channel relative to the moored *Benavidez*, the pilot commented to the master, "I don't like the look of this," and went to the port bridge wing with the master to monitor their vessel's proximity to the *Benavidez*. From the bridge wing they looked aft to view the 459 feet (140 meters) of ship behind them. At 2224, the pilot ordered in quick succession, "Right ten," followed in seconds by "Right twenty," and then "Hard right." Both the third mate and the helmsman acknowledged the helm orders: the rudder was put to right. The pilot told investigators that his intention was to turn or "lift" the *Ocean Freedom*'s stern away from the *Benavidez*.

Radar image from the voyage data recorder of the *Ocean Freedom* at 2224 with all vessels indicated in red, the *Ocean Freedom* and its heading in white, and the intended track line in blue.

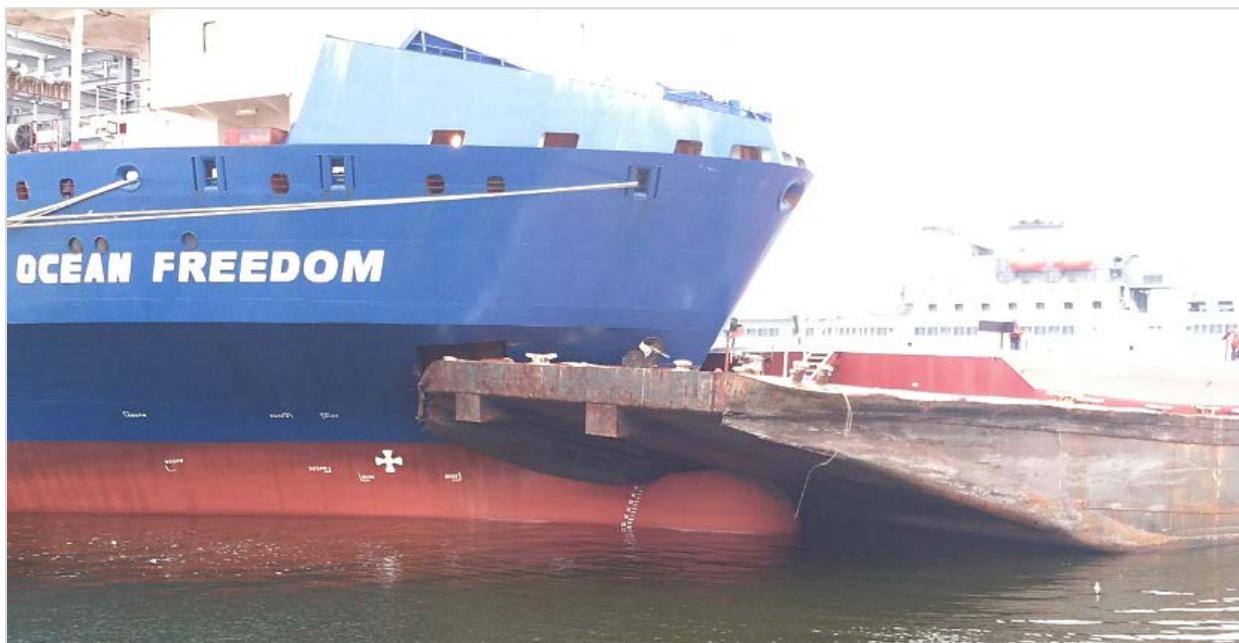
As the *Ocean Freedom* moved across the approximately 800-foot-wide channel at about 9 knots directly toward a fleet of tank barges moored to the north bank, the pilot ordered the sounding of five short blasts on the ship's whistle. Aware of the impending collision, he announced on VHF radio that there was an "emergency on the north bank" as the *Ocean Freedom* headed toward the barges. The crew on two tugboats tending the barges, the *Nueces* and the *Pecos*, having heard the whistle and radio calls, maneuvered clear of the *Ocean Freedom*. Just before 2226, the *Ocean Freedom*'s bow impacted the *Kirby 28044*, the outermost of the three moored tank barges, at about 8 knots on a heading of about 320 degrees. The barge's starboard bow was lodged between the stem and the bulbous bow of the *Ocean Freedom* just above the waterline.

Impaled by the bow of the *Ocean Freedom*, the starboard bow of the *Kirby 28044* is lodged just above the vessel's bulbous bow. In the background is the USNS *Benavidez*. (Photo by Coast Guard)

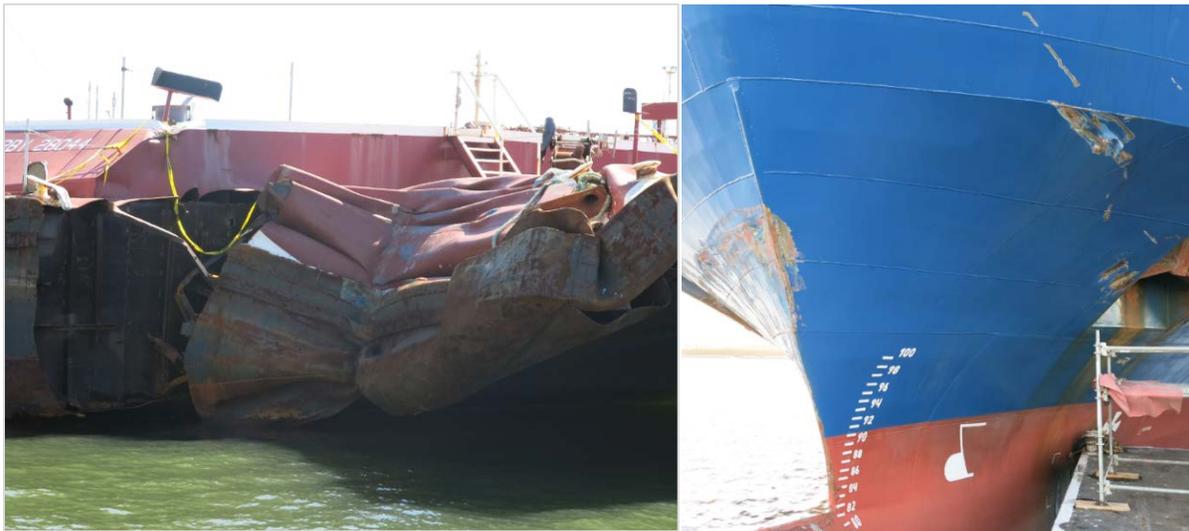
The *Kirby 28044* sustained damage to its starboard bow, causing penetrations, fractures, and cracks to its hull and inner tank. There was no report of fire or pollution; the barge, which was being prepared for a cargo of naphtha, was not loaded at the time of the accident. The two inner barges, *Kirby 29103* and *29125*, were also damaged, having sustained dents, scrapes, and fractures due to compression forces from the collision.

The *Ocean Freedom* incurred damage to its bow above the waterline, predominantly on the port side. There was a small penetration in the hull plating, with the remainder of the damage in the form of indentations and scrapes.

At left, damage to the starboard bow of the *Kirby 28044*. At right, damage to the port bow of the *Ocean Freedom*.
