# National Transportation Safety Board

## Marine Accident Brief

### Flooding and Sinking of Fishing Vessel *Capt. David*

<b>Accident no.</b>	DCA16PM026
<b>Vessel name</b>	<i>Capt. David</i>
<b>Accident type</b>	Flooding and sinking
<b>Location</b>	Atlantic Ocean, about 40 miles* east of Oregon Inlet, North Carolina 35°44.2' N, 74°42.5' W
<b>Date</b>	February 15, 2016
<b>Time</b>	About 1440 eastern standard time (coordinated universal time – 5 hours)
<b>Injuries</b>	None
<b>Property damage</b>	Loss of vessel and catch, \$68,000 est.
<b>Environmental damage</b>	None reported
<b>Weather</b>	Broken to overcast cloud cover, fog with visibility of about 1.5 miles, south-southwest winds 20–30 knots with gusts to 35 knots, air temperature about 54°F, water temperature about 50°F, seas 8–10 feet
<b>Waterway information</b>	Atlantic Ocean along the western edge of the Gulf Stream above the continental shelf

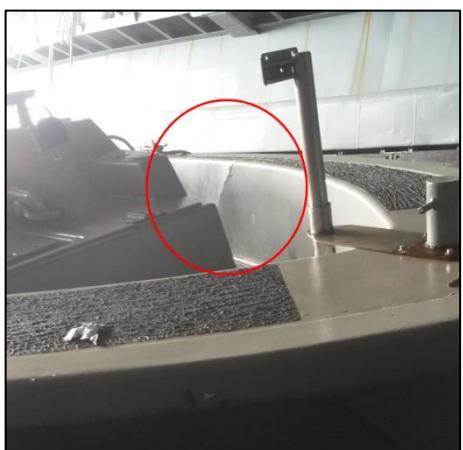
Severe hull crack on MPL11 port inboard wall, circled in red.

Severe damage—a continuous fiberglass hull crack running from the outboard gunwale edge down to the inboard deck—was noted on the port side of the bow cockpit. Investigators were provided video footage of the PL re-entering the well deck upon return to the *Carter Hall* that showed the PL's port side impact against the ship's steel well deck bulkhead, accompanied by an audible bang. Interviews

of the boat crew indicate this heavy contact was the event that caused the portside hull damage, which subsequently required the PL to be removed from service for repair.

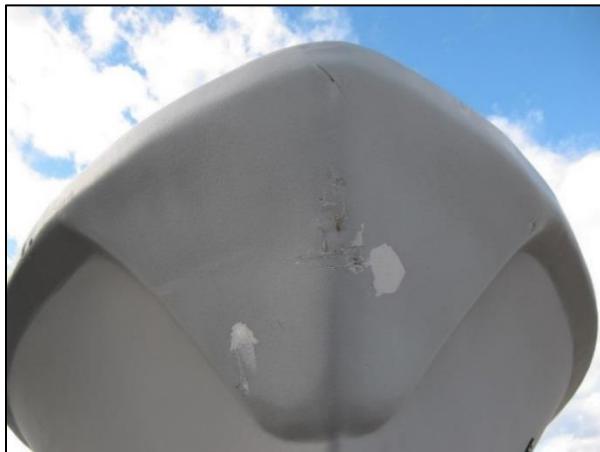
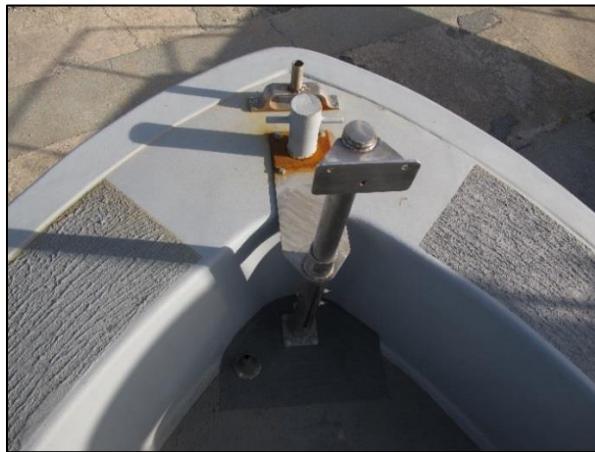
**Postaccident inspection of the PL showed a scratch, some scuffing, small patches of paint loss, and some darker material transfer on stem (left). Padded foam, integrated onto the hull, protects the upper portion of the stem and gunwales. The gunwale and topside of bow area of the PL (right) had no visible signs of severe damage.**

Additional exterior damage was limited to scuffing along the gunwales, small patches of paint loss, paint cracking, and a few deeper gouges along the sides below the gunwales that penetrated the paint coating but did not damage the fiberglass hull.

The examination of the PL hull did not resolve the discrepancy between the descriptions of the severity of the contact provided by the crews of both vessels. The examination found damage that could be attributed to the well deck wall impact, the well deck bottom contact, and the davit hook hitting the bow during launch. However, no clear evidence of bow damage from contact with the *Capt. David* was observed. The absence of severe damage in the bow area may be explained by noting that, although the build material (fiberglass) and displacement of both vessels were similar, a vessel’s stem and bow area is built stronger and therefore more likely to damage a less reinforced area when contacting another hull.
