National Transportation Safety Board

Marine Accident Brief

Allision of Kodiak Tow with North Landing Bridge

Accident no.	DCA16FM028
Vessel names	<i>Kodiak</i> and barge <i>SJ-199</i>
Accident type	Allision
Location	North Landing River at mile marker 20.2, Intracoastal Waterway; Chesapeake, Virginia 36°43'3.11" N, 76°6'0.04" W
Date	March 1, 2016
Time	About 0322 eastern standard time (coordinated universal time – 5 hours)
Injuries	None
Property damage	\$275,000 est.
Environmental damage	None
Weather	Clear visibility 10 miles, winds calm, air temperature 39°F
Waterway information	The North Landing River extends in a northerly direction from Currituck Sound at the North Carolina border. The river is part of the Intracoastal Waterway that connects Albemarle Sound with the Elizabeth River in Portsmouth, Virginia, and has a controlling depth of 9 feet. It measures 80 yards wide at the North Landing Bridge.

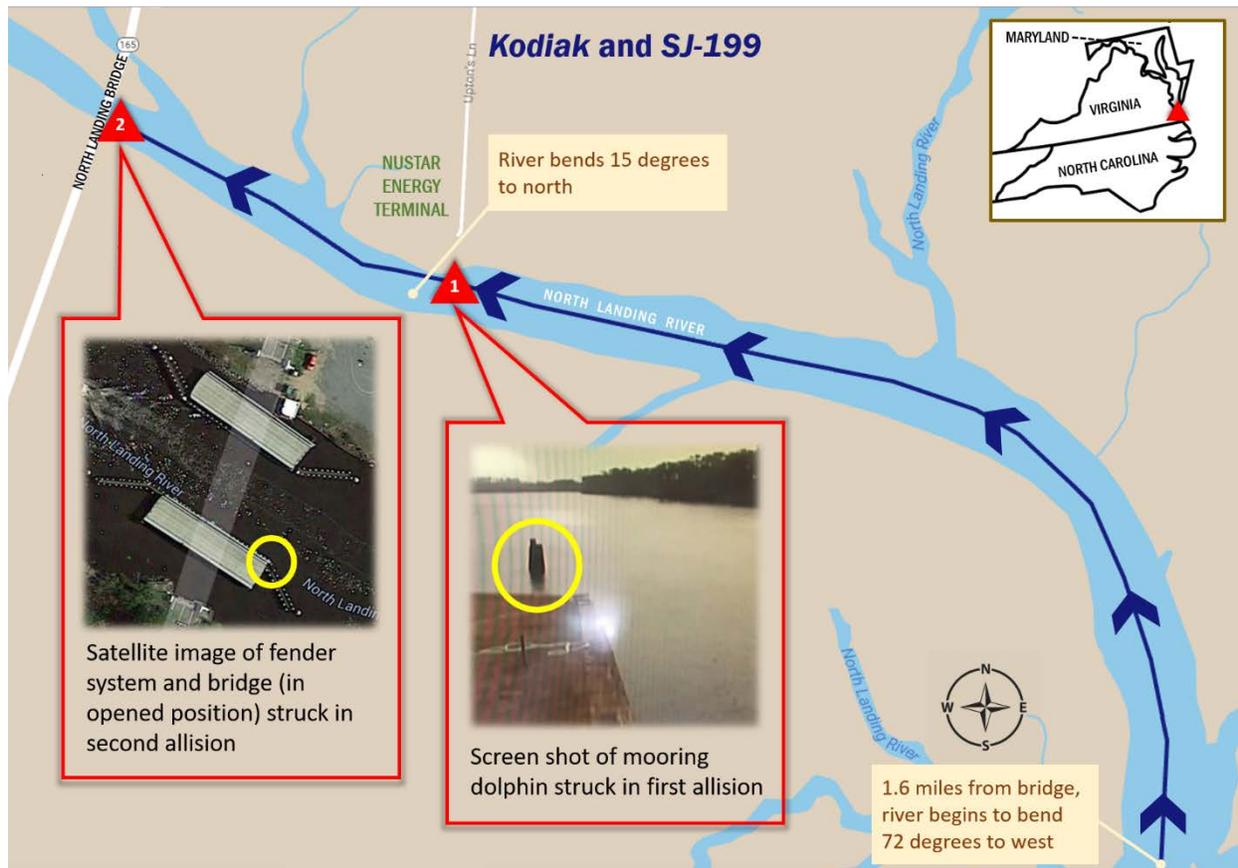
Accident site where *Kodiak* tow allided, first, with the mooring dolphin and, second, with the bridge. (Background and satellite image by Google Maps; screen shot courtesy of US Coast Guard)

At a distance of 750 yards from the bridge, the *Kodiak* tow struck and knocked down a mooring dolphin that was just east of the NuStar Energy terminal dock, which ran parallel with the shore on the north side of the river. From that position, on the starboard side of the river, the mate had to steer through the 15-degree bend and then line up the tow to proceed through the 80-foot-wide horizontal opening of the North Landing Bridge. He told investigators that he tried to slow the barge by placing the *Kodiak*'s engines in neutral.

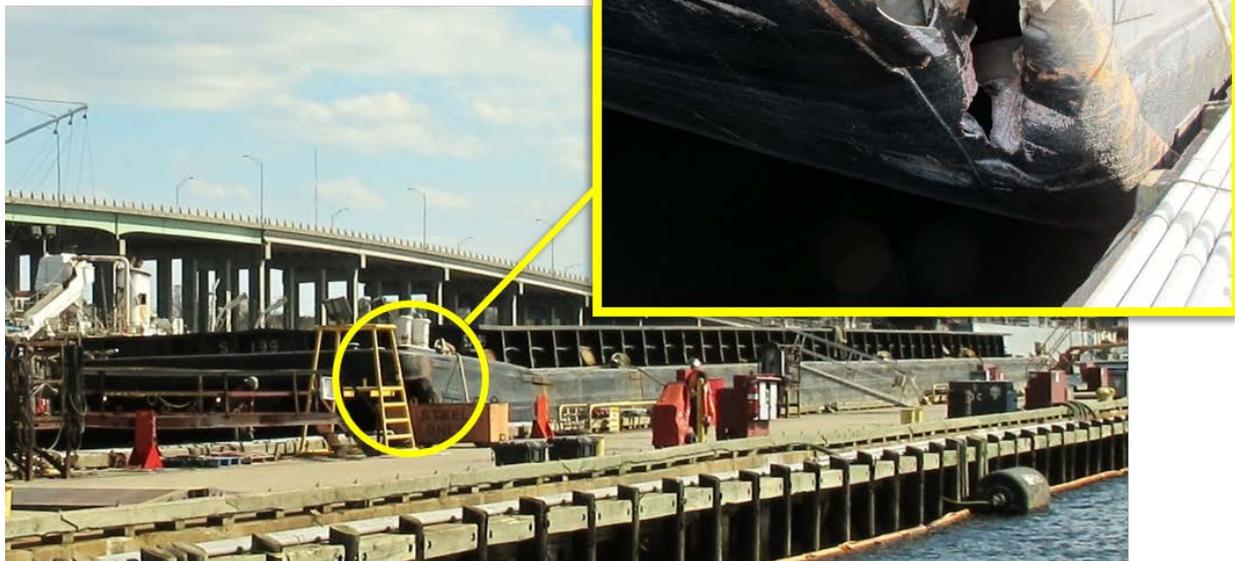
Feeling the contact from the allision, the captain awoke and came to the bridge to assess the damage. He told investigators that he heard the mate talking to the bridge tender via radio, recalling, “Said he [the mate] hit something on bottom and had to realign barge to come through bridge.” The mate told the captain that he thought he struck an underwater object. Because it was dark, the mate did not notice any damage to the fender system and therefore did not bother using the *Kodiak*’s searchlight to look for damage. Also, because the damage was below the main deck, the deckhand on the bow and the bridge tender could not see the penetration at the corner of the rake on the port side of the *SJ-199*.

Barge *SJ-199* docked at the repair yard.

Damage totaled an estimated \$25,000 for the hole the barge sustained in the port corner of the rake and an estimated \$250,000 for the damage to the bridge’s fender, structure, and gears on the south side.

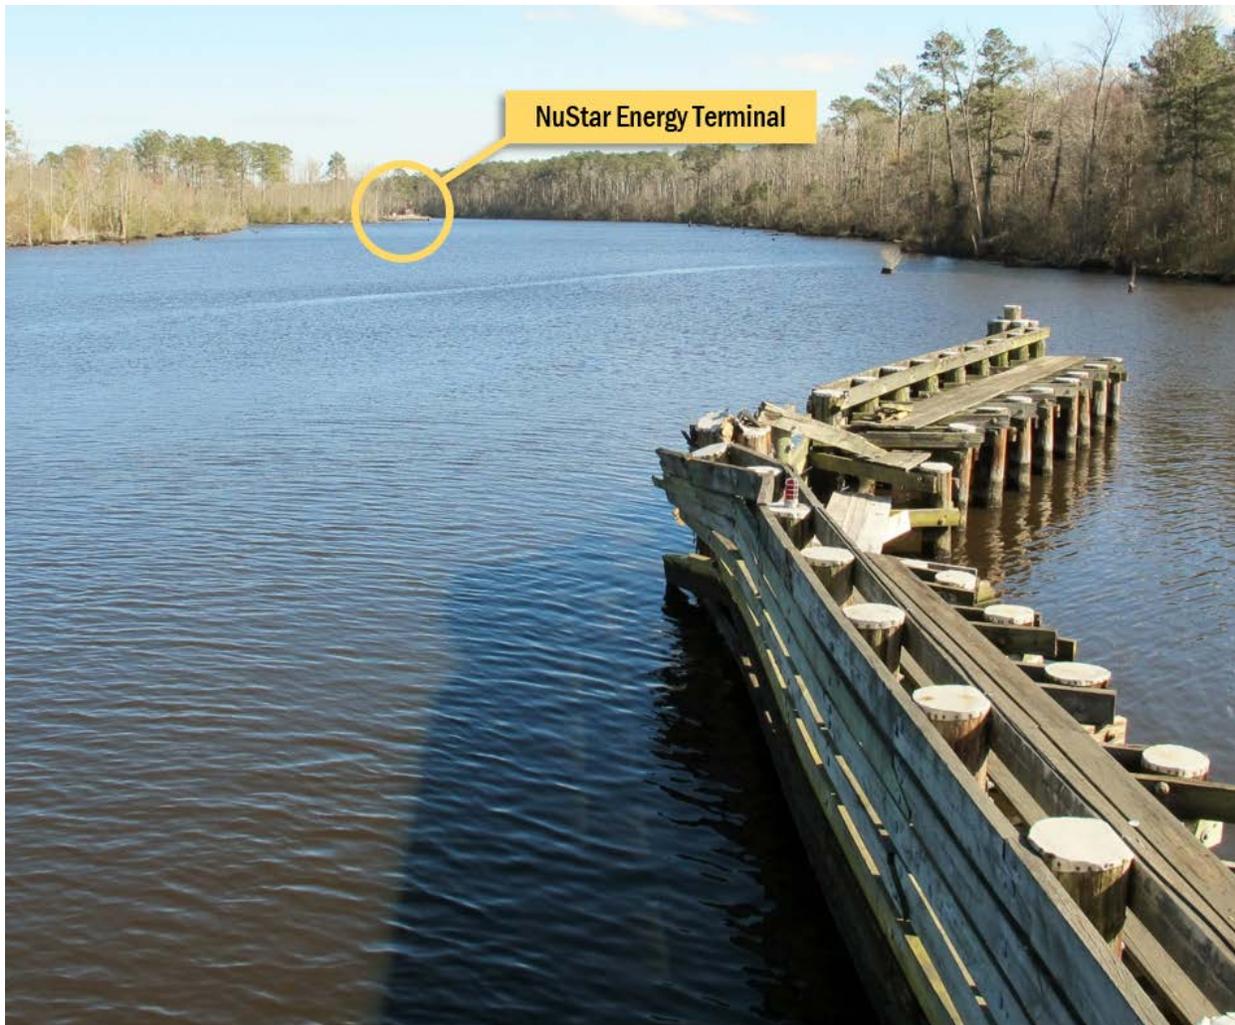
However, while approaching the opened swing bridge, the port side of the *SJ-199* struck the south side of the bridge fender system and the corner of the bridge positioned above the fender system. The mate estimated the barge struck the bridge at a speed of 1.5 knots (1.73 mph).

Damage to the southside fender of the North Landing Bridge.
