National Transportation Safety Board

Marine Accident Brief

Capsizing and Sinking of Fishing Vessel *Lydia & Maya*

Accident no.	DCA16FM053
Vessel name	<i>Lydia & Maya</i>
Accident type	Capsizing and sinking
Location	Jordan Basin, Gulf of Maine, about 45 miles south-southeast of Bar Harbor, Maine 43°35.0' N, 068°04.7' W
Date	August 17, 2016
Time	0008 eastern daylight time (coordinated universal time – 4 hours)
Injuries	None
Property damage	\$600,000 est.
Environmental damage	Approximately 100-yard-by-300-yard oil sheen observed
Weather	Overcast skies and rain, visibility at 1.6 miles, winds southerly at 23 knots with gusts up to 27 knots, waves 4 feet high with swells 8 feet high, air temperature 69°F, water temperature 66°F
Waterway information	Open waters in the Gulf of Maine, Atlantic Ocean

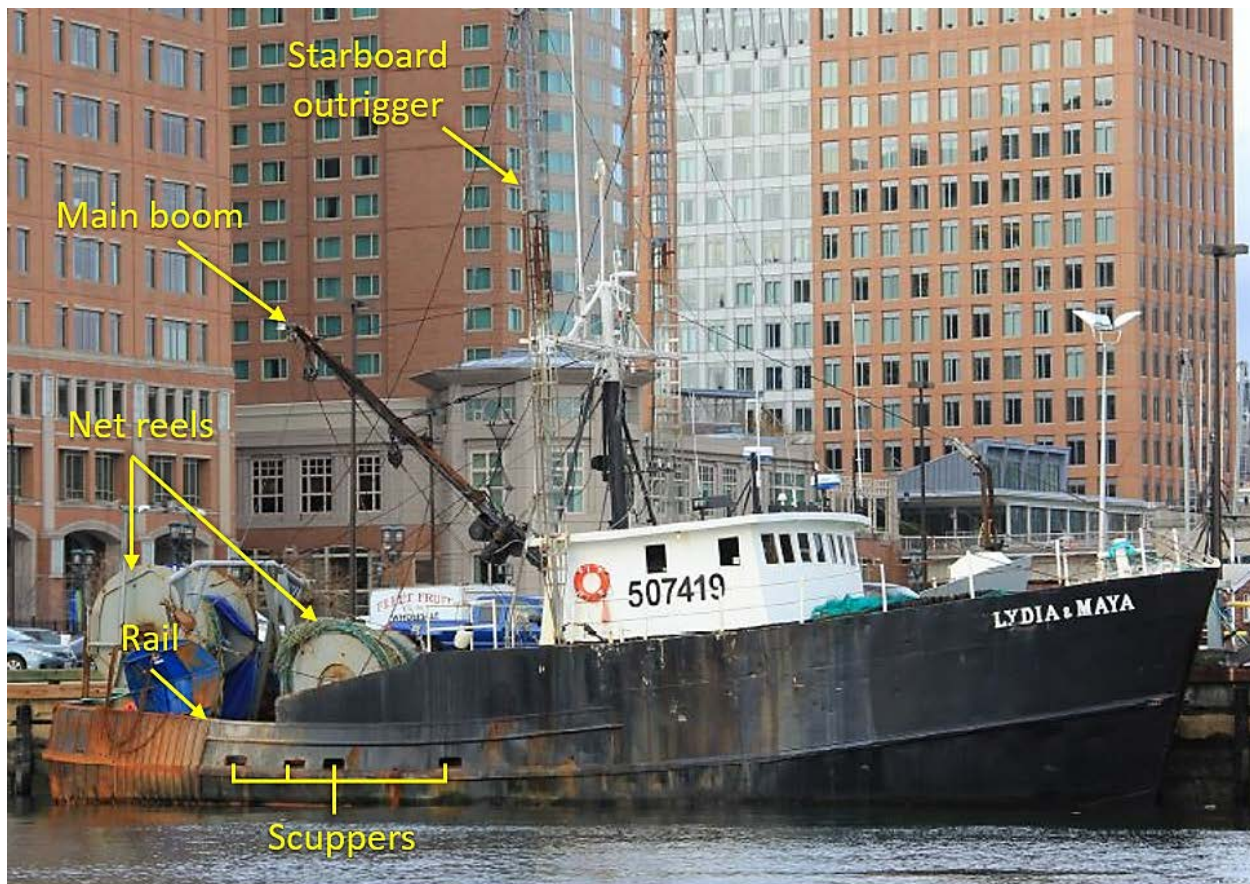
Main boom and net reels on the *Lydia & Maya* as well as the starboard outrigger, rail, and scuppers. (Photo by Coast Guard)

Deckhand no. 1 also observed that the starboard outrigger that was left in the deployed position over the starboard side of the vessel was submerged. Additionally, the main boom, which had been supporting the last catch of fish in the net, had snapped and was swinging. The boom breaking was likely the noise he heard while navigating the vessel. Deckhand no. 2 believed that the net and contents had fallen onto the main deck; he recalled seeing a deckhand trying to cut open the net with a knife to “bleed” the fish from the bag. Conversely, deckhand no. 1 believed that the contents of the net had fallen overboard.

- 2) *Blocking the scuppers on the stern of the vessel while transiting,* which prevented accumulating water from draining overboard. A deck filled with water creates an undesirable free surface effect, while the weight of the additional water increases the height of the vessel's center of gravity and decreases its freeboard, consequently reducing the vessel's overall stability.⁴ Additionally, high water on deck may begin flooding the vessel through non-watertight hatches and doors, which are often left open.

- 3) *Breaking of the center boom,* which resulted in the 7,000 pounds of fish in the net likely falling onto the starboard side of the main deck. These events likely shifted the vessel's center of gravity to starboard, considering that a starboard list was reported.

Fishing vessel operators should ensure that suspended loads are not left unattended but are lowered to the deck and properly secured before transiting. Operators should also ensure that all scuppers (freeing ports) in the bulwarks are kept clear for rapid draining of water on deck. A deck filled with water creates an undesirable free surface effect, while the weight of the additional water increases the height of the vessel's center of gravity and decreases its freeboard, consequently reducing the vessel's overall stability.

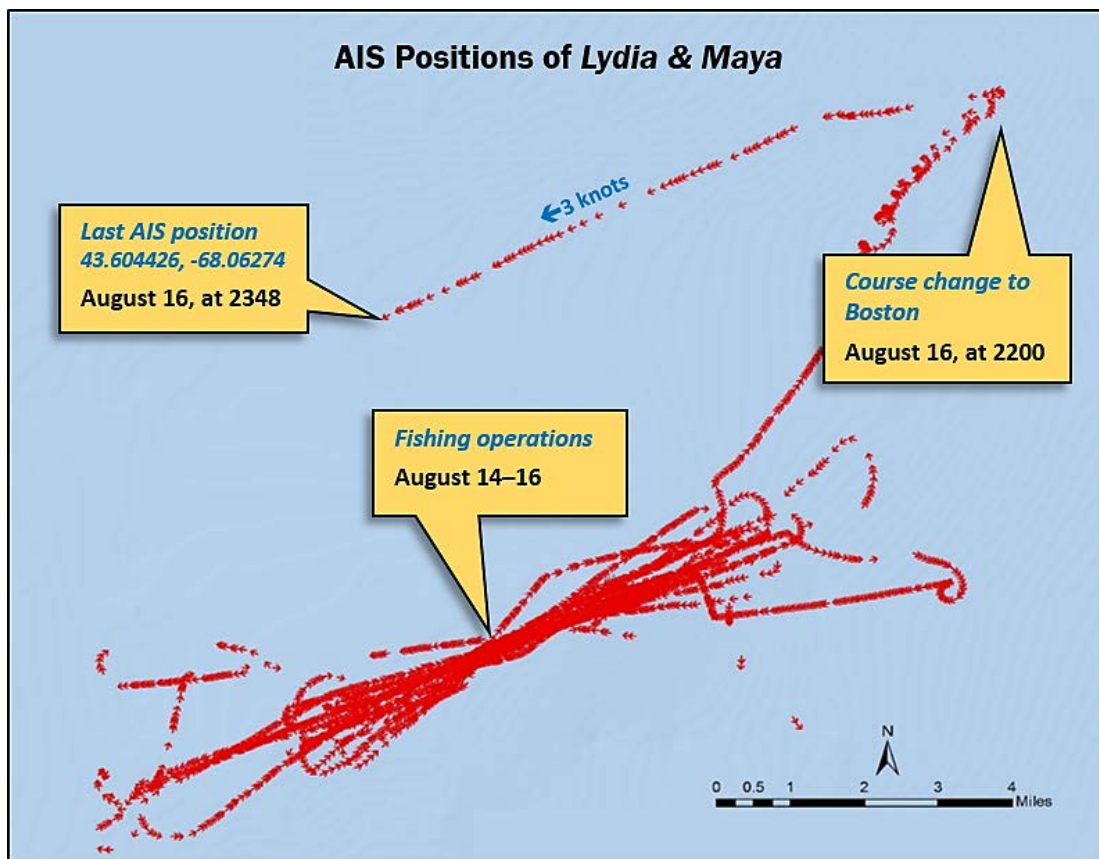
Automatic identification system (AIS) data of *Lydia & Maya*'s trackline during the accident voyage, as reported by the Coast Guard's Navigation Center (NAVCEN).
