National Transportation Safety Board

Marine Accident Brief

Allision of *Peter F Gellatly* Tow with IMTT Bayonne Pier A

Accident no.	DCA15LM030
Vessel names	<i>Peter F Gellatly</i> , Double Skin 501
Accident type	Allision
Location	New York Harbor, Kill Van Kull waterway at IMTT Bayonne Pier A, Bayonne, New Jersey
Date	August 1, 2015
Time	2147 eastern daylight time (coordinated universal time – 4 hours)
Injuries	None
Property damage	\$2.7 million est.
Environmental damage	630 gallons of no. 6 fuel oil released into the waterway
Weather	Partly cloudy, visibility 10 miles, winds west at 8.1 mph, air temperature 80°F
Waterway information	Kill Van Kull separates the southern shore of the city of Bayonne, New Jersey, from Staten Island, New York, and connects the Upper Bay of New York Harbor with Newark Bay and Arthur Kill. Kill Van Kull is a major channel for container, petroleum, and bulk cargo in New York Harbor and has extensive through-traffic.

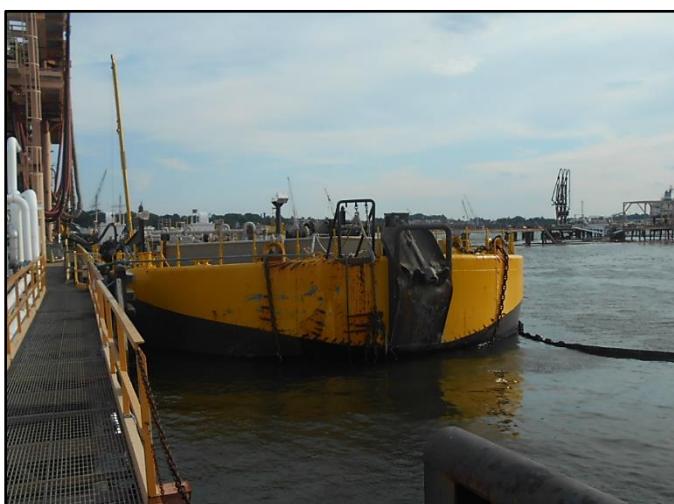
Double Skin 501 moored at IMTT Bayonne Pier 1 after the accident. (Photo by US Coast Guard)

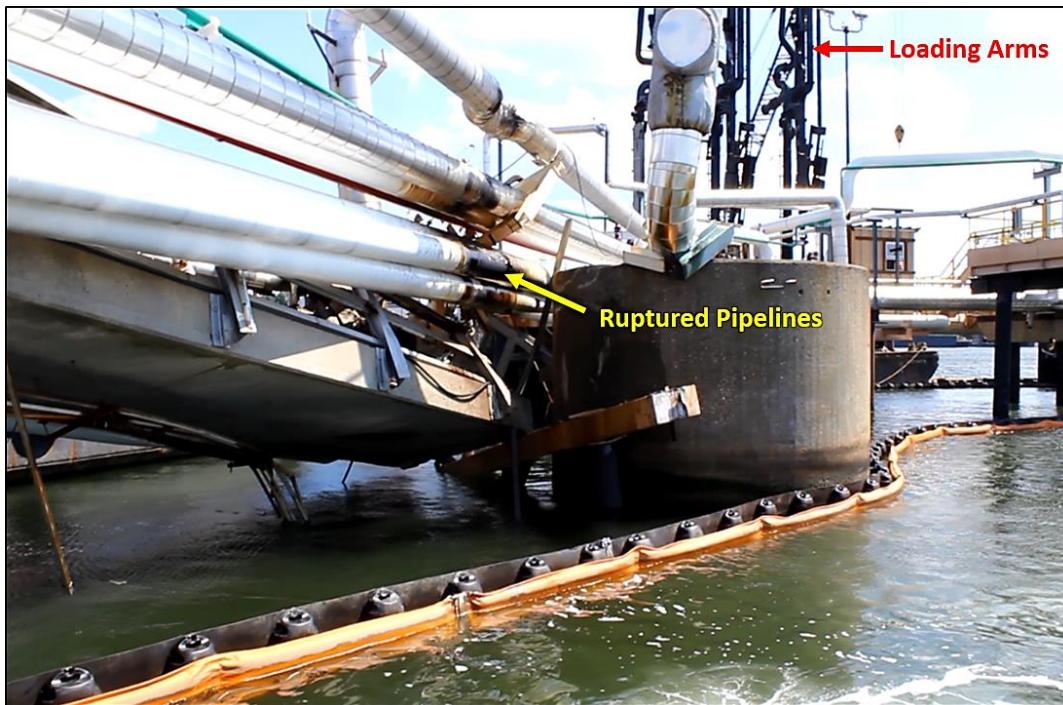
Damaged pipelines leading to loading arms on IMTT Bayonne Pier A.

The force of the allision caused pipelines on the west side of the pier to rupture, with one of the ruptured pipelines discharging 630 gallons of no. 6 oil into Kill Van Kull. Damage to the pier, catwalk, and pipelines totaled about \$2.7 million. Repairs to the *Double Skin 501* foremast, which toppled when it struck the *Isola Bianca* mooring lines, totaled \$10,000. The *Peter F Gellatly* was undamaged.

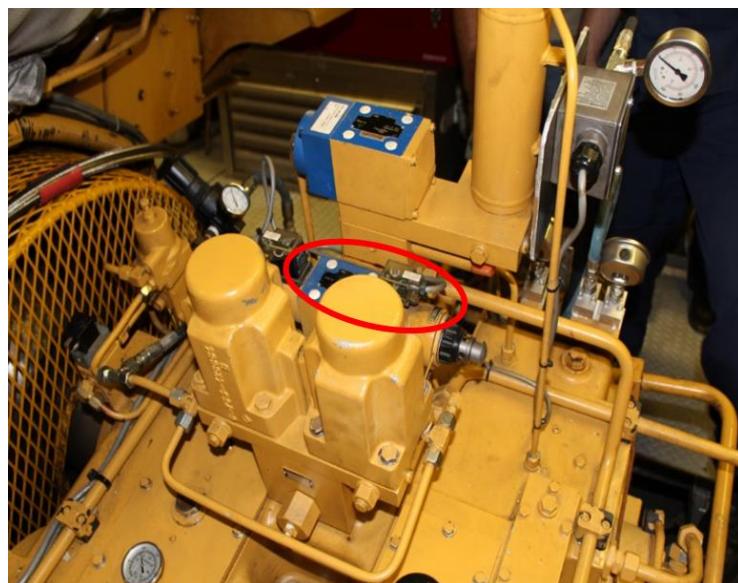
After the accident, technicians examined the *Peter F Gellatly*'s reduction gear mechanisms and electronic control systems and found loose wires on the astern connector for the electronic selector valve solenoid on the starboard marine gear unit. The company concluded that the loose wires caused a mechanical failure of the shift solenoid. The technicians found no other indications of mechanical failure that contributed to the locking or jamming of the selector valve that held the transmission in the ahead position. Several anomalous issues were noted during test operations of the control system, resulting in the technicians recommending replacement of the logic processor in the control system.

Reintjes starboard engine reduction gearbox. The astern wiring harness on the electronic selector valve solenoid had loose 12-volt wires at the terminal connection, circled in red.
