# National Transportation Safety Board

## Marine Accident Brief

### Fire aboard Towing Vessel *Jaxon Aaron*

<b>Accident no.</b>	DCA16FM050
<b>Vessel name</b>	<i>Jaxon Aaron</i>
<b>Accident type</b>	Fire
<b>Location</b>	Lower Mississippi River, mile marker (mm) 770, north of Memphis, Tennessee 35°31.352' N, 089°56.654' W
<b>Date</b>	August 13, 2016
<b>Time</b>	About 1140 central daylight time (coordinated universal time – 5 hours)
<b>Injuries</b>	None
<b>Property damage</b>	\$10.2 million est.
<b>Environmental damage</b>	None
<b>Weather</b>	Mostly cloudy, visibility at 10 miles, winds south at 12.7 mph, air temperature 86°F
<b>Waterway information</b>	The river stage near mm 770 on the Lower Mississippi River was 8 feet and falling.

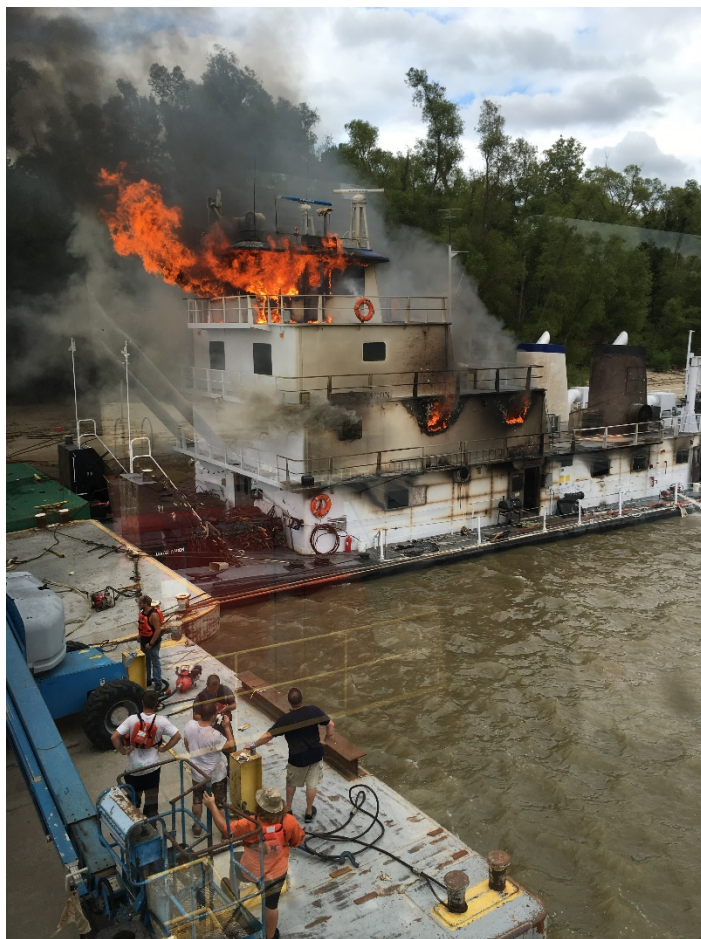
*Jaxon Aaron* on the right descending bank during the firefighting effort. (Photo by *Joe Ellis* crewmember)

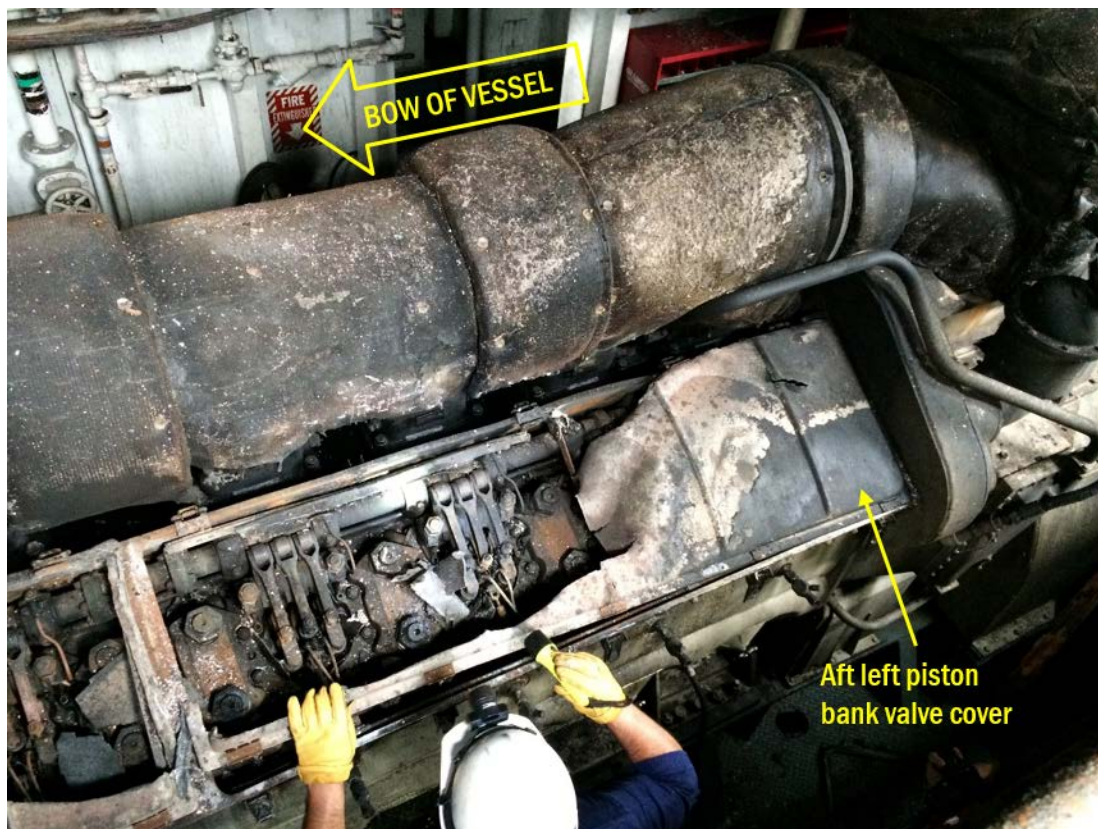
Although the spring toggles on the aft left piston bank valve cover held the cover in place at the time the no. 15 power assembly components failed, the cover surface itself was damaged from the fire, allowing lube oil to spray on the exhaust manifold. However, the explosion cover located on the lower side of the crankcase for the no. 15 cylinder showed no damage or signs of oil spray.

**Damage discovered during the post-fire forensics examination to the left bank, rocker cover, and cylinder heads on the port main diesel engine.**

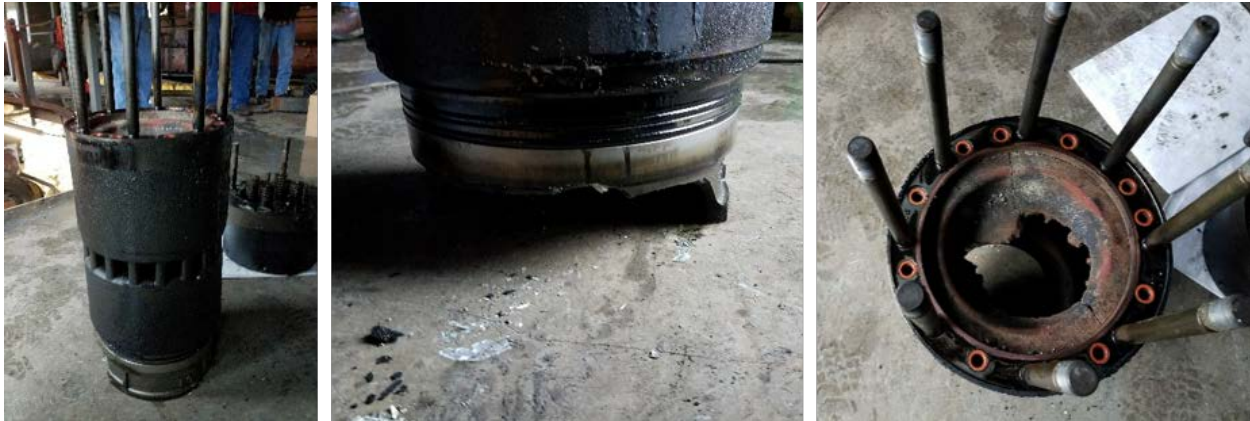
The cause of the fire was determined to be a catastrophic failure of components of the no. 15 power assembly or “power pack” on the port main diesel engine. As with most other large internal combustion engines used in marine or other industrial services, this engine was designed to allow replacement of the cylinder head assembly, cylinder liner, piston, piston rings, and piston rod without removal of the entire engine. These parts were pre-assembled into a power pack unit, which then could be removed or installed during a maintenance period. When the no. 15 power assembly was removed from the main diesel engine of the *Jaxon Aaron* after the fire, severe damage was found in the cylinder head and the lower casing.

The engine had approximately 9,100 hours of service since the last replacement, which took place during the overhaul before the vessel was placed back into service by the new owner. Although a detailed metallurgical failure analysis of the no. 15 power pack assembly components was not performed, investigators requested that the owner arrange for an independent laboratory to perform an oil sample analysis on the lube oil from the port main diesel engine. The results from this analysis indicated that there was a “marginally high” level of water contamination in the engine’s lubricant.

Low levels of water contamination are normally found in an engine’s lubrication, but high levels of contamination are troubling, as water accelerates internal corrosion of metal components and oxidation of the oil, which decreases the oil’s lubricating performance and effectiveness. Investigators could not determine whether water was introduced into the lubrication system during the firefighting effort or possibly as a consequence of an internal coolant leak into the no. 15 cylinder during operation. The leak would have resulted in a condition known as hydrostatic lock, or hydrolock, in which the piston, designed to compress gases, cannot compress the liquid coolant introduced into the combustion chamber and thereby a catastrophic failure ensues. The port engineer stated to investigators that the company did not have a program for scheduled lube oil sampling and analysis for the vessels in the fleet but did check periodically the lubrication oils for fuel oil

From left to right: (1) the power assembly of the no. 15 cylinder removed from the port main diesel engine, with the cylinder head and cylinder liner separated; (2) damage discovered to the lower casing of the assembly base; (3) the damaged cylinder head. (Photos by US Coast Guard)

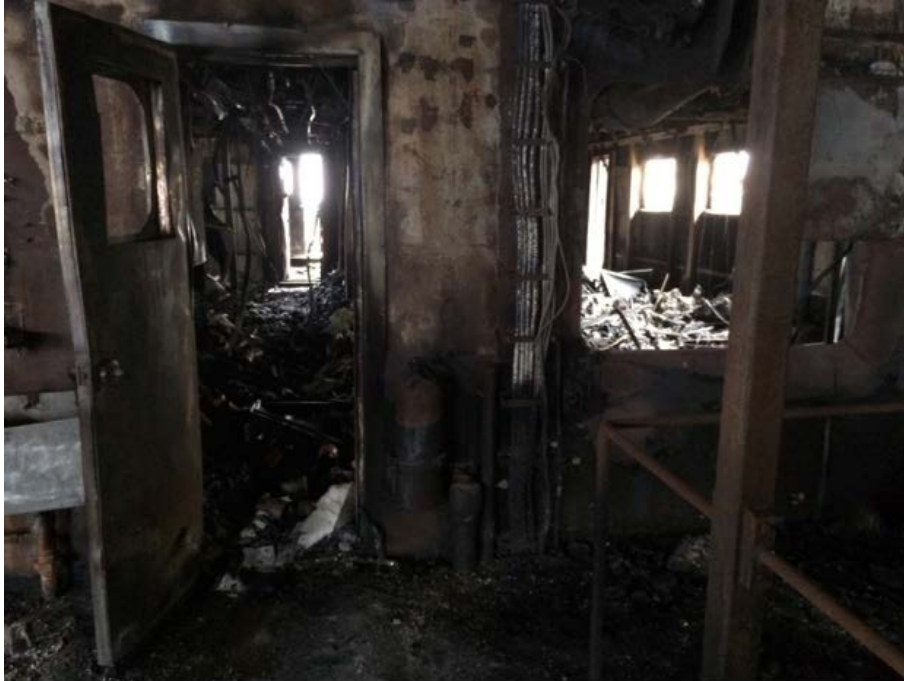
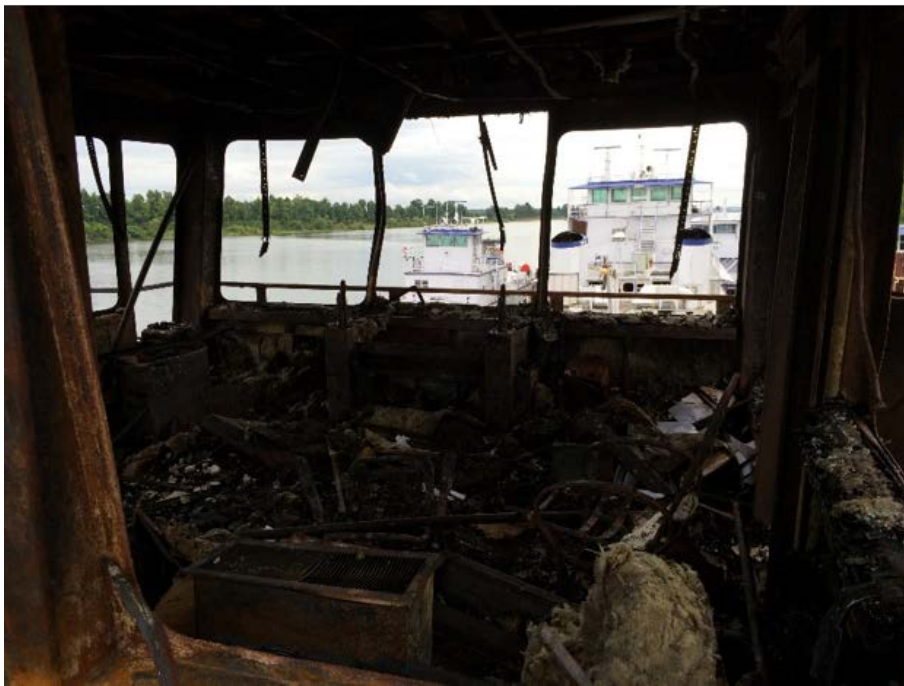
Based on the fire-pattern analysis, the fire likely migrated rapidly up the port exhaust stack and into the overhead of the engine room, where it damaged the electrical wiring between both generators and the main switchboard causing the loss of power. Because the common bulkhead between the aft portion of the accommodation space and the forward portion of the engine room did not provide any significant structural fire protection, the heat and flame migrated into the chief engineer's stateroom and then into the hallway just forward of the engine room. The furnishings and wood materials used in the interior areas of the *Jaxon Aaron* served as a fuel source supporting a significant and rapid growth of the fire, which migrated forward and upward through the accommodation spaces and into the wheelhouse.

Fire damage to the *Jaxon Aaron*. At top, looking forward through both the stainless-steel door in the engine room and the opening where the window was located in the bulkhead between the chief engineer's stateroom on the main deck and the forward portion. At bottom, looking forward into the wheelhouse.

Furthermore, the vessel was not equipped with closure mechanisms or dampers in the engine room's air intake and exhaust ventilation ducts. These dampers were not required by regulation at the time of the fire. Not only did the lack of dampers or closure mechanisms in the engine room allow the fire an unlimited supply of oxygen during its early phase, but the significant combustible load in the interior areas of the vessel served as a fuel source once that initial flame and heat penetrated the forward engine room bulkhead.
