National Transportation Safety Board

Marine Accident Brief

Flooding and Sinking of Fishing Vessel *Alaska Juris*

Accident no.	DCA16FM047
Vessel name	<i>Alaska Juris</i>
Accident type	Flooding and sinking
Location	Bering Sea, about 160 miles* west of Adak, Alaska 52°32.0' N, 178°41.0' E
Date	July 26, 2016
Time	About 1130 Alaska daylight time (coordinated universal time – 8 hours)
Injuries	None
Property damage	\$4.3 million est.
Environmental damage	Approximately 87,000 gallons of diesel fuel and lubricants
Weather	Poor visibility, fog, light winds at 10 knots, slight seas with swells 3–4 feet, air temperature 45°F, sea temperature 49°F
Waterway information	The Bering Sea is north of the Aleutian Islands, which form an island chain in the north Pacific Ocean.

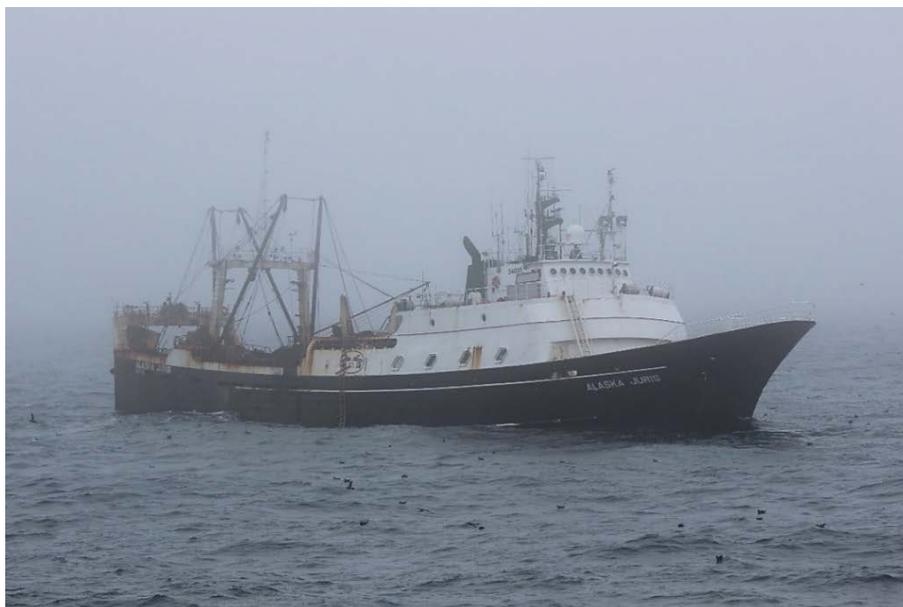
Alaska Juris, abandoned on the day of the sinking. (Photo courtesy of US Coast Guard)

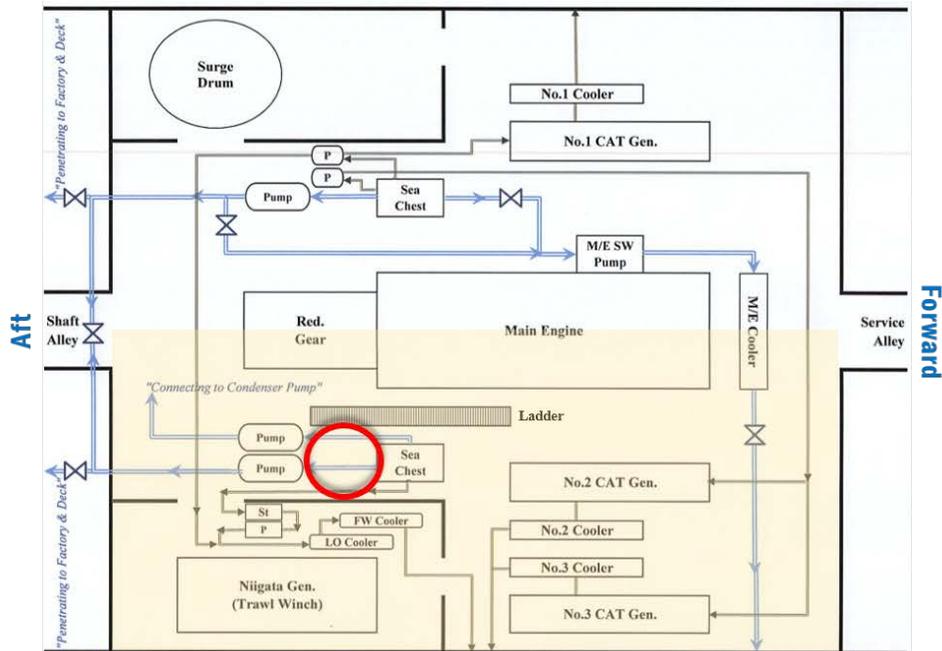
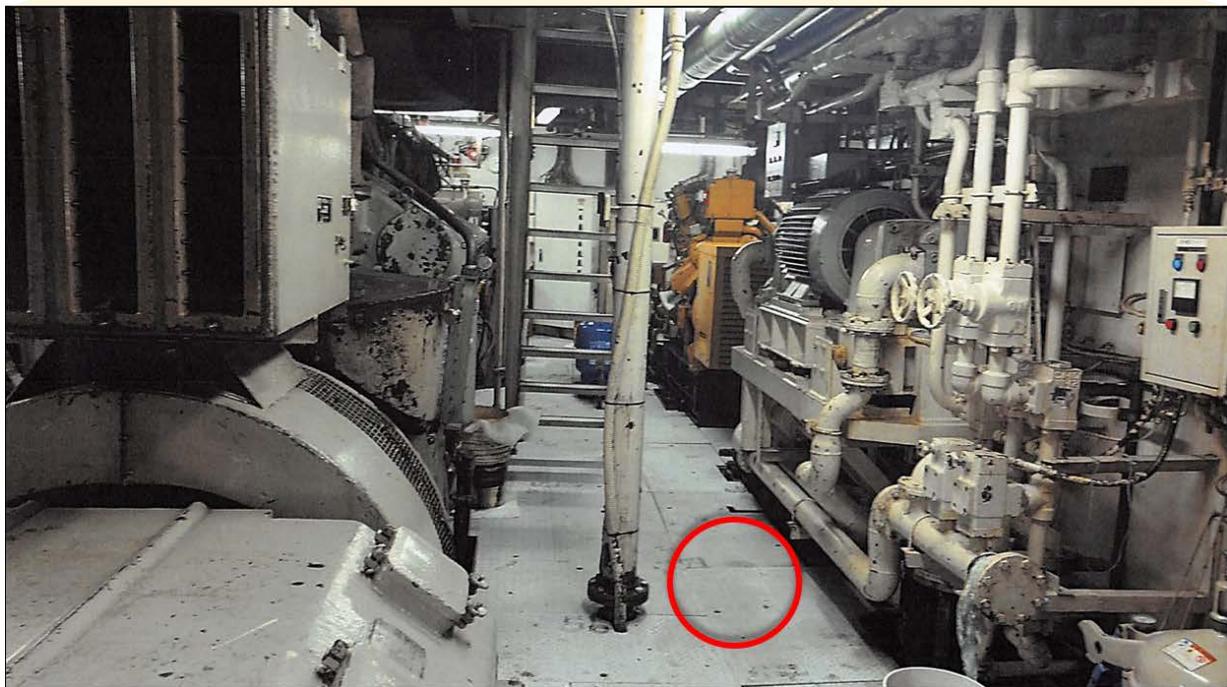
According to the Japanese technician, the water was “spurting up” from under the aft portion of the starboard generator and displacing the deck plates. Although the water was approximately 5 feet above the bottom of the center of the bilge, no bilge alarm had sounded. Based on the description and height of the water, at least four bilge alarms should have been activated throughout the lower engine room.

Location in the lower engine room (in photo, looking forward) where water was observed “spurting up” under the starboard generator and displacing the deck plates. (Diagram courtesy of Fishing Company of Alaska; photo by M. Shackelford)

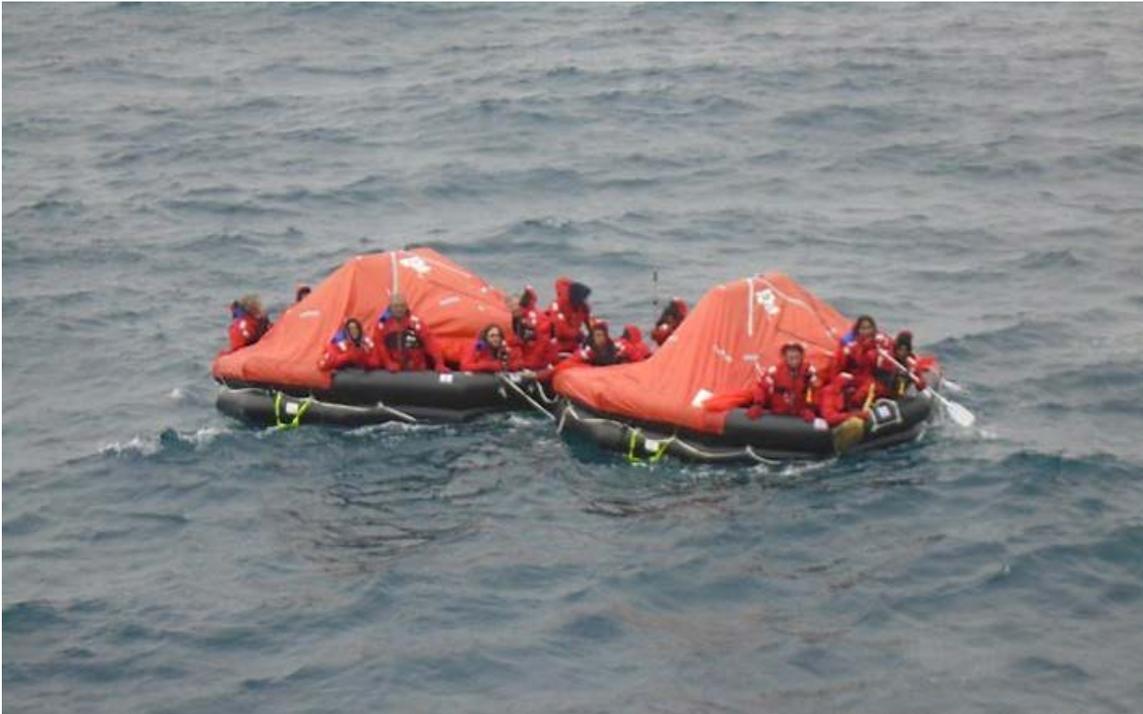
The crew in the liferaft on the starboard side attempted to join the other liferafts on the port side but the wind and current caused it to drift away from the vessel faster than the crewmembers could paddle. At that point, the captain abandoned the vessel and entered one of the liferafts on the port side.

Two of *Alaska Juris*'s liferafts with a total of 28 crewmembers aboard. A third liferaft with the other 18 crewmembers had drifted away after being deployed from the starboard side of the vessel. (Photo courtesy of bulk carrier *Spar Canis*)

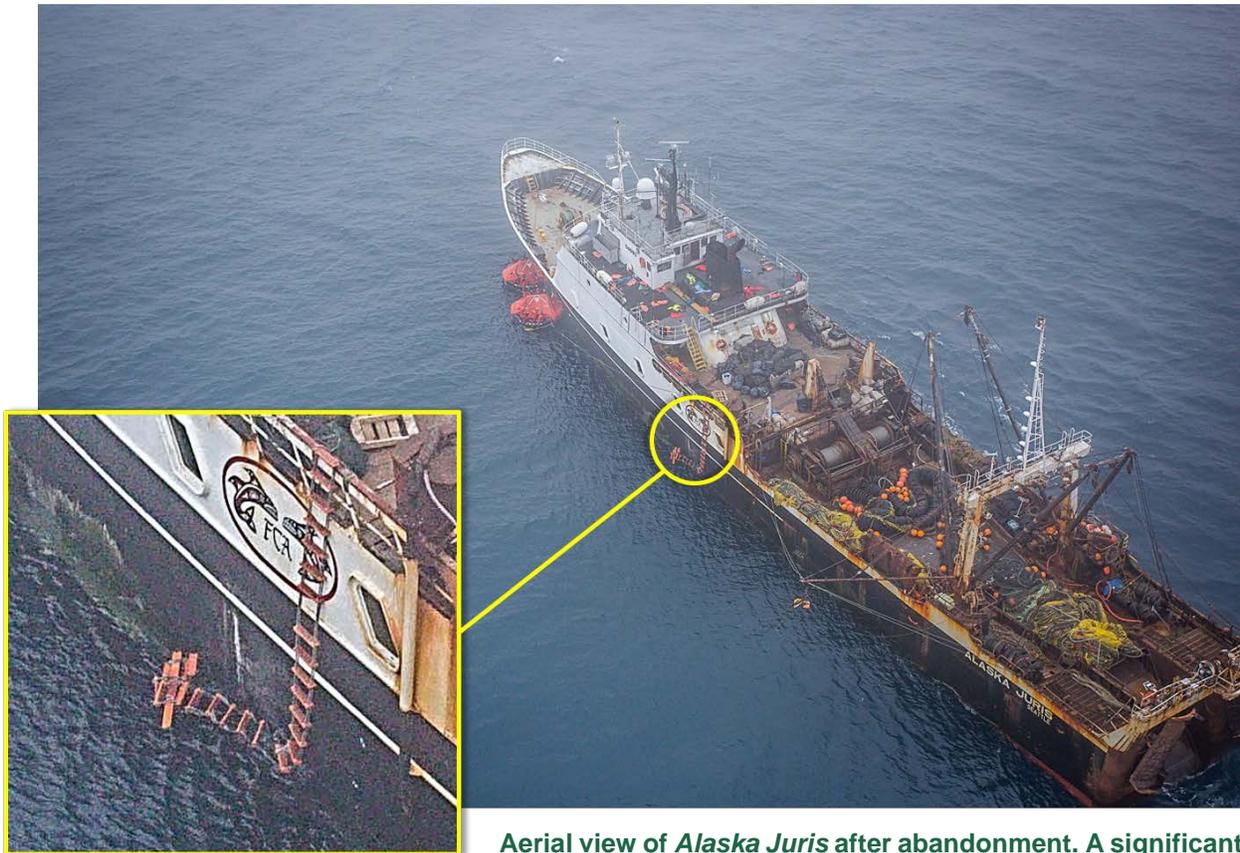
Third, after everyone had donned immersion suits, the embarkation ladders to the liferafts were not deployed properly. The liferafts were cradled on the wheelhouse deck at the embarkation area in accordance with the vessel's safety plan. However, the ladders were deployed from the deck below, where they were tied to the rail for the crew to disembark. As a result, crewmembers had to climb over the rail to disembark and, instead of just the bottom of the ladder touching the

water's surface as intended, about 10 rungs of the ladder and the spreader were in the water. The spreader, also known as the "preventer," is a longer rung designed to lay against the vessel's side and prevent the ladder from twisting. An overhead photo of the *Alaska Juris* shows the spreader floating in the water on the port side. Moving the ladders from their designated position to the lower deck shortened the climb into the raft, but with the wave action against the hull it added a degree of difficulty for crewmembers climbing over the rail and down the ladders in immersion suits. Further, it could have added the risk of the lower portion of the ladder damaging or puncturing the liferaft.

Aerial view of *Alaska Juris* after abandonment. A significant portion of the embarkation ladder that was improperly deployed over the port rail floats alongside the hull in the water. (Photo by Coast Guard)

- Update liferaft assignment sheets after crew changes.
- Ensure that crewmembers have access to properly sized immersion or exposure suits.
- Train crewmembers on proper use of all lifesaving and survival gear, including ladders, liferafts, and sea painters (lines).
