National Transportation Safety Board

Marine Accident Brief

Grounding and Subsequent Breakup of Small Passenger Vessel *Spirit of Kona*

Accident no.	DCA16FM046
Vessel name	<i>Spirit of Kona</i>
Accident type	Grounding and breakup
Location	Kailua Bay, Island of Hawaii, Hawaii; 19°38.2' N, 156°00.0' W
Date	July 24, 2016
Time	About 0220 Hawaii-Aleutian standard time (coordinated universal time – 10 hours)
Injuries	None
Property damage	\$1.1 million est.
Environmental damage	About 275 gallons of diesel and lubricating oil in water
Weather	Overcast, rain squalls, southeast winds at 22 knots with gusts up to 27 knots, seas 8–10 feet, air and water temperature 80°F
Waterway information	Kailua-Kona is located on the west (dry) side of the Island of Hawaii and is a popular tourist destination. The port has a pier used by cruise and charter boats. There is no breakwater to protect this small exposed harbor. Many of the vessels home-ported in Kailua Bay use offshore moorings. The coastline is mostly black, jagged lava.

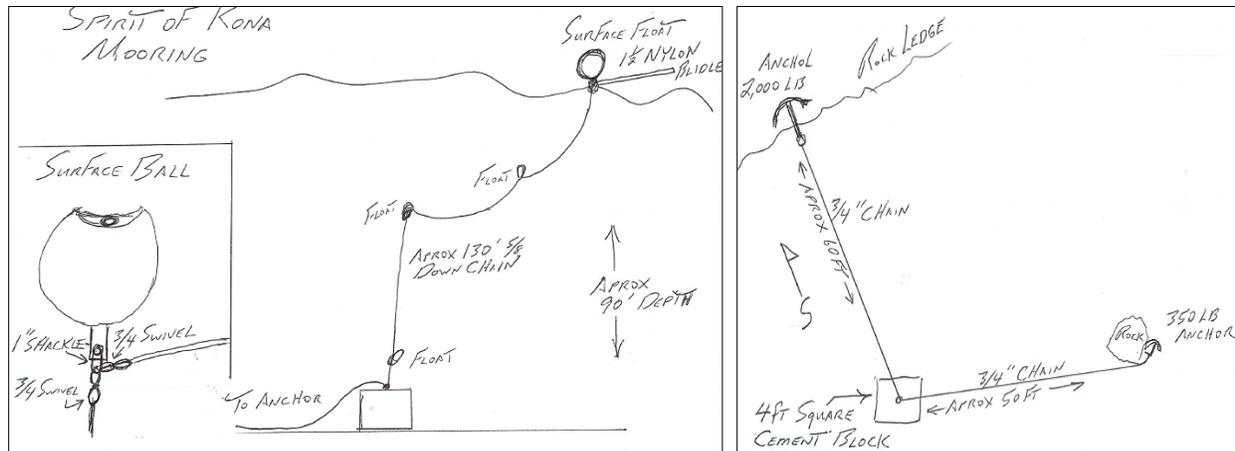
The *Spirit of Kona* was kept at an offshore mooring position about 0.4 nautical miles south of the Kailua pier. The privately owned mooring arrangement, as described by the vice president of Blue Sea Cruises, consisted of two anchors—one weighing 2,000 pounds; the other, 350 pounds—along with chains on the sea floor in about 90 feet of water. These anchors were attached to a block of concrete and positioned with the larger anchor in a southerly direction and the smaller anchor in a westerly direction from the block. A chain was suspended from the block by three subsurface floats and connected to a “surface ball” by a swivel and shackle. The *Spirit of Kona* used a mooring bridle consisting of two nylon lines, attached to the port- and starboard-bow mooring bits of the boat, that connected to the surface ball. At the ball, the lines were secured together by a shackle that connected to another swivel at the surface ball.

Sketches of the *Spirit of Kona's* mooring arrangement (not to scale) drawn by the vice president of Blue Sea Cruises.

The vice president reported to the Coast Guard that everything from the surface ball down to the bottom was in place and intact during his inspection of the mooring installation after the accident. Salvage company Cates International later recovered some of the 1.5-inch-wide nylon lines that were used as the mooring bridle, but the shackle that attached the 0.75-inch swivel to the buoy was missing. Investigators later discovered that a shackle, suspected to be the one that connected the mooring swivel to the surface ball, was recovered. That shackle showed no visual signs of deformation or other damage and was therefore ruled out as the source of failure. The mooring's swivel and section of line to which the shackle had been connected was not found. It is likely, but undetermined due to the missing material, that the failure point was located between the swivel connected to the bridle and the boat. Because these items were not recovered and the mooring installation itself was found intact, investigators could not determine whether the failure occurred at the bridle connection or at the swivel connected to the shackle and chain. Prior to Tropical Storm Darby, there were no noted cases where the *Spirit of Kona* had broken free from its mooring.

The National Transportation Safety Board determines that the probable cause of the grounding and subsequent breakup of the *Spirit of Kona* was the failure of the vessel's mooring equipment in tropical storm conditions. Contributing to the *Spirit of Kona* breaking free from its mooring was the failure of Blue Sea Cruises to take additional precautions to secure the vessel in advance of an oncoming tropical storm.

There was no requirement for Blue Sea Cruises to place a crew on board the *Spirit of Kona* during tropical storm conditions to maintain the position of the vessel at the mooring. On the contrary, hurricane and tsunami guidance advises boaters not to stay on board after securing their vessels but instead to “go ashore and seek shelter and safe haven.”⁴ The guidance also recommends doubling anchor lines (or chains); placing anti-chafing wrap on lines; checking cleats, chocks, and winches; and ensuring that the vessel's battery is able to run the automatic bilge pumps. Although the vice president stated that he did check on the vessel before the storm, he took no additional precautions such as placing extra lines or chains on the vessel or adding anti-chafing wrap to existing lines.

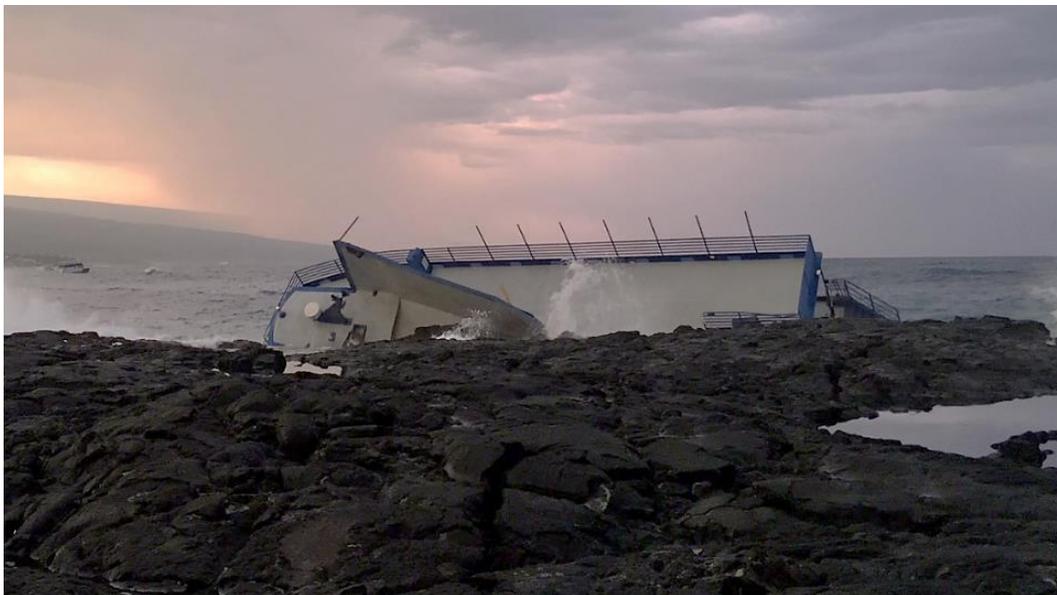
On notification, Coast Guard and Hawaii state officials proceeded to Kukailimoku Point, where the *Spirit of Kona* had grounded. They witnessed the vessel partially sunken, listing heavily to port, and being battered by the storm surf. Local police notified the vice president of Blue Sea Cruises, who arrived on scene a short time later.

Spirit of Kona lying on its port side on the rocks near Kukailimoku Point. (Photo by Coast Guard)

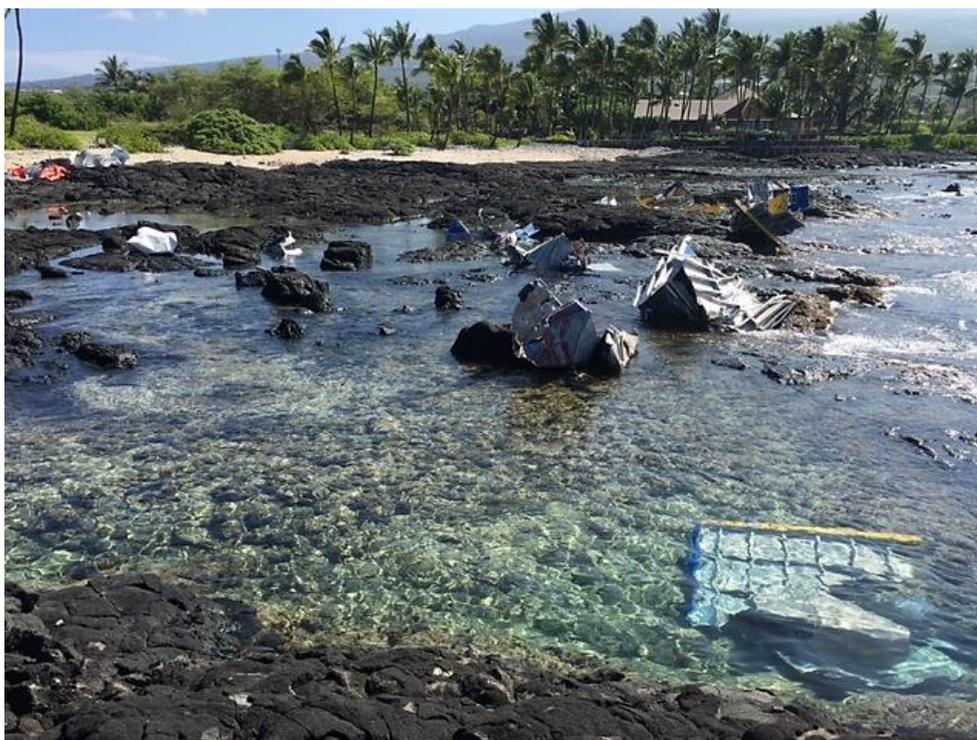
About 0855, according to an attending state official, the *Spirit of Kona* disappeared beneath the waves, leaving behind debris and an oil sheen. According to the Coast Guard, no other boat broke free from its mooring during the storm.

Wreckage of the *Spirit of Kona*. (Photo by Coast Guard)
