# National Transportation Safety Board

## Marine Accident Brief

### Fire aboard Fishing Vessel *American Eagle*

<b>Accident no.</b>	DCA16FM025
<b>Vessel name</b>	<i>American Eagle</i>
<b>Accident type</b>	Fire
<b>Location</b>	South Pacific Ocean, about 790 miles northeast of American Samoa 06°29.4' S, 159°58.8' W
<b>Date</b>	February 10, 2016
<b>Time</b>	0710 Samoa standard time (coordinated universal time – 11 hours)
<b>Injuries</b>	None reported
<b>Property damage</b>	>\$500,000 est.
<b>Environmental damage</b>	None reported
<b>Weather</b>	Clear with visibility to 17 miles, winds east at 8 knots, air temperature 87°F
<b>Waterway information</b>	Open ocean with 3-foot swell, current 235° at 1.3 knots

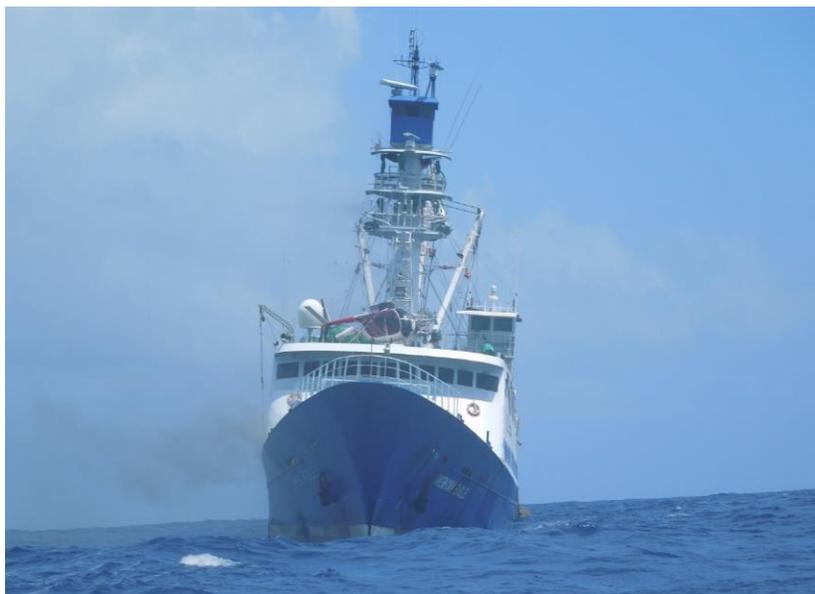
***American Eagle* abandoned and listing to port. (Photo by *American Eagle* crew)**

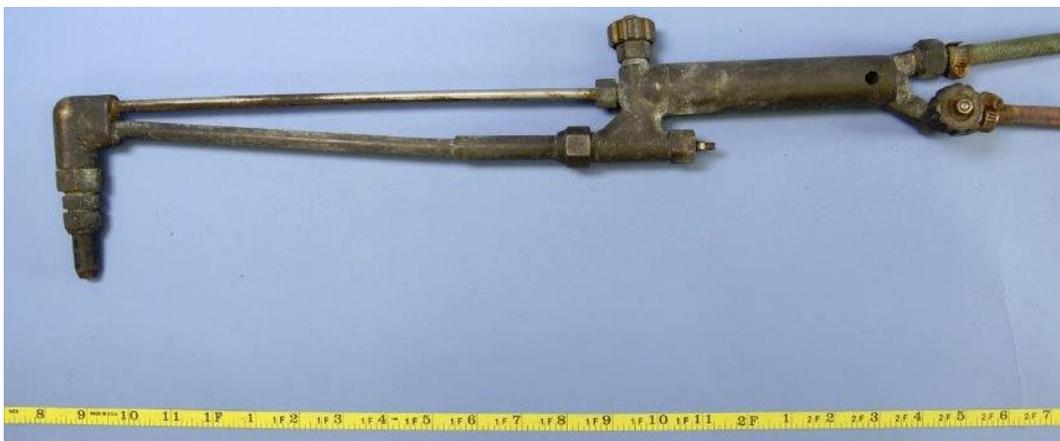
**Oxy-acetylene torch recovered from *American Eagle*.**

An approximately 90-foot-long dual-gas hose was rigged between the torch and the melted end near the fire. The oxy-acetylene torch and two sections of hose (one adjacent to the torch, the other to the regulator) were examined at the NTSB's Materials Laboratory to determine potential causes for the fire. Although the hose closest to the fire as well as the cylinder valves and gauges were destroyed by the flames and heat, investigators were able to determine two possible mechanisms that could have led to the initiation of the fire based on the sections provided: leakage from the hose and flashback.

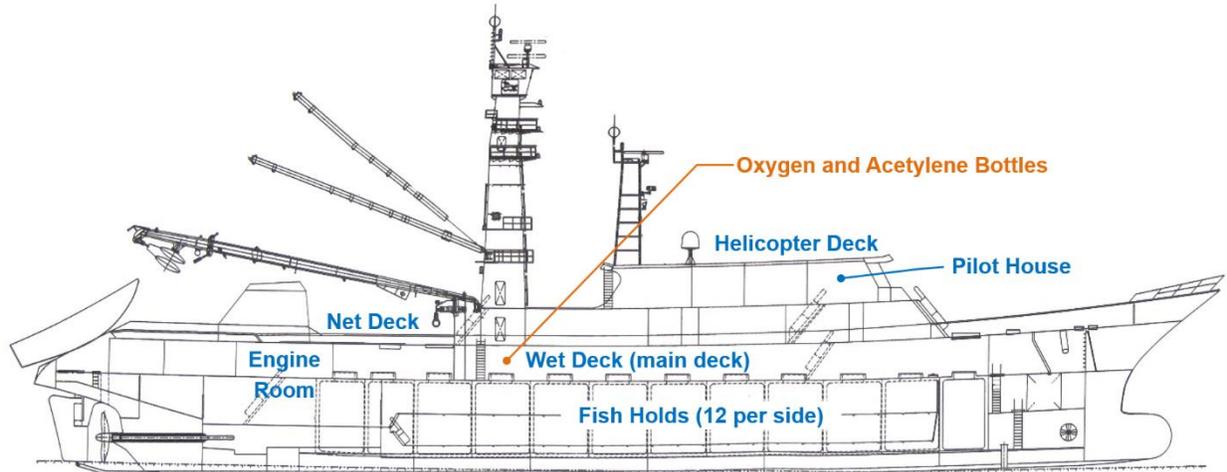
About the same time, a crewmember who was in the chief engineer’s cabin heard a loud explosion. He left the cabin and walked aft to a ladder leading down to the wet deck on the starboard side. From the top of the ladder, he witnessed flames at the base of the ladder where the oxygen and acetylene cylinders had been stored. He told investigators that the flames were coming from the gauges on top of the tanks.

**Schematic of *American Eagle* identifying location of oxygen and acetylene bottles.**

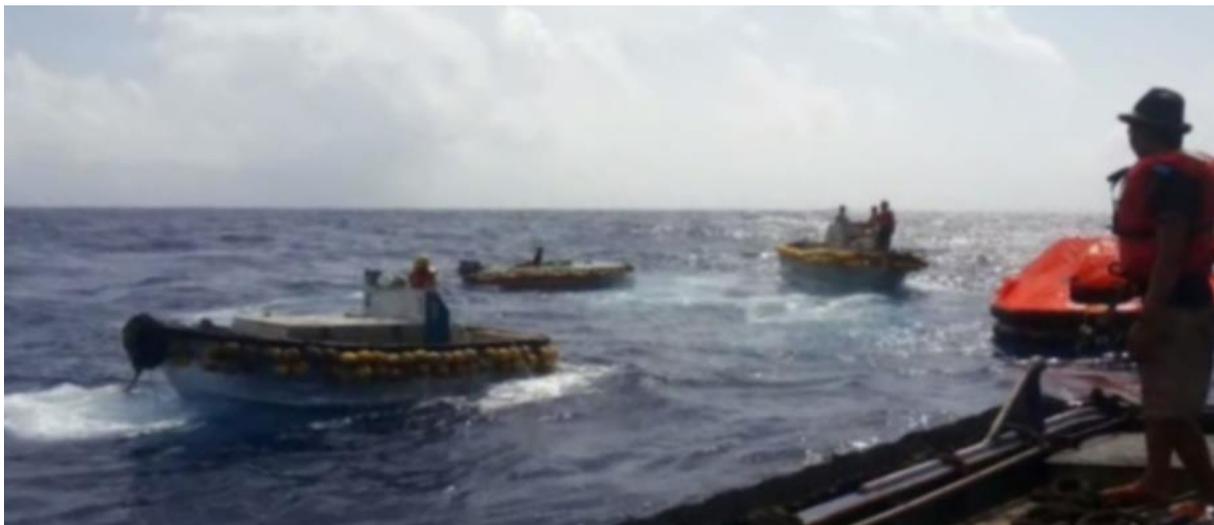
Frame from crew video taken from the *American Eagle's* skiff of ship's boats and liferafts adrift after abandoning ship. (Video provided by Coast Guard)

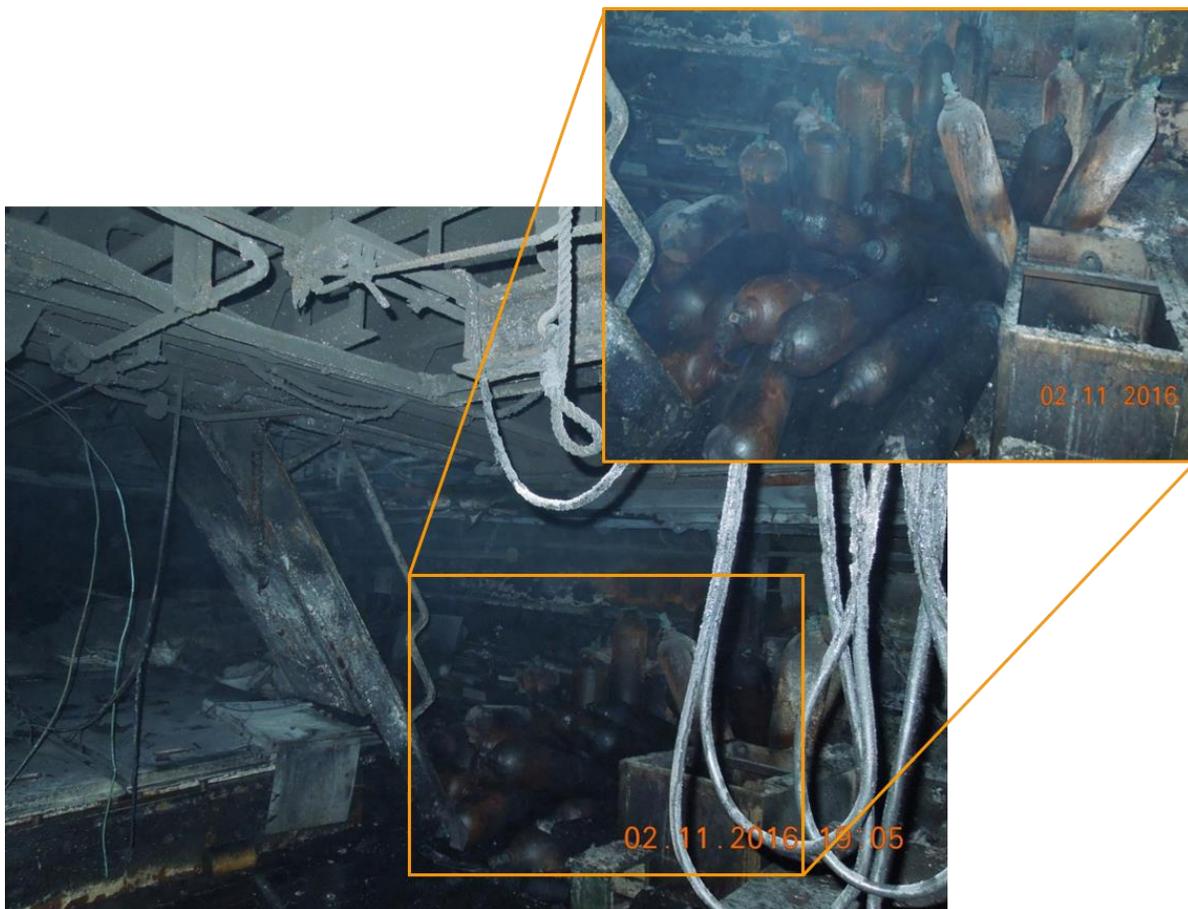
The fuel source for the fire was determined to be acetylene gas stored in several cylinders. Oxygen and acetylene cylinders were stored together on the wet deck near the ladder on the starboard side. The captain said they were secured to the bulkhead by a strap. Typically, the welders secured the oxy-acetylene torch by closing the valves on the torch side of the assembly only; the valves for the “in use” oxygen and acetylene bottles and regulators were always left open on the tank side and ready for immediate use. Post-fire, investigators found that none of the oxygen or acetylene bottles had safety caps that are normally installed when not in use to protect the valves atop the cylinders from damage.

A waste bucket used for discarded cigarette butts was located adjacent to the cylinders. Investigators learned that the area on the wet deck near the ladder was a regular smoking stop for the crew who passed through the space.

Oxygen and acetylene bottles post-fire on the starboard side of the wet deck aft of the ladder, with close-up of bottles without safety caps. Bottles were displaced from their storage location forward of the ladder. (Photo by *American Eagle* crew)

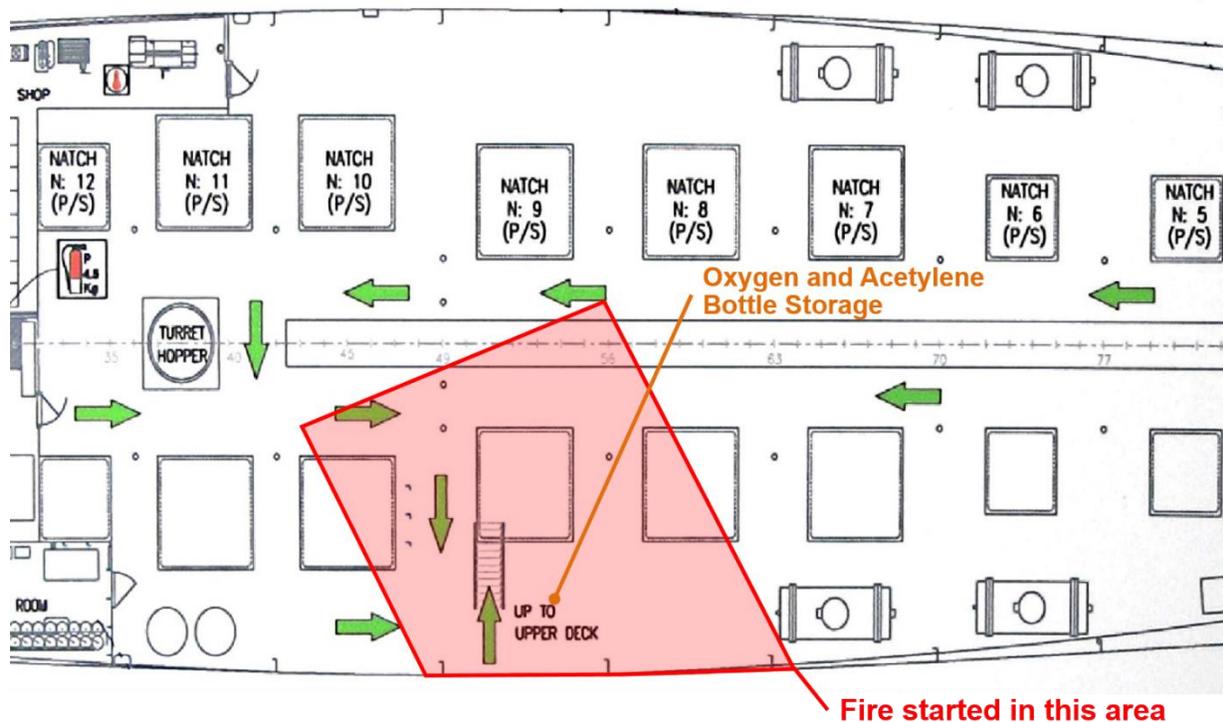
**Wet deck layout including locations of oxygen and acetylene bottle storage and area where Coast Guard investigators determined the fire likely started. Green arrows show planned egress routes from the wet deck. (Schematic from *American Eagle's* "Fire Control & Life Saving Plan")**

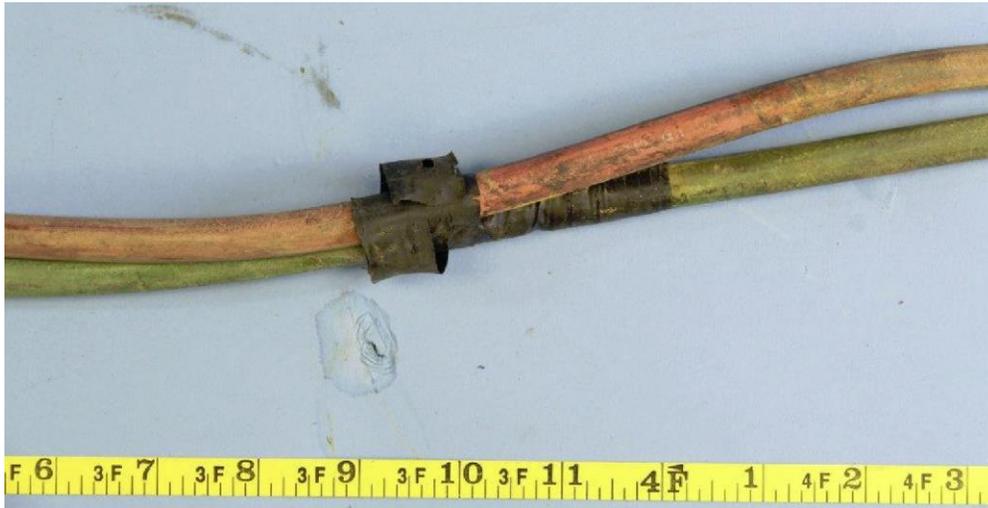
Leakage from the hose was the most likely cause based on the evidence. The examined welding apparatus hose was in poor condition with discoloration, color fade, crazing, cracking, bending wear, several holes, and a 6-inch electrical tape repair at a hose separation. Several of the holes had been repaired, which is not a recommended practice. Leakage from the acetylene hose alone was an ignition hazard because there is essentially no lower or upper flammability limit for the gas (lower flammable limit: 2 percent; upper flammable limit: 98 percent). Any leakage from the oxygen lines only intensified the potential condition, likely creating the flammable atmosphere

Nevertheless, flashback is the less likely of the two potential causes of the fire because the hose showed no signs of thermal damage or an explosion (bulging, tearing, etc.). In addition, flashback usually takes place while the torch is in use, while at the time of the fire the torch had just been shut off. The visible damage to the hose was more consistent with photo/environmental degradation of the polymeric hose material (faded exterior color, surface crazing and cracking, and splitting).

**Recovered hose with evidence of repairs consistent with electrical tape. The entire lengths of both hose sections showed signs of degradation.**

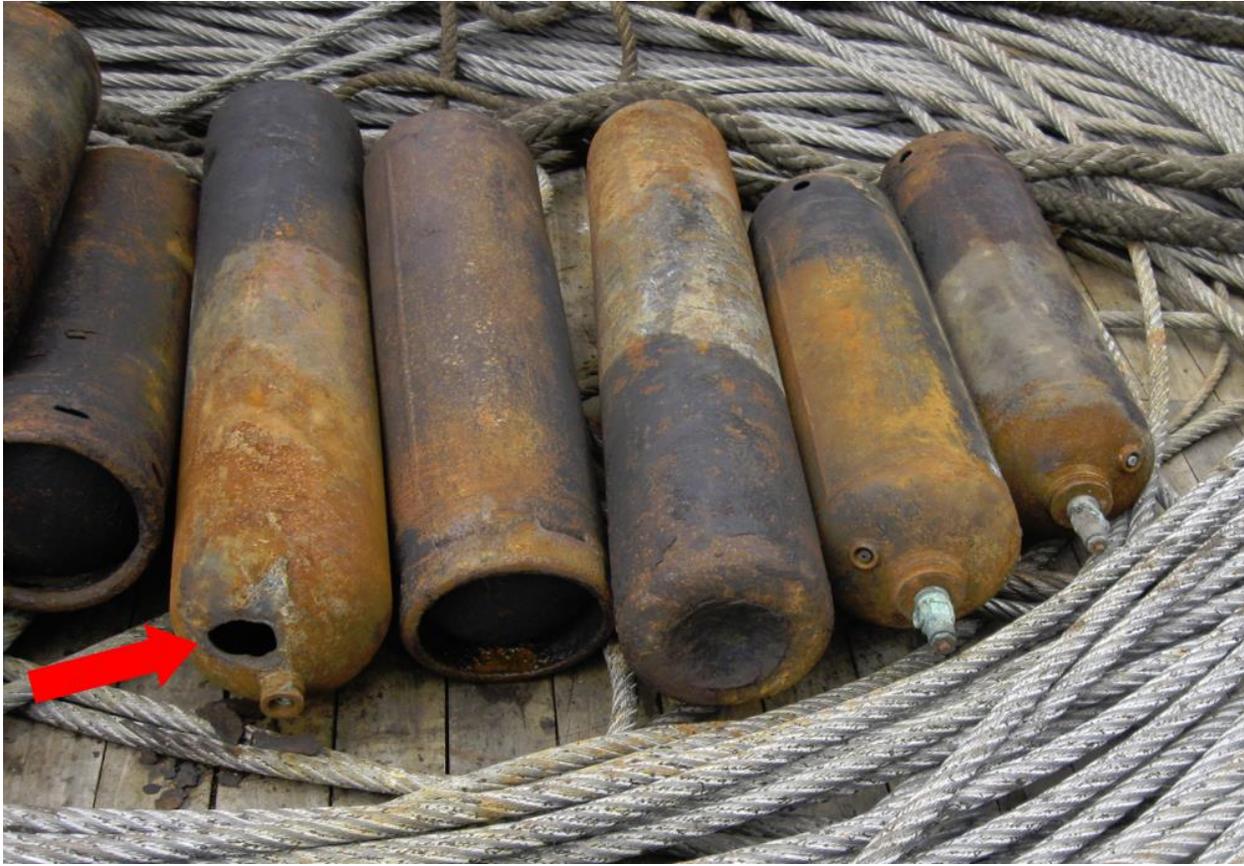
Once the fire started, the substantial number of oxygen and acetylene bottles in the space would have provided enough fuel and oxygen to make the fire difficult to extinguish. To avoid cylinder explosions, acetylene bottles have low-temperature melting fuse plugs at the top of the cylinder to allow gas to escape when the cylinder becomes heated. Following the fire, some cylinders had melted holes where fusible plugs had been fitted. The pressurized gas contents of the cylinders were released to the fire through these holes.

Oxygen and acetylene bottles on deck post-fire. Arrow shows a hole at the melted pressure-relief fusible plug location on one of the bottles. (Photo by Coast Guard)
