National Transportation Safety Board

Marine Accident Brief

Sinking of Fishing Vessel *Capt. Kevin*

Accident no.	DCA16FM043
Vessel name	<i>Capt. Kevin</i> (formerly the <i>Sou'Wester III</i> , the <i>Capt. Tammy</i> , and the <i>Lucky I</i>)
Accident type	Sinking
Location	Gulf of Mexico, Sabine Pass Jetty Channel, 29°38.9' N, 093°49.7' W
Date	July 11, 2016
Time	0400 central daylight time (coordinated universal time – 5 hours)
Injuries	Minor injury from diesel fuel ingestion
Property damage	\$139,500 est.
Environmental damage	Undetermined quantity of diesel and lube oil leaked from the vessel, which had an estimated 1,000 gallons of diesel fuel on board.
Weather	Visibility 10 nautical miles, south winds at 16 knots, seas 4–6 feet, air temperature 84° F, water temperature 88.5° F.
Waterway information	Sabine Pass Jetty Channel: two parallel jetties 550 yards apart extend 3.5 miles from shore. Controlling depth is 40 feet; depths outside the channel are 8–16 feet.

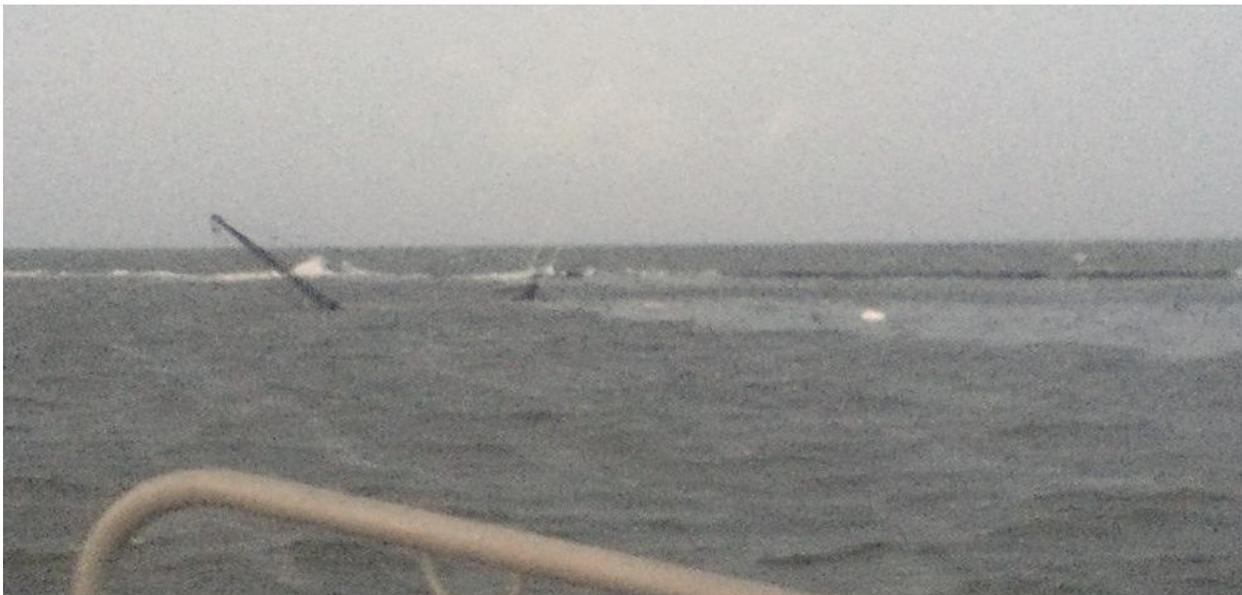
The sunken *Capt. Kevin* leaking oil with the western Sabine Pass jetty in the background. (Photo by Coast Guard)

The captain bought the *Capt. Kevin* on September 16, 2015, for \$9,900. He told investigators that he had made temporary soft-patch repairs to a damaged section of the fiberglass hull on the starboard side of the bow that extended below the waterline. This section was 2 feet by 4 feet in size and located on the integral forepeak tank. He made the repairs using a store-bought fiberglass repair kit while the vessel was in the water. The captain believed that, about 0300 on the morning of the sinking, the temporary fiberglass patch failed and the vessel began taking on water in the forepeak.

The National Transportation Safety Board determines that the probable cause of the sinking of the *Capt. Kevin* was (1) an inadequate and temporary hull repair that failed, allowing flooding of the vessel's interior spaces, and (2) the crew not securing the watertight hatch to the forepeak that would have contained the flooding to the forepeak tank.

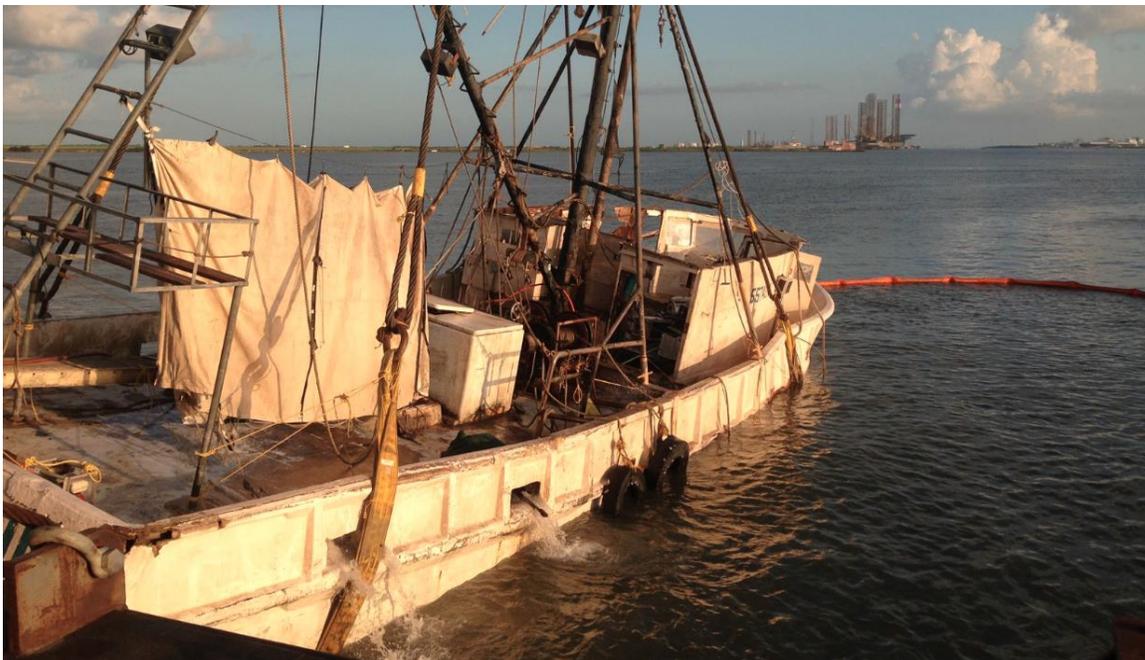
The recovery of the *Capt. Kevin* by derrick barge *Mr. Two Hooks*. (Photo by Coast Guard)
