National Transportation Safety Board

Marine Accident Brief

Flooding and Sinking of Small Passenger Vessel *Maximus*

Accident no.	DCA16FM039
Vessel name	<i>Maximus</i>
Accident type	Flooding and sinking
Location	Turtle Bay, Mexico, 27°29.5'N, 114°50.1'W
Date	May 12, 2016
Time	1655 Pacific daylight time (coordinated universal time – 7 hours)
Injuries	None
Damage	\$575,000 est.
Environmental damage	None reported
Weather	Clear, visibility 8 miles, winds north-northwest at 25 mph, 3–4-foot seas, air temperature 65°F, water temperature 60°F ¹
Waterway information	Turtle Bay is located on the west coast of Mexico's Baja California peninsula.

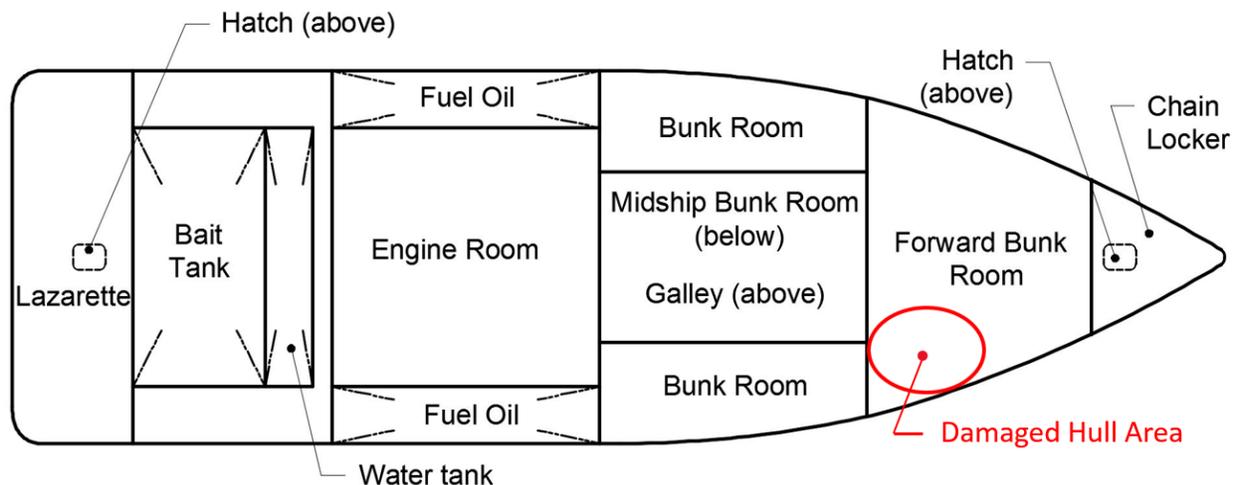
Simplified top-view diagram of below-deck compartments. The area of hull damage is circled in red.

The mate ran to the engine room, opened the suction valve for the forward bunk room, and started the bilge pump. The captain ordered the remaining crewmembers to grab 5-gallon buckets and start bailing water out of the forward bunk room and to find the location of flooding. The captain and the mate quickly eliminated all sources of seawater going forward from the engine room to the forward heads and the bait tanks. Then the captain instructed the crew to use the portable electric fuel-transfer pump to remove water from the forward bunk room as he attempted to contact the US Coast Guard on marine single-sideband (SSB) radio without success. The captain used a satellite phone to contact his wife and asked her to relay their emergency and coordinates to the Coast Guard; at 1727, Coast Guard Sector San Diego received her call. The captain left the wheelhouse to assess the flooding. When he stood outside the engine room hatch, he noticed water in the midship bunk room, indicating that the flooding had progressed aft to a second watertight compartment. The location of water ingress was not identified from inside the bunk rooms and the water continued to rise.

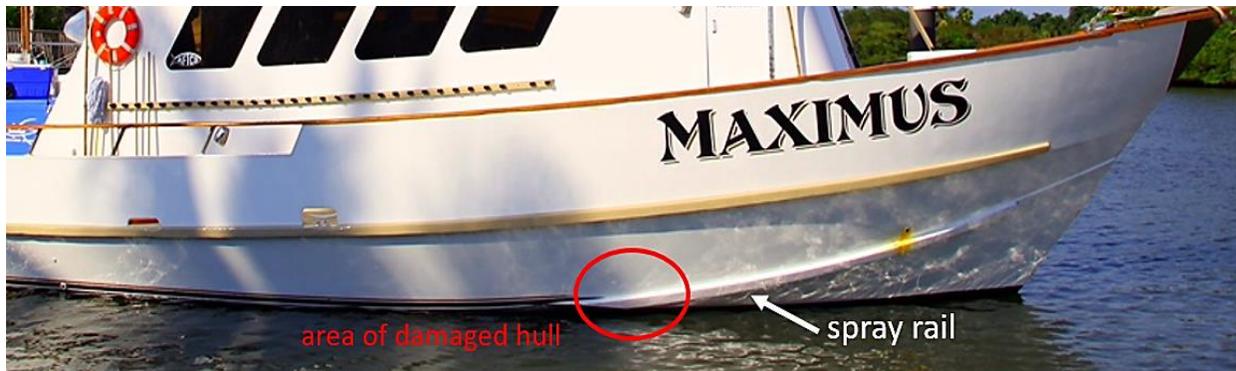
The mate went forward, opened the chain locker hatch forward of the forward bunk room, and entered the space to assess the water level, which was normal. He then grabbed a snorkel mask and jumped overboard, attempting to survey the underside of the hull. However, the ocean waves were pounding against the hull, and poor water clarity prevented him from effectively surveying below the waterline. As he made his way toward the bow on the starboard side, he discovered a “softball-size” section of the hull missing at the wooden spray rail at the waterline. As the mate described it, “a V-shaped piece was missing, a chunk [of the hull] was gone.” He did not stay in the water long because the waves continued to pound him against the vessel. The cook used a gaff to pull the mate from the water, and the mate told the captain what he had found.

***Maximus* in Cabo San Lucas before the accident. A red circle indicates the reported area of hull damage. (Photo by Maximus Sportfishing)**

For more than an hour and a half, the *Maximus* captain and crew continued to dewater the vessel without success. The captain determined that the flooding could not be slowed based on the hole in the hull and the limited capacity of the bilge pump, and that he and the crew should abandon ship. He instructed the mate to distribute lifejackets to the crew, and they all went to the top deck to manually launch the liferaft that was stowed there. The captain removed the hydrostatic release unit and lashing. The crew attached an additional 45 feet of line to the painter and threw the liferaft canister from the top deck into the water. The liferaft inflated and was tied off on the leeward side of the vessel while the crewmembers began collecting their personal items. Then the captain activated the emergency position-indicating radio beacon (EPIRB).²

The National Transportation Safety Board determines that the probable cause of the flooding and sinking of small passenger vessel *Maximus* was a hull breach near the waterline from an unknown cause. Contributing to the accident was the ineffectiveness of the installed high-level bilge alarm system to alert the crew to water accumulating in the hull.

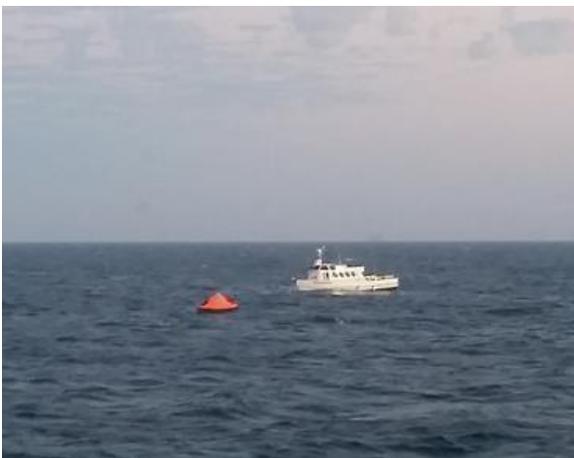
At 1959, helicopter 6501 departed the scene after confirming that the *Maximus* crewmembers were safely on board the *Shannon Dann*. As the helicopter departed, the flight crew observed the *Maximus* floating high in the water with a slight starboard list and trim by the bow, its navigation lights energized. The last recorded position of the vessel was 27°29.5'N, 114°50.1'W.

At left, *Maximus* and its liferaft. At right, the *Maximus* crewmembers about to be brought aboard *Shannon Dann*. (Photo by Shannon Dann crew)
