# National Transportation Safety Board

## Marine Accident Brief

### Sinking of Fishing Vessel *Lady Gertrude*

<b>Accident no.</b>	DCA16FM051
<b>Vessel name</b>	<i>Lady Gertrude</i>
<b>Accident type</b>	Sinking
<b>Location</b>	Atlantic Ocean about 40 nautical miles east-southeast of Point Pleasant, New Jersey 40°04.17'N, 73°16.77'W
<b>Date</b>	August 15, 2016
<b>Time</b>	0453 eastern daylight time (coordinated universal time – 4 hours)
<b>Injuries</b>	None
<b>Damage</b>	\$400,000 est.
<b>Environmental damage</b>	Minimal; a light oil sheen was observed. An estimated 2,500–3,000 gallons of diesel fuel were on board the vessel
<b>Weather</b>	Clear visibility, southwest winds at 10 knots, seas 3–4 feet, air temperature 79°F, water temperature 77°F
<b>Waterway information</b>	Atlantic Ocean near the New York-New Jersey Bight; depth about 180 feet.

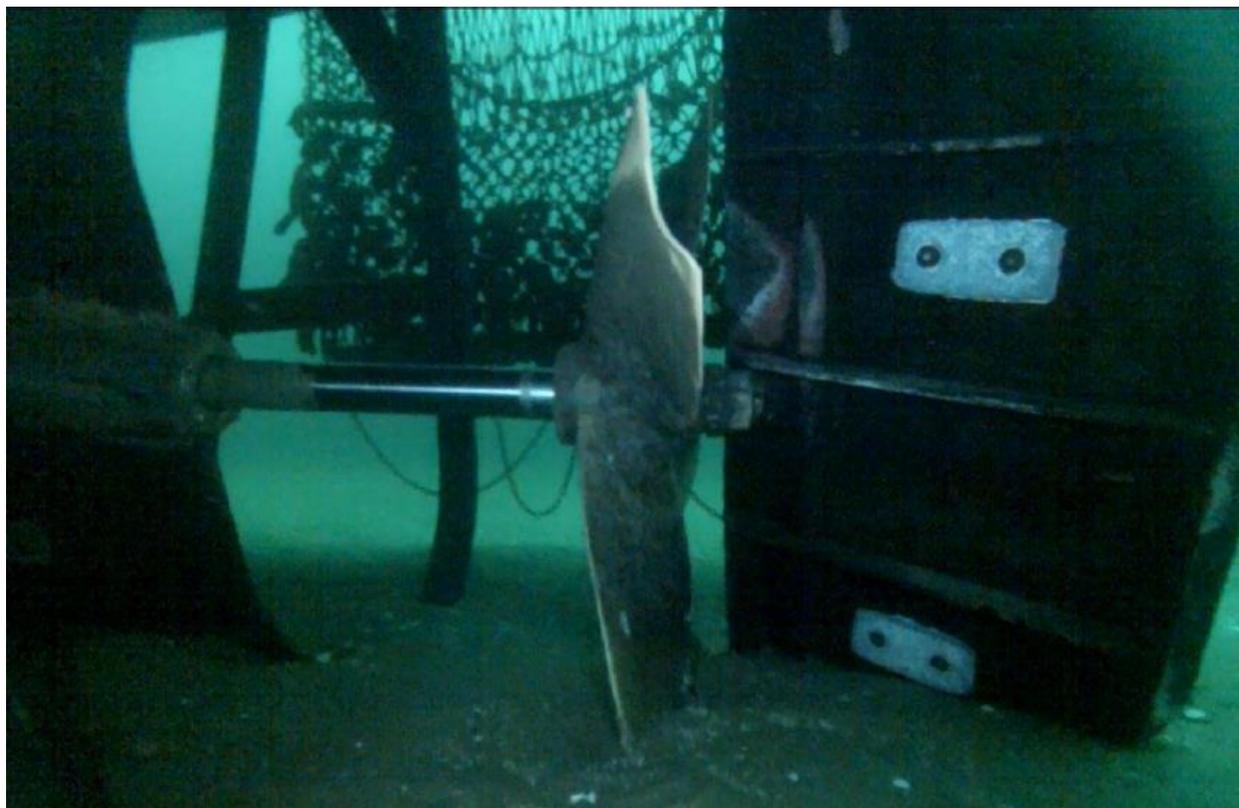
***Lady Gertrude* on the ocean floor. The propeller shaft has backed out of the stern tube and the shaft locking nut is jammed against the balanced rudder. (Photo by Depth Charge Marine)**

A diver inspected the wreck in 180 feet of water the day after the accident. The diver's video showed that the propeller had shifted aft and was jammed against the rudder. The diver

determined it was not safe to enter the fish hold. He did not note any other apparent breaches to the hull. The *Lady Gertrude* was valued at \$400,000.

The National Transportation Safety Board determines that the probable cause of the sinking of the *Lady Gertrude* was the fracture of the propeller shaft forward of the stern tube stuffing box, resulting in uncontrollable flooding of the vessel's fish hold and progressive flooding through non-watertight bulkheads of the engine room and lazarette.
