National Transportation Safety Board

Marine Accident Brief

Flooding of Towing Vessel *Atlantic Raider*

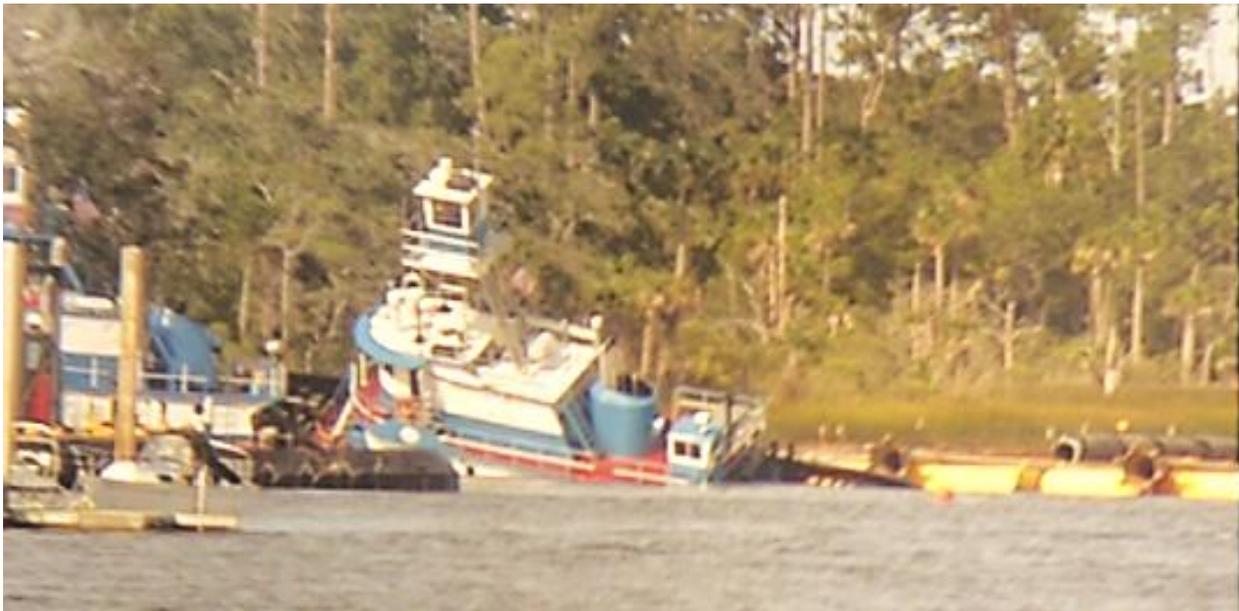
Atlantic Raider aground on the shallows of the west side of the Blount Island Channel. Note that the port quarter is under water up to the lower wheelhouse deck. (Photo by Coast Guard)

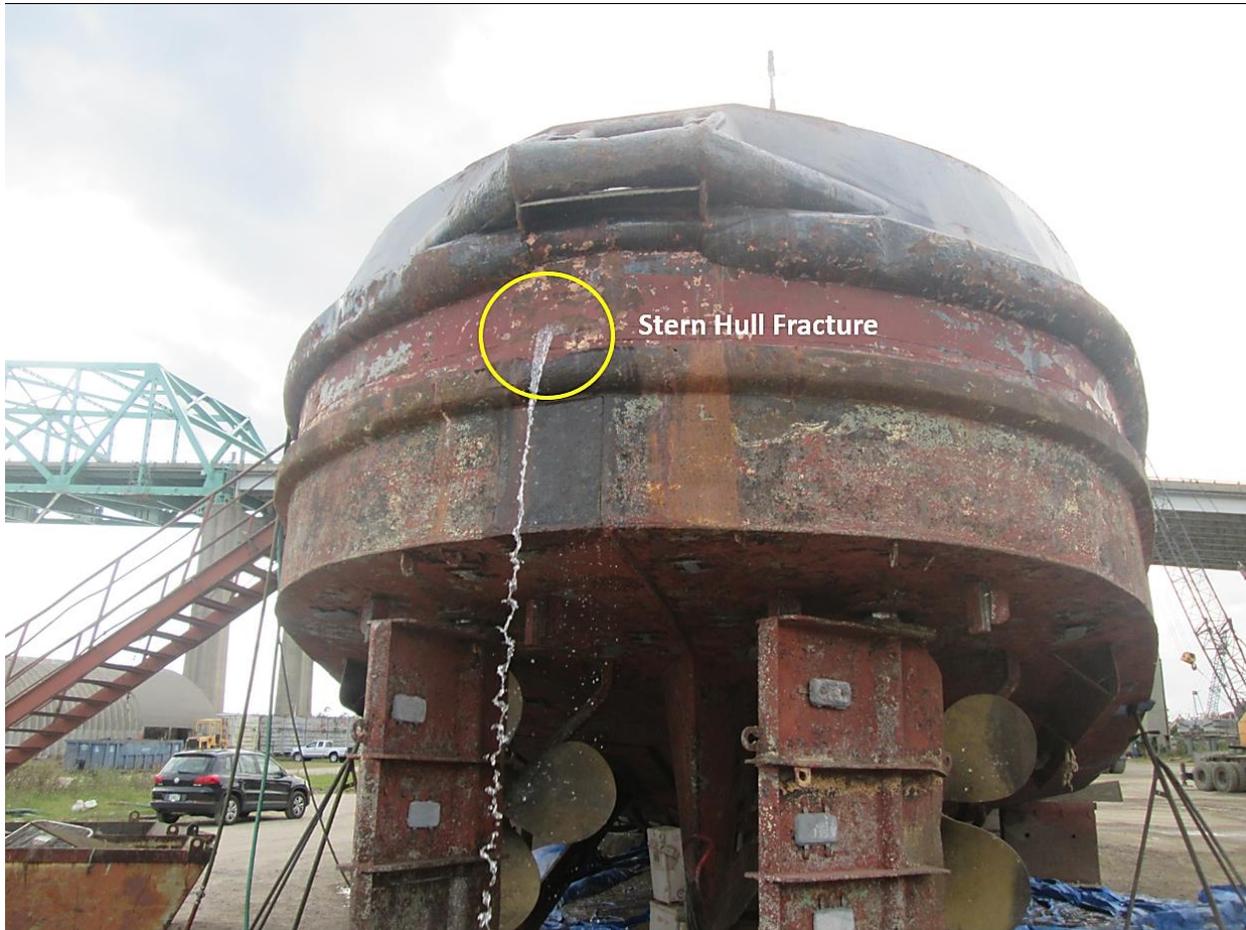
Stern hull fracture discovered in drydock. (Photo with permission of A. P. Boudreaux, surveyor)

On November 30, the *Atlantic Raider* was put into drydock. A horizontal hull fracture 9.5 inches long and 0.5 inches wide was found on the vessel's stern at a weld seam, about 10.5 feet above the keel. The vessel's rudder compartment was on the inboard side of the stern hull fracture. A 1-inch hole and two pinholes were also discovered on the corroded bulkhead leading into fuel tank no. 4. The captain and the owner's representative stated that they did not know of the fracture until after the accident.

According to a company representative, the *Atlantic Raider* did not normally have 26,000 gallons of fuel on board as it did the morning of the accident. At that condition, the draft of the vessel would have been deeper than normal—about 10.5 feet—putting the hull fracture at the waterline. Water likely entered the rudder compartment through the hull fracture and increased the draft by the stern, which would have caused the flooding rate to increase. About 5 hours later, the vessel began to sink by the port quarter.

The National Transportation Safety Board determines that the probable cause of the flooding of the *Atlantic Raider* was a stern hull fracture that allowed ingress of water into the rudder compartment and caused the vessel to sink by the port quarter. Contributing to the accident was flooding through an open door to the engine room.
